FINAL REPORT

on investigation of accident
of aircraft DA-20-A1 Katana
Registration No OK-CLO

Reg. No.: **SKA2014004**

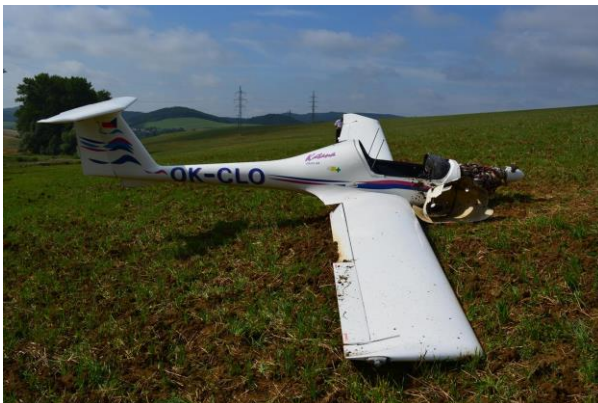
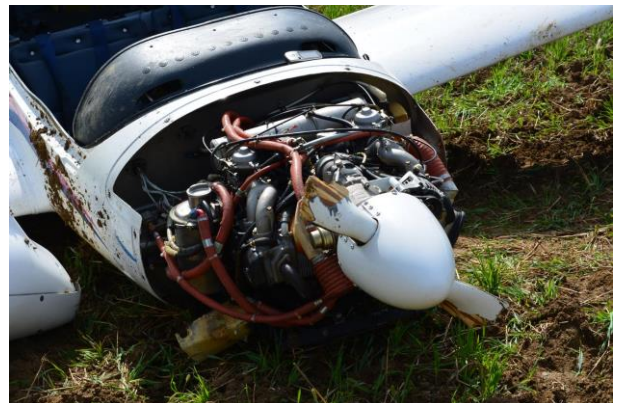
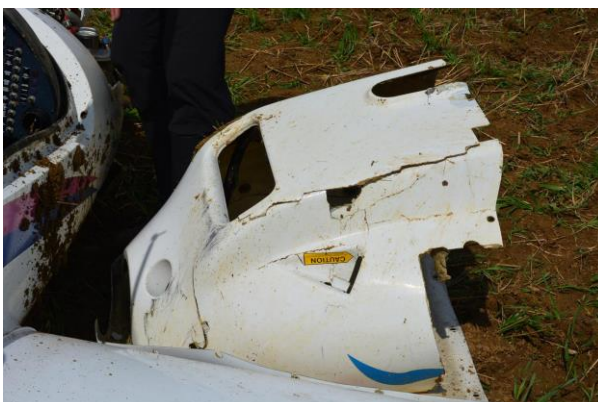
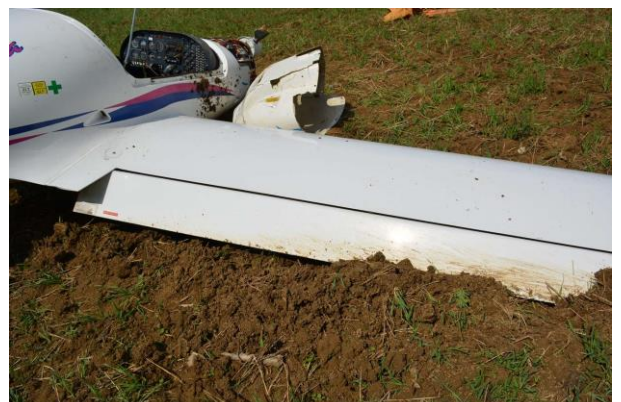
The aircraft was destroyed in the accident.

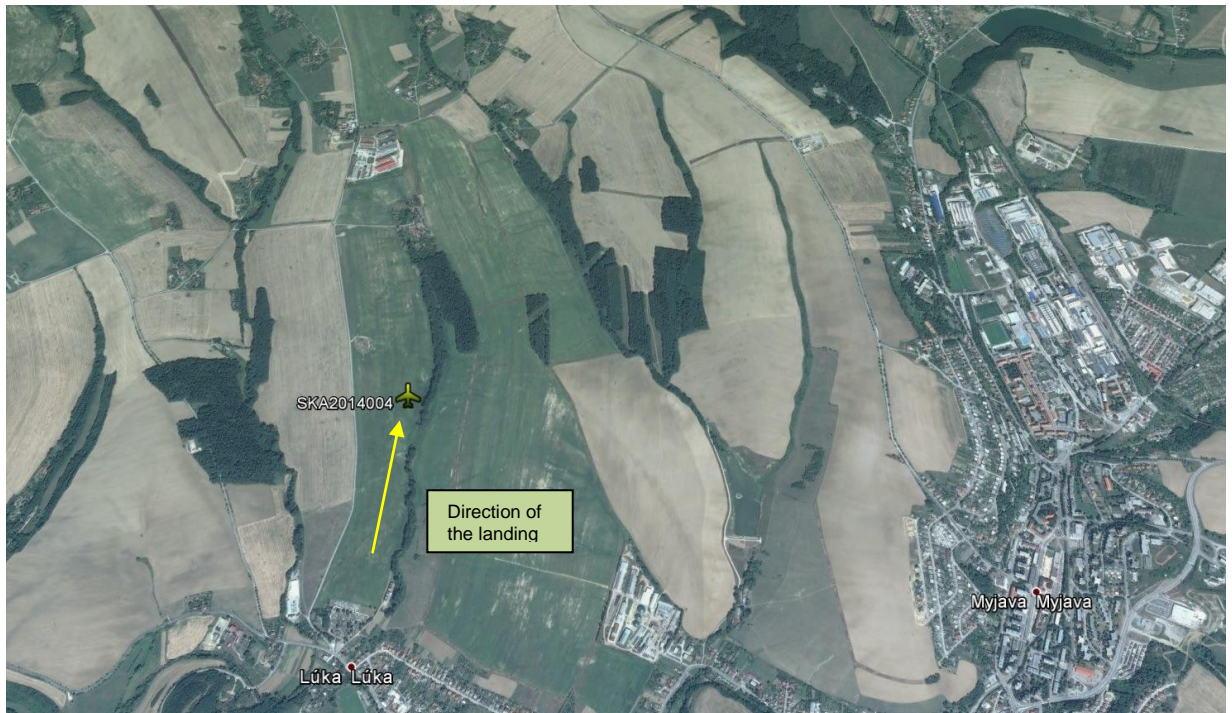
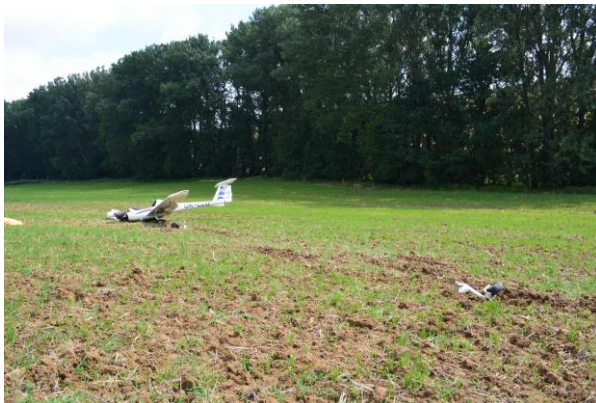
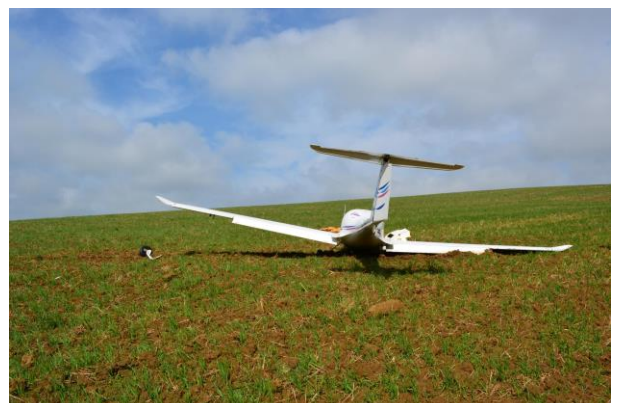
The aircraft was destroyed after it had landed on a drenched field and continued the drift movement with gradual disintegration of its body until the full stoppage.

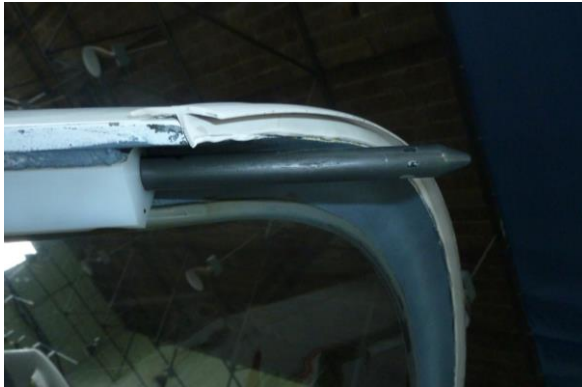
Fig.1 Detail of disengaged locking wedge in the closed position

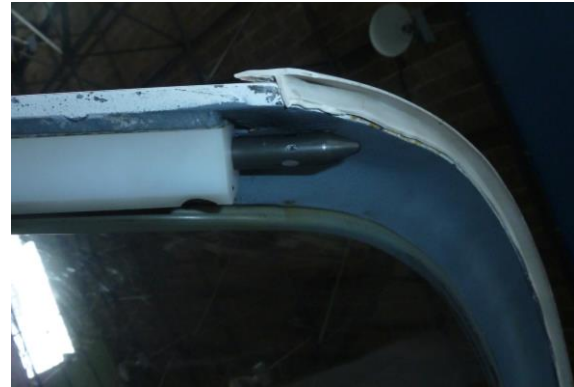
Fig.2 Detail of engaged locking wedge in the opened position

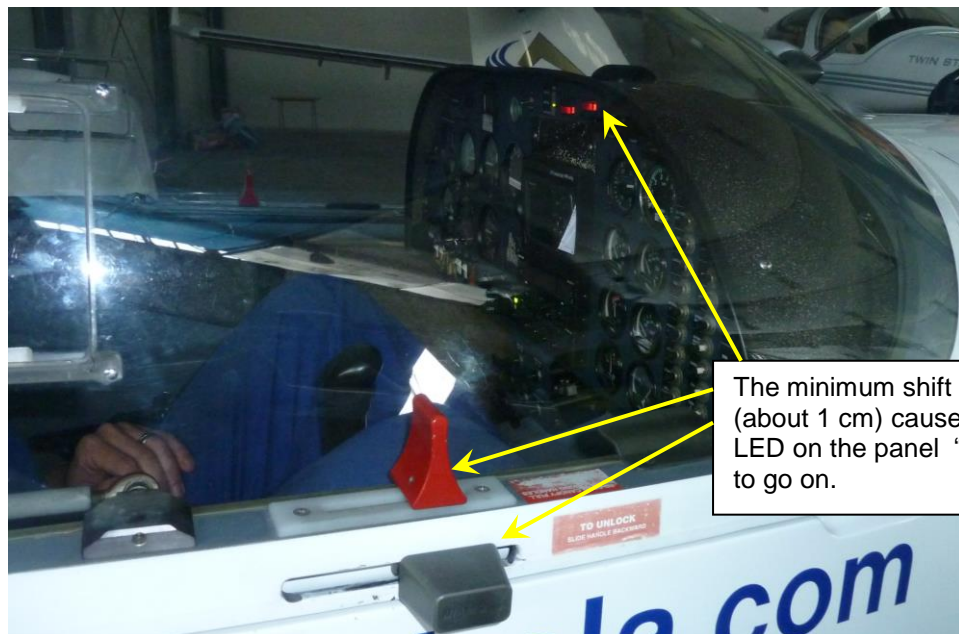
Fig.3 Activation of the LED lamp in the cockpit

Fig.3 documents a slight motion of the cockpit lock handle (as prerequisite of the opening of the cockpit), which causes the activation of the red LED lamp “CANOPY” situated in the view field of both the pilot and the passenger.
