MINISTRY OF TRANSPORT, CONSTRUCTION  
AND REGIONAL DEVELOPMENT  
OF THE SLOVAK REPUBLIC

# FINAL REPORT

on investigation of accident  
of unpowered paraglider **Axispara Pluto L**  
without registration number

Reg. No. SKA2014005

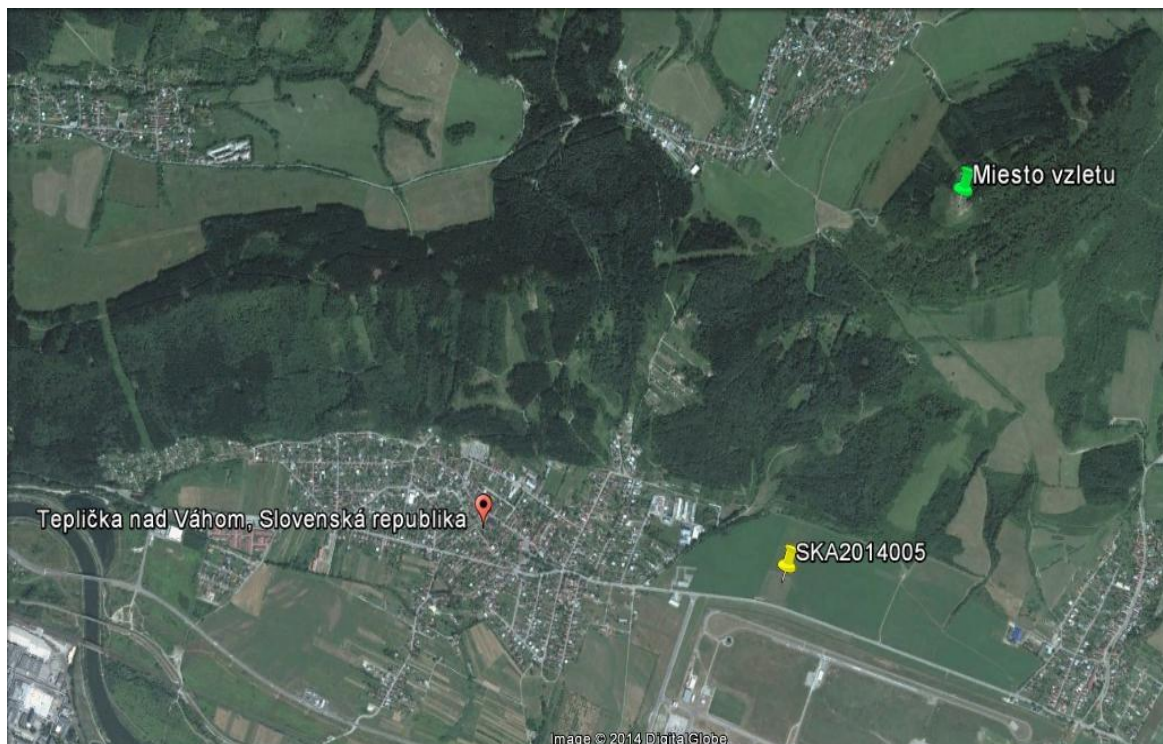
## 1.12 Wreckage and impact information

During the critical flight the pilot made a descent manoeuvre, so-called spiral glide. Upon its termination, when coming out of the spiral flight, the pilot wanted to turn left. UPG collapsed and got into a negative turn, probably due to excessive braking and achievement of stall speed, followed by airflow separation from the airfoil and loss of the lifting force. The pilot tried to balance this collapse, but he failed due to the low altitude and UPG fell to the ground.

After the accident the condition of UPG and its equipment did not show any signs of excessive wear or damage. During the critical flight the pilot had at his disposal a rescue parachute, but the use of rescue equipment was impossible because UPG fell to the ground from a height of less than 15 m.
