FINAL REPORT

on investigation of accident
of helicopter type **CH-7B Cicaré**
Registration No. **OM-M669**

Reg. No. **SKA2014006**

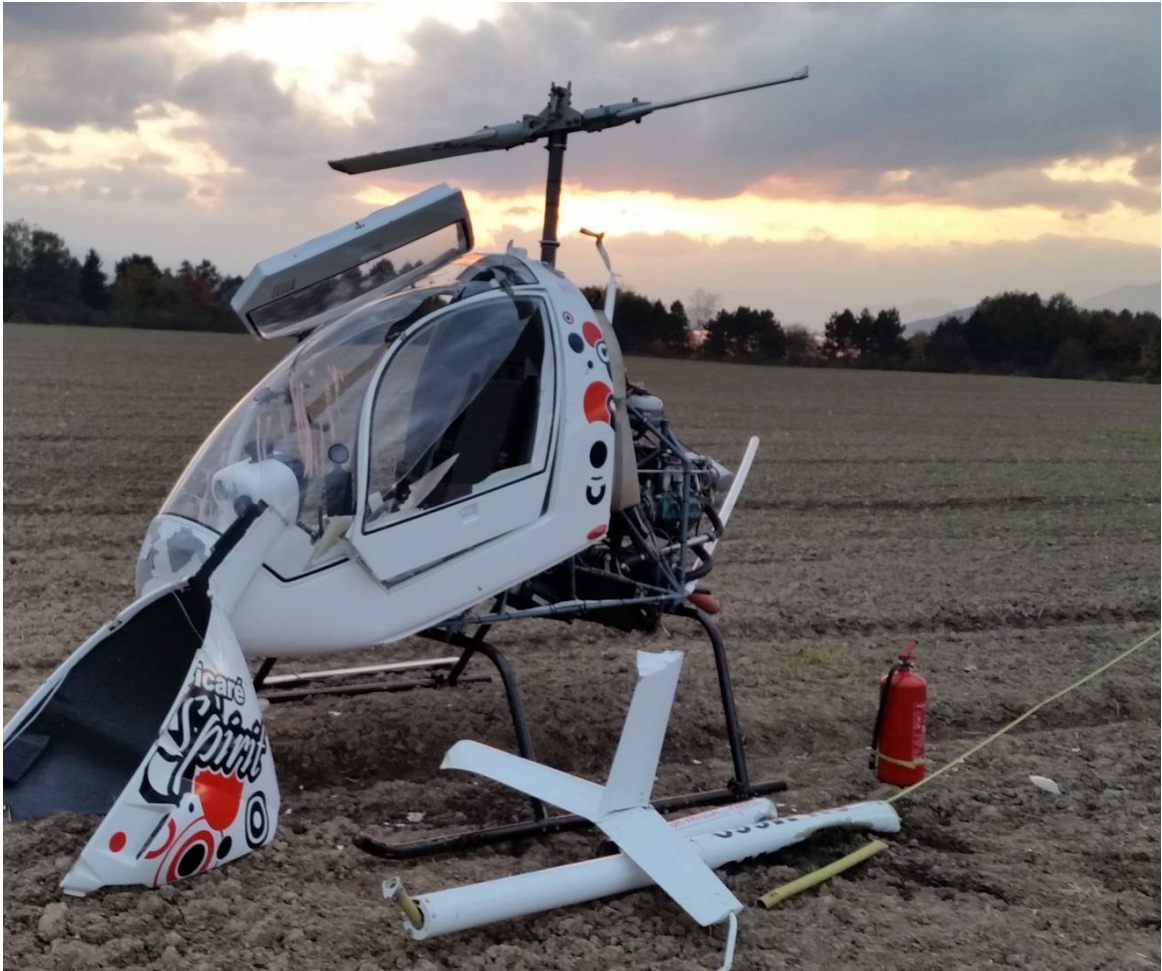
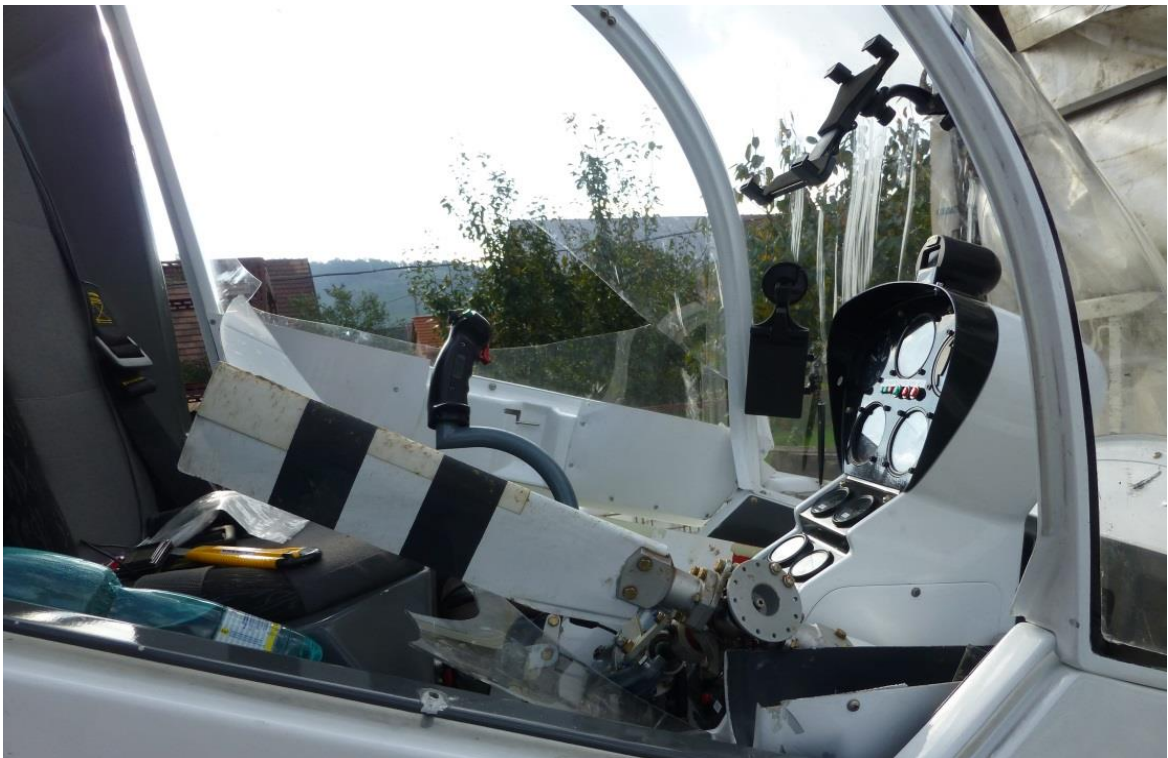
FSV was destroyed in the accident – broken rotor blades, separated tail section, broken cockpit canopy, damaged and bent parts of landing gear.

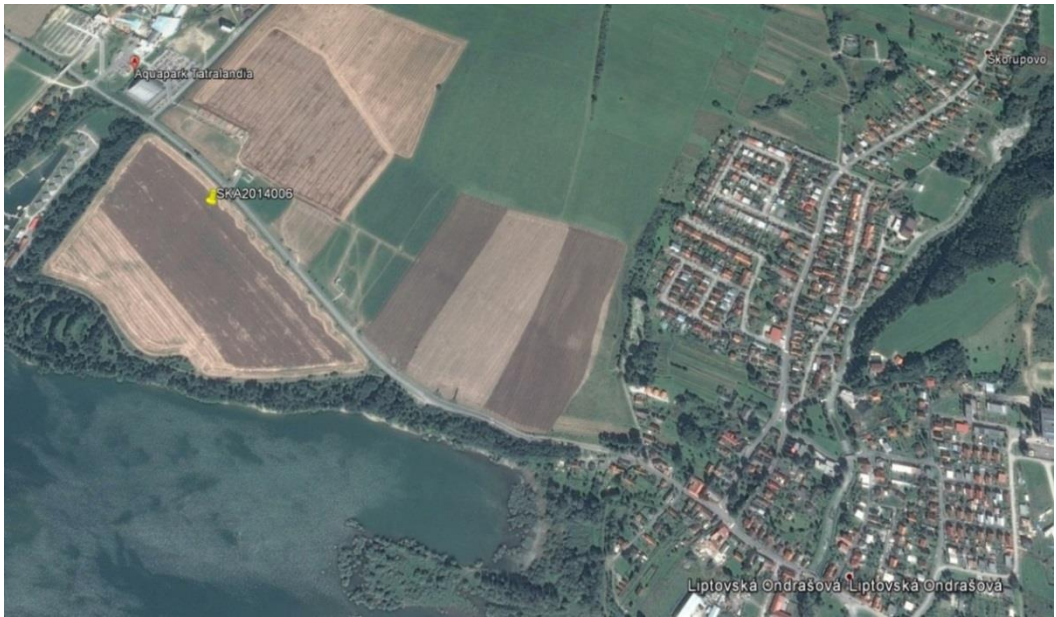
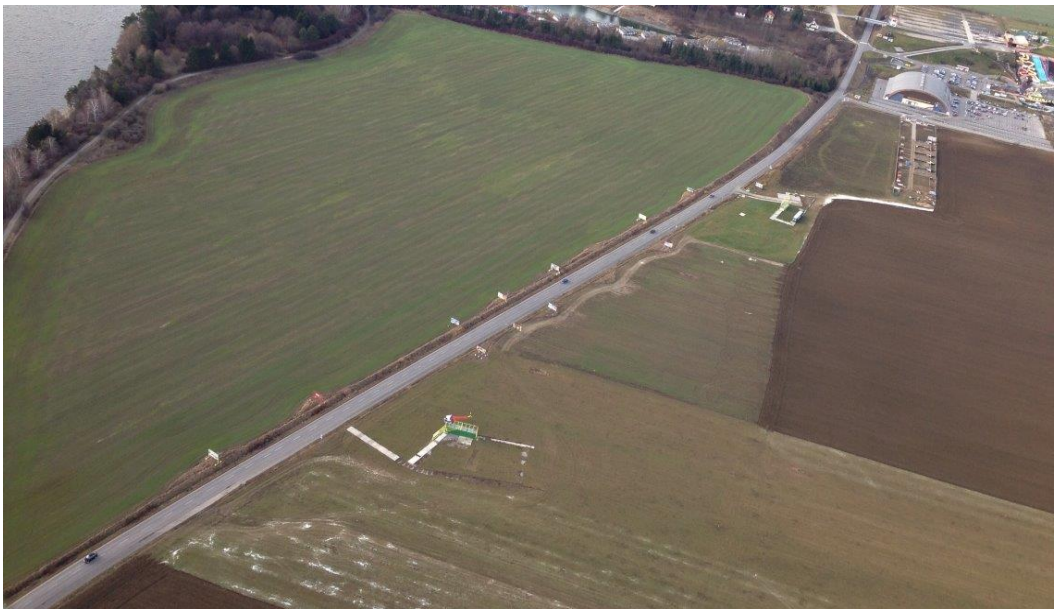
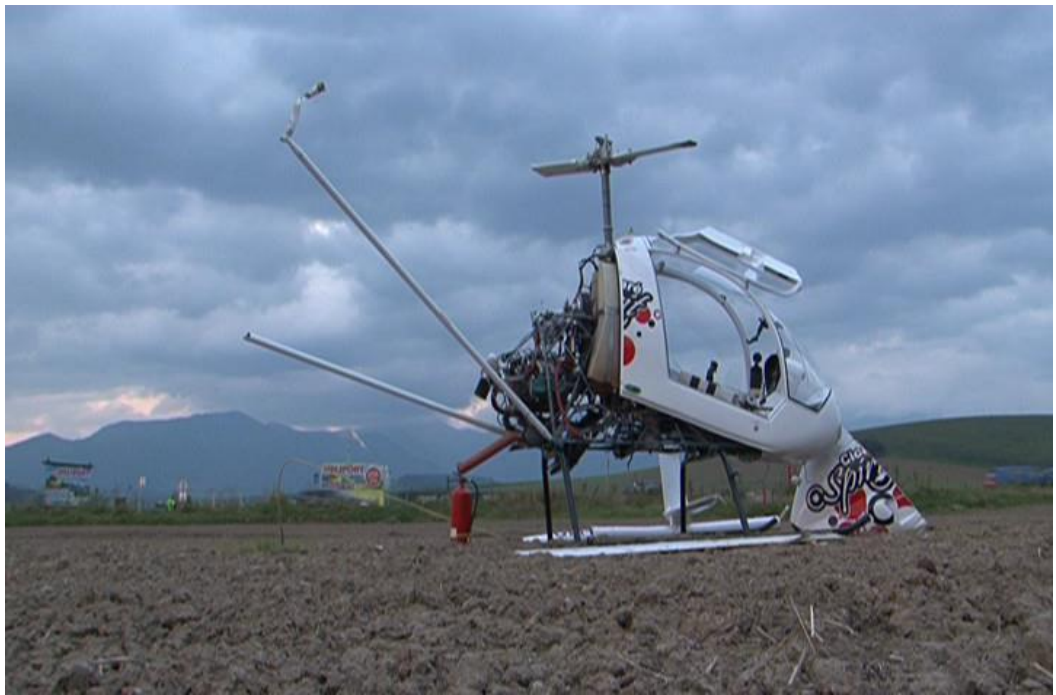
FSV crashed to the field without major obstacles.

The pilot climbed with FSV to a height of 2 m, but when he tried to run up the helicopter above the ground, FSV did not have sufficient power for such take-off due to the tail wind. When FSV flew over the road due to gusty tail wind (from direction of 50°) it sagged and caught the ground with anti-torque rotor and left skid. The tail section with anti-torque rotor was knocked off and FSV landed on the left side.
