FINAL REPORT

on investigation of accident
of flying sport vehicle type **SKY STAR**
Registration No. **OM-M506**

Reg. No.: **SKA2014007**

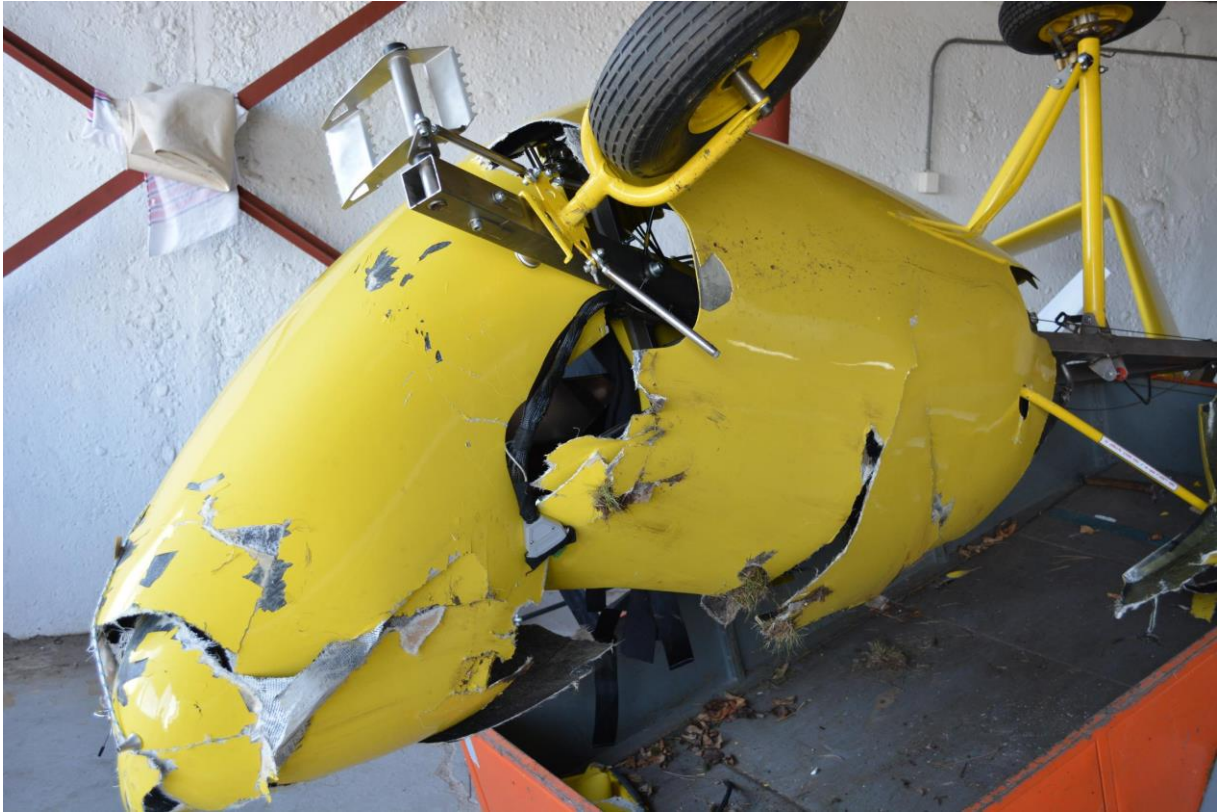
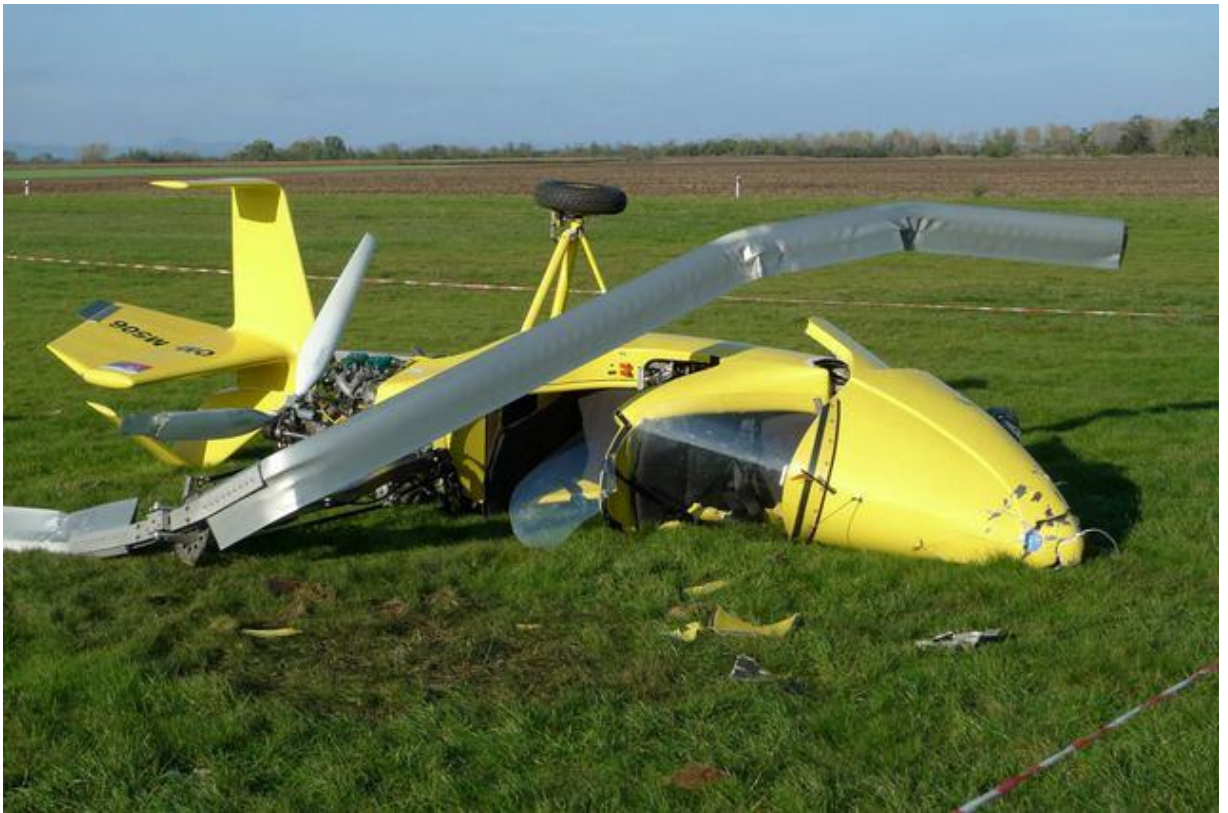
FSV was destroyed due to collision of its right landing gear with the ground.

The following impact of rotor blades and, due to spring compression, of the pusher-type airscrew to the ground caused their destruction. FSV was sliding on the ground about 330 cm from the place of impact until it stopped and rolled onto the right side.

FSV was destroyed in the accident.

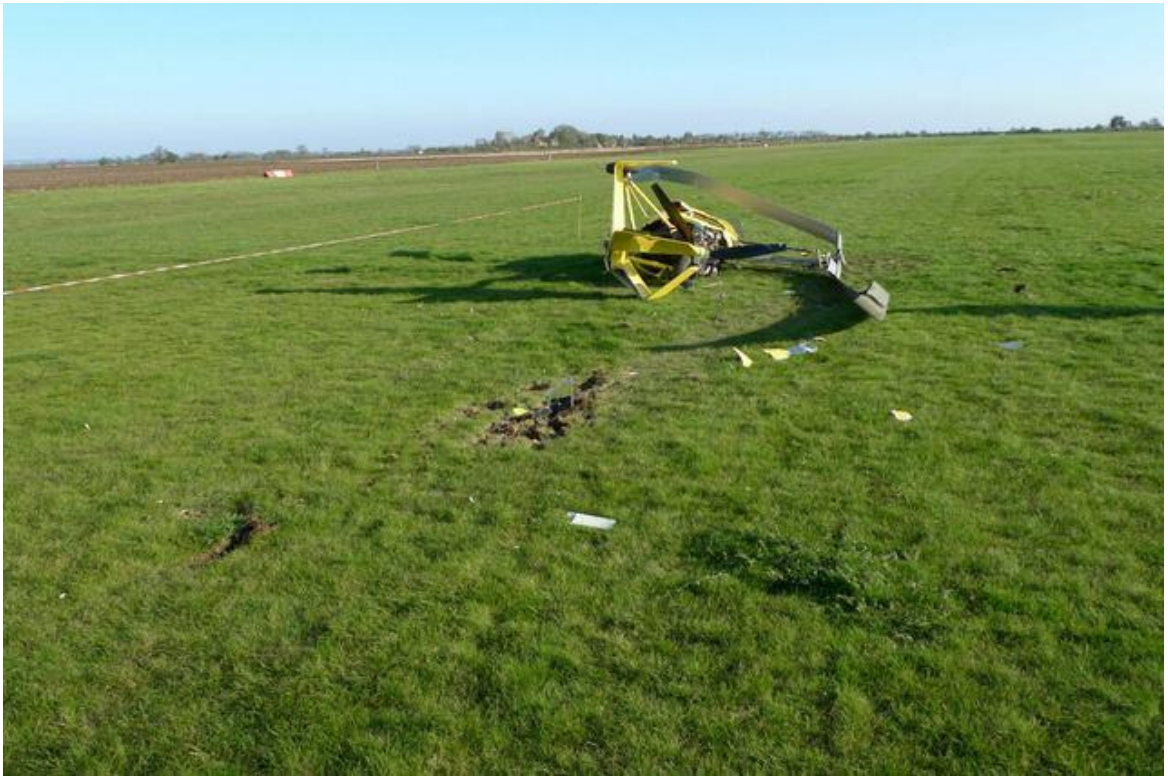
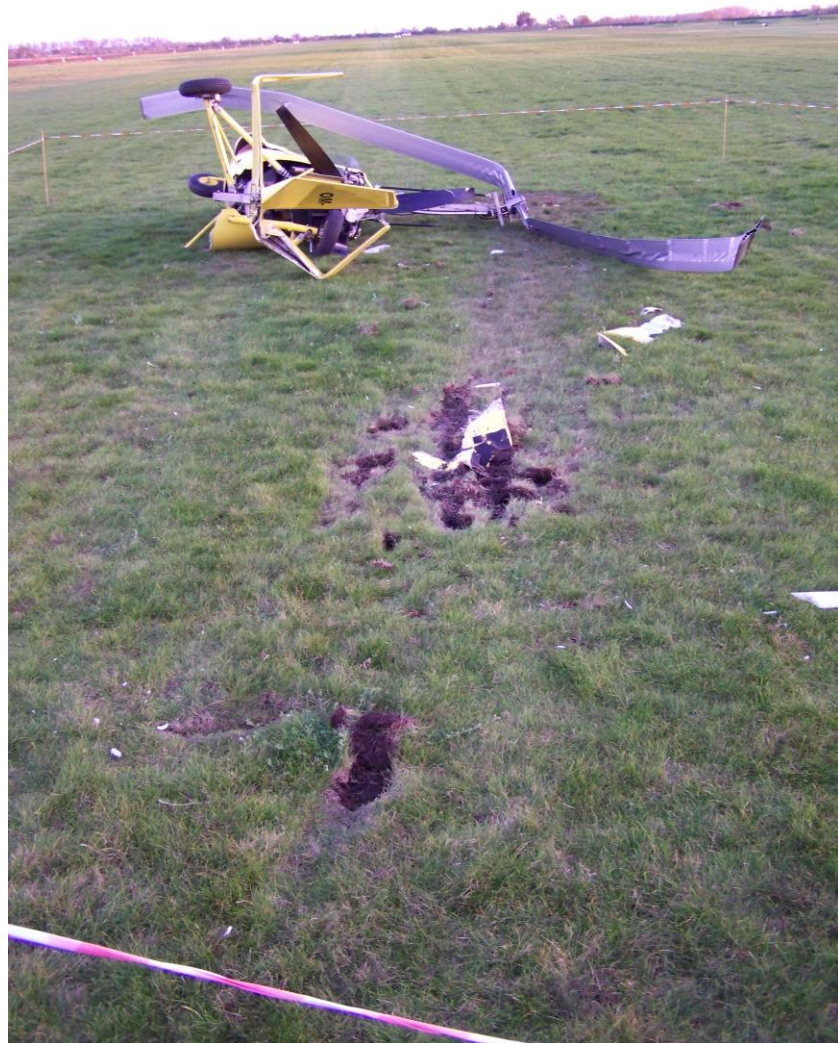
The place of impact in a half length of the RWY15 of airport LZSY.

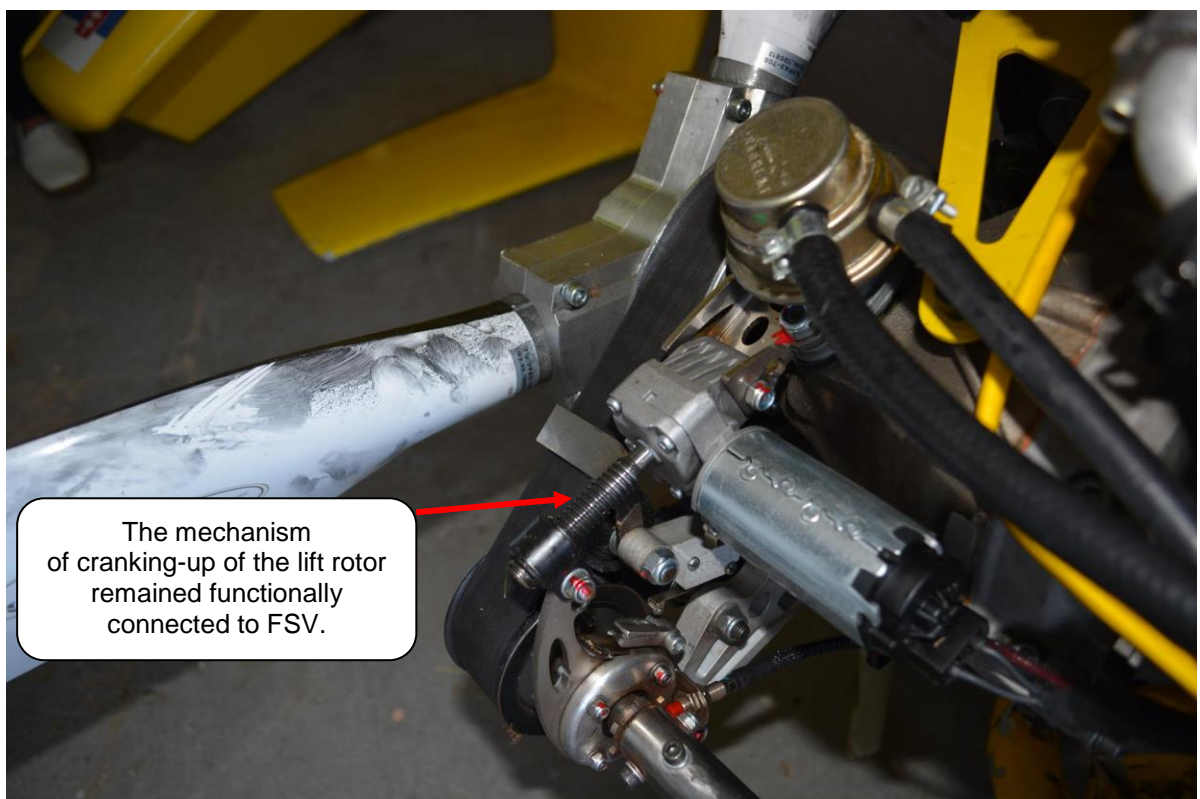
The inspection of FSV wreckage detected that the mechanism of cranking-up of rotor before the take-off had not automatically disconnected when the prescribed engine speed was achieved, but remained functionally connected to the rotor during the take-off.

The failure of disconnection of the mechanism cranking-up the rotor before the take-off created the reaction moment during the take-off, which caused the turning of FSV to the right and the resulting gyroscopic moment caused its bending to the right side.

This connection also prevented the lift rotor from cranking up to a higher speed and developing the required lift for further climb of FSV.

- FSV had valid documentation and did not show any fault before the incident.
- The mechanism cranking-up the lift rotor remained functionally connected due to failure of electric motor.

Generation of non-compensable reaction moment, which was caused by steady mechanical cranking-up of the lift rotor during the take-off.

For building FSV autogyro with automatic disconnection of cranking up of the lift rotor to require the building-in of a device signalling disconnection of this mechanism.
