Reg. No.: SKS2014001

FINAL REPORT

on investigation of serious incident

Incorrect procedure of ATC staff

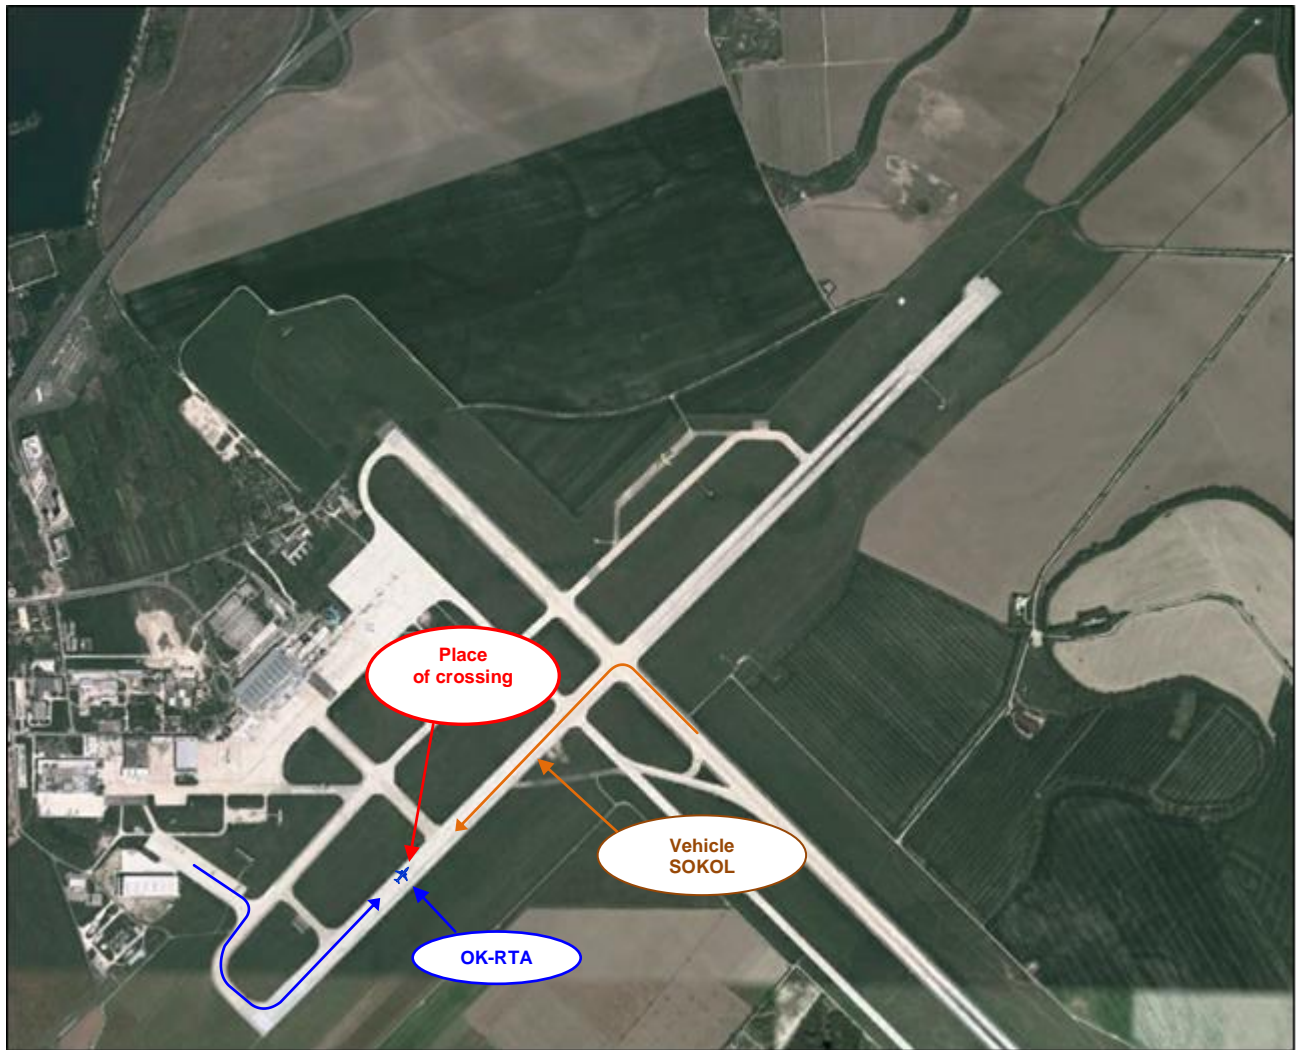
At **12:25:21** AC APP Štefánik asked PC TWR Štefánik whether they had coordinated the VFR flight via DEVÍN, or wanted him to coordinate the flight. During this conversation, the pilot of OK-RTA, in the ground roll phase, reported to PC TWR Štefánik the presence of a vehicle (SOKOL) on RWY at **12:25:22**. As he was approaching the lift-off speed, he did not abort the take-off for the fear of a collision with the vehicle that still moved along the middle of RWY22 toward him. The position of vehicle SOKOL on RWY22 was approximately 30 – 40 m behind TWY A in the direction of TWY C. The height of aircraft OK-RTA at the time of crossing with the vehicle SOKOL was approximately 5 – 7 m above RWY, the estimated horizontal distance between the vehicle SOKOL and the aircraft OK-RTA at the time of lift-off was approximately 150 – 200 m.
