FINAL REPORT

on investigation of accident
of hang glider type **RELIEF 14**
Registration No **OM-H453**

Reg. No: **SKA2015006**

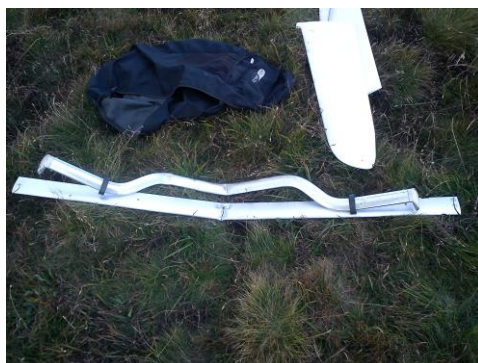
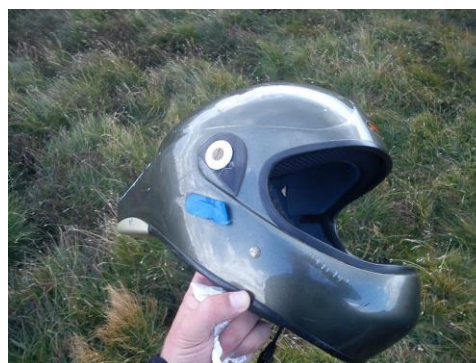
HG was slightly damaged in the accident:

- Breaking of both tapered wings (one probably by impact on the rock on the ground and the other by impact of the pilot's body);
- Deformation of trapeze.

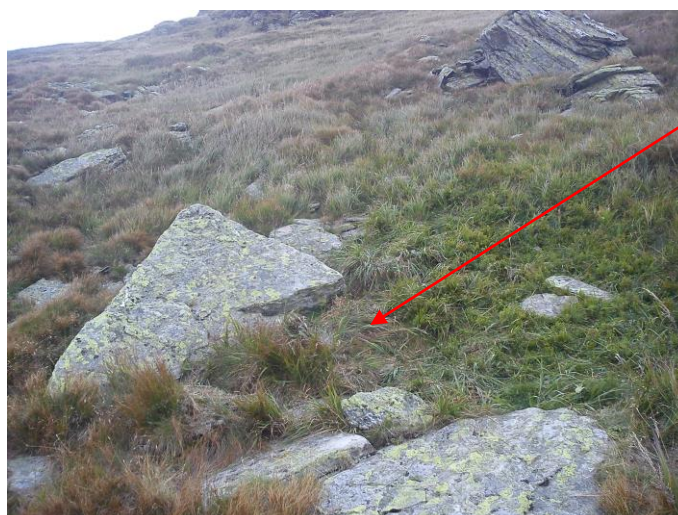
HG crashed 24 m under the level of the take-off, 270 m west of the pylon.
