FINAL REPORT

on the safety investigation of the air accident
of paraglider MAC PARA TECHNOLOGY, LUCKY 3-34
without a license plate

Reg. No.: SKA2017001

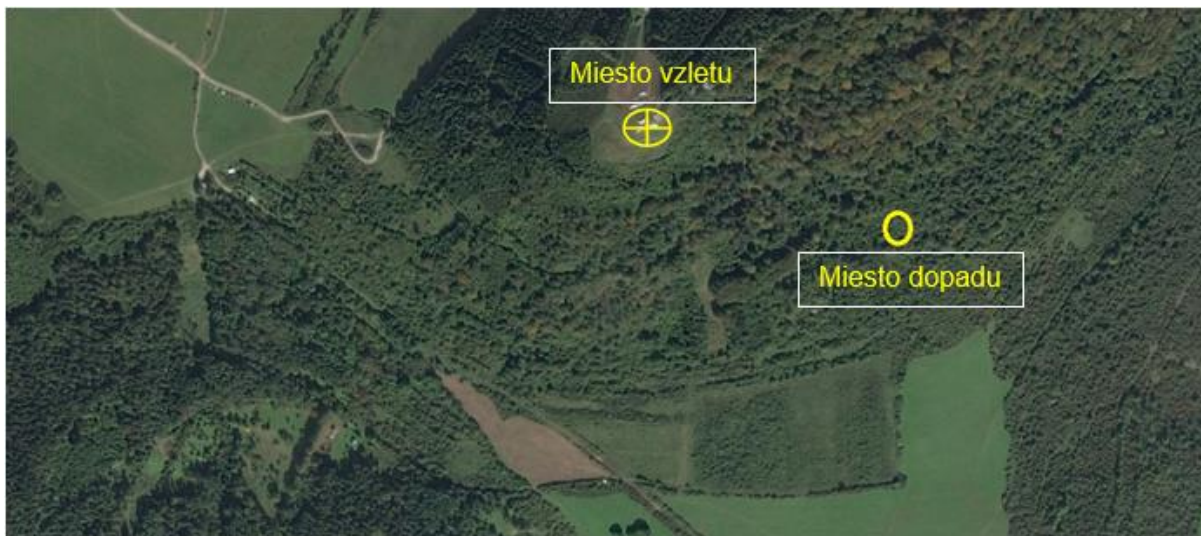
The pilot fell about 400 metres away from the take-off site. The site of the air accident was located in rugged, forested, steep terrain, which hindered rescuers' access.

Coordinates of the point of fall impact: 49°14'06"N
18°49'52"E
