FINAL REPORT

on the safety investigation of the air accident

aircraft type **L-29 Delfin**

Registration Mark **OM-JLP**

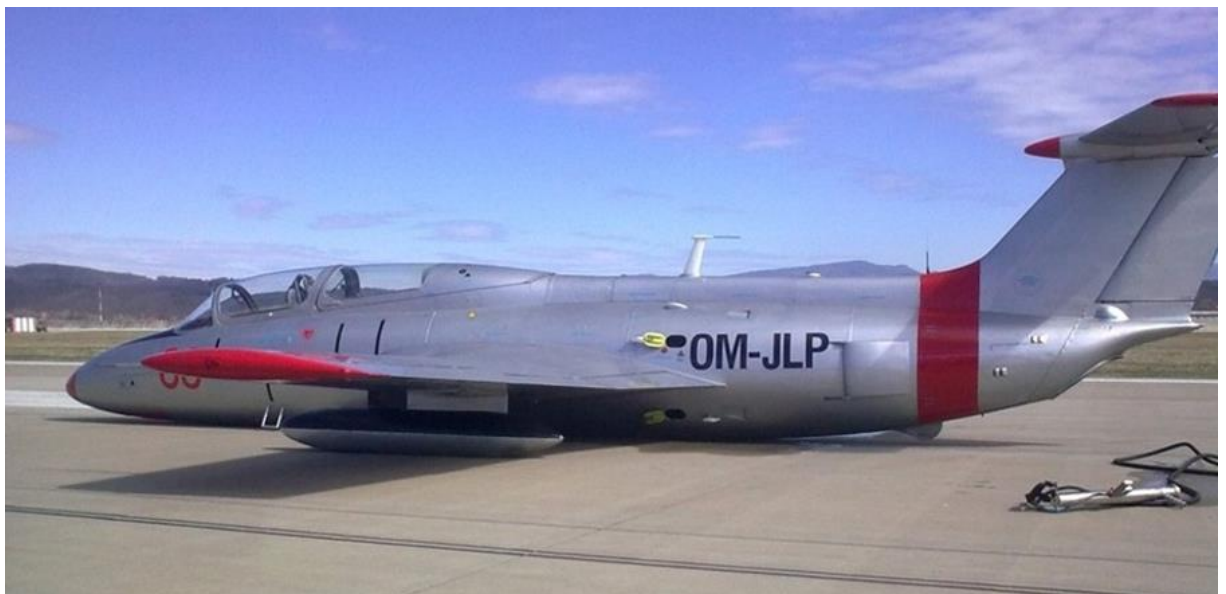
During the sliding of the landing gear, the aircraft dropped and the rear fuselage and AFT touched the concrete surface of the RWY. When touching the RWY, the pilot switched off the engine and the aircraft slid further down the RWY until it stopped.

The position of the aircraft after stopping on the RWY

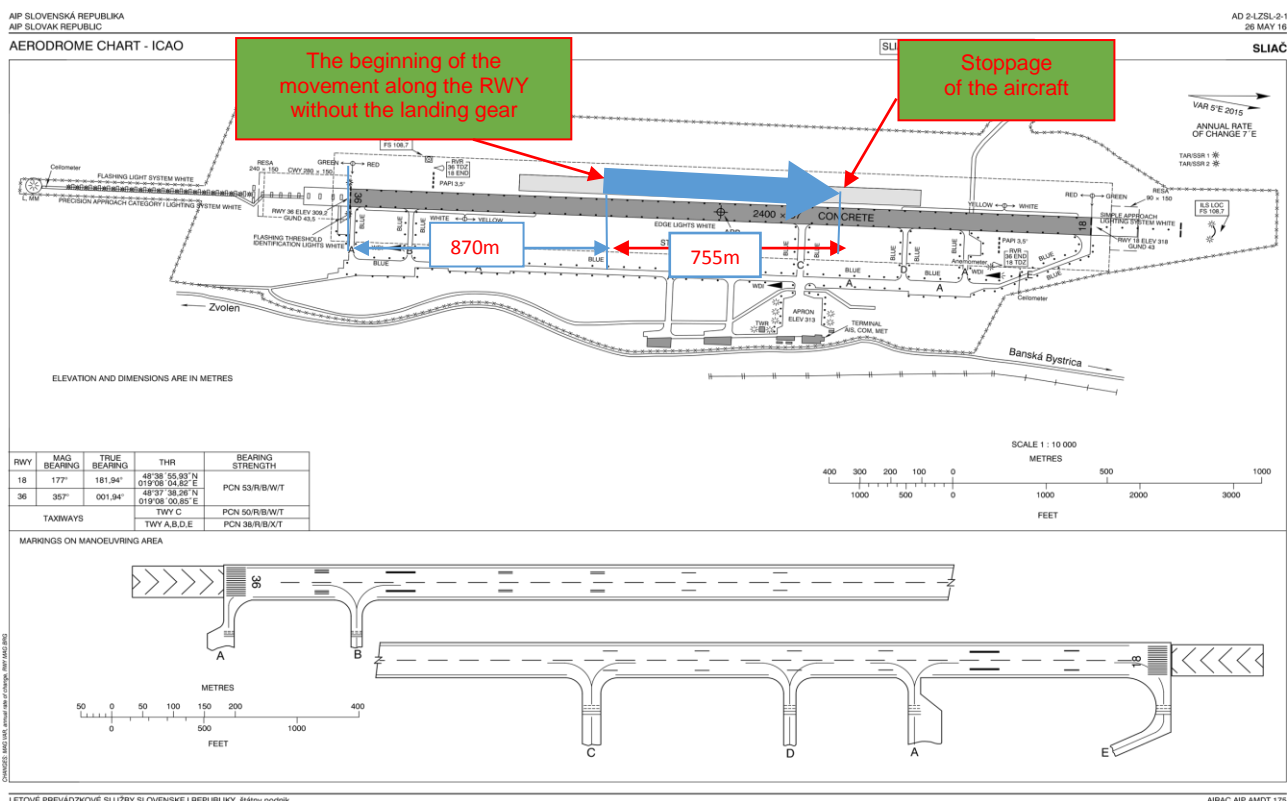
The diagram of the movement of the aircraft along the RWY

The retraction of the landing flaps in combination with the premature retraction of the landing gear just after the peeling of the aircraft caused the changed aircraft to touch the RWY. On touching the RWY the aircraft continued moving at 755 m along the fuselage and AFT until it stopped. During this sliding movement, the pilot correctly switched off the engine to reduce the possibility of sucking in a foreign object and shortening the movement. The premature retraction of the landing gear resulted in a violation of the provisions of the flight manual, which states that the landing gear is moved after take-off at a height of 20-25 m.

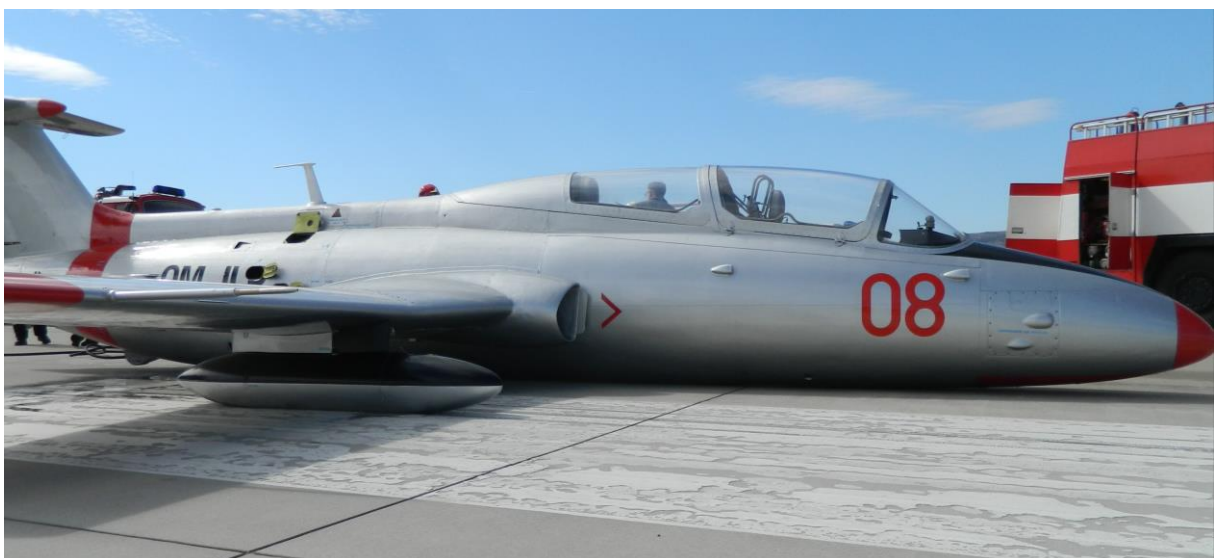
The aircraft was damaged to a large extent in the abutting and movement along the concrete RWY (covering on the rear fuselage, bar nos. 5-26, main landing gear covers, damage by local fire in the engine section, damaged wing beams, damaged AFT) , so its repair would be inefficient.

After stopping the aircraft remained on the RWY on the fuselage and AFT

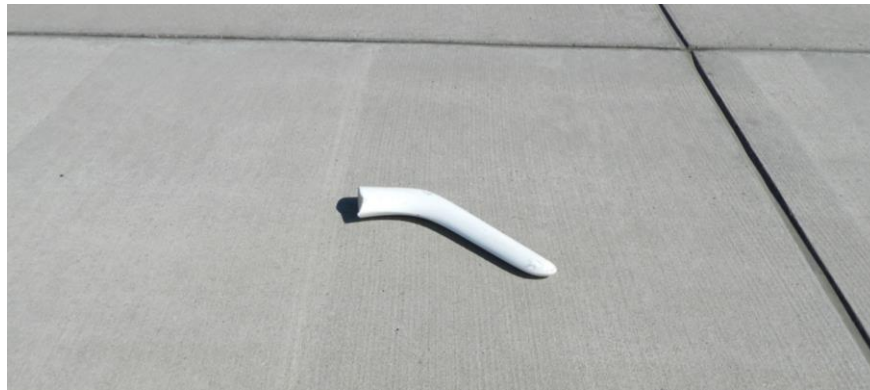
Part of broken radio antenna equipment
