AVIATION AND MARITIME INVESTIGATION AUTHORITY
Námestie slobody 6, P.O.BOX 100
810 05 Bratislava

FINAL REPORT

on the safety investigation of an air accident
of flying sports equipment type **BKK-01-RIKI-1**
with the registration mark **OM-M723**

Reg. No: **SKA2017003**

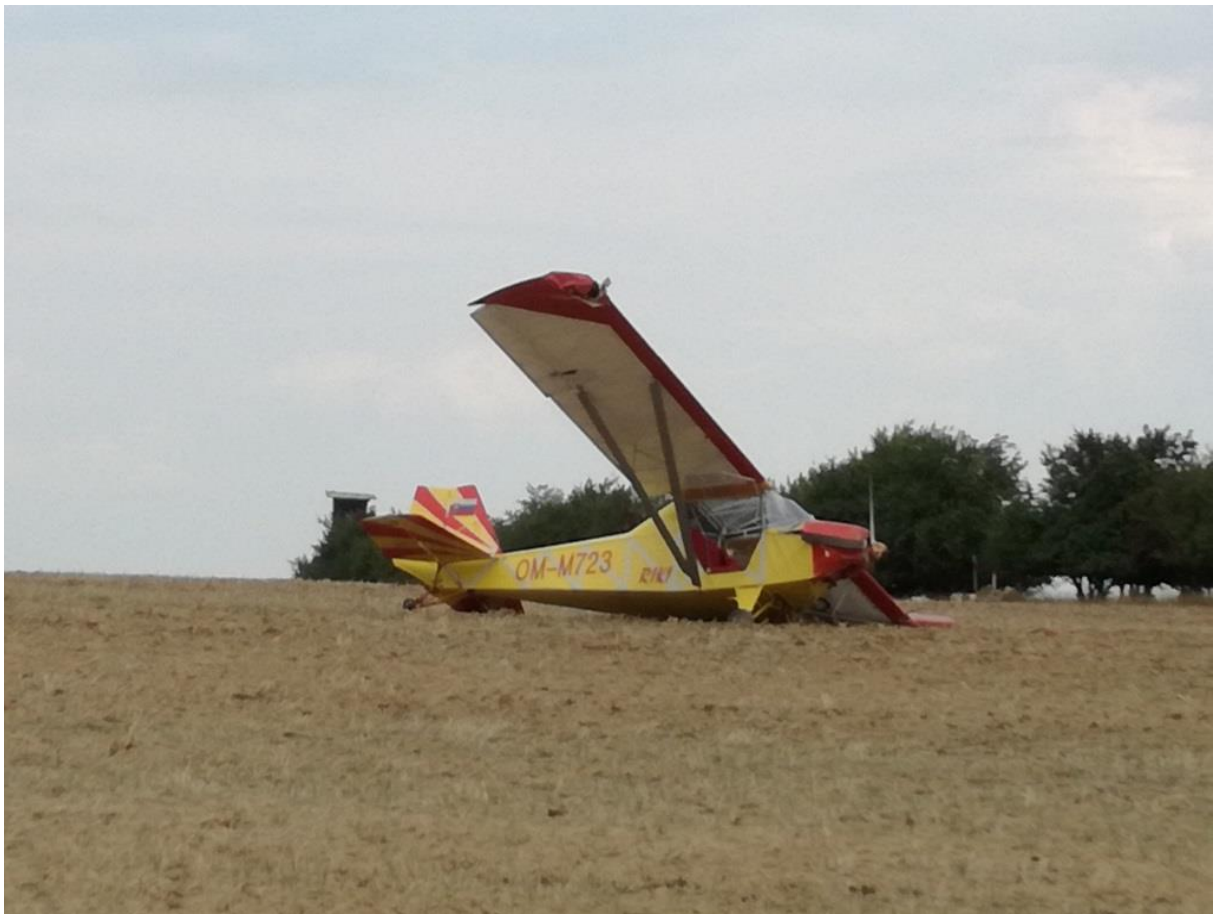
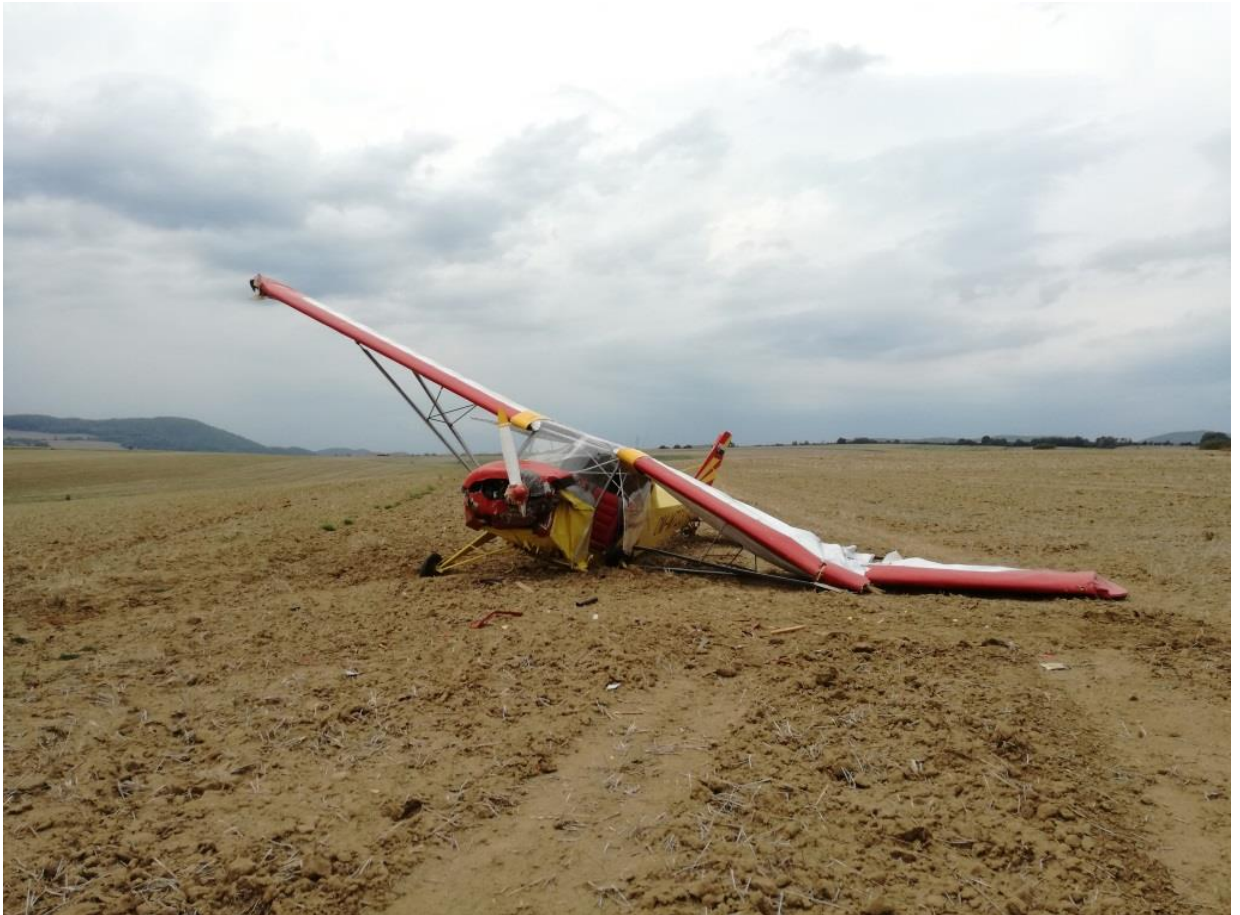
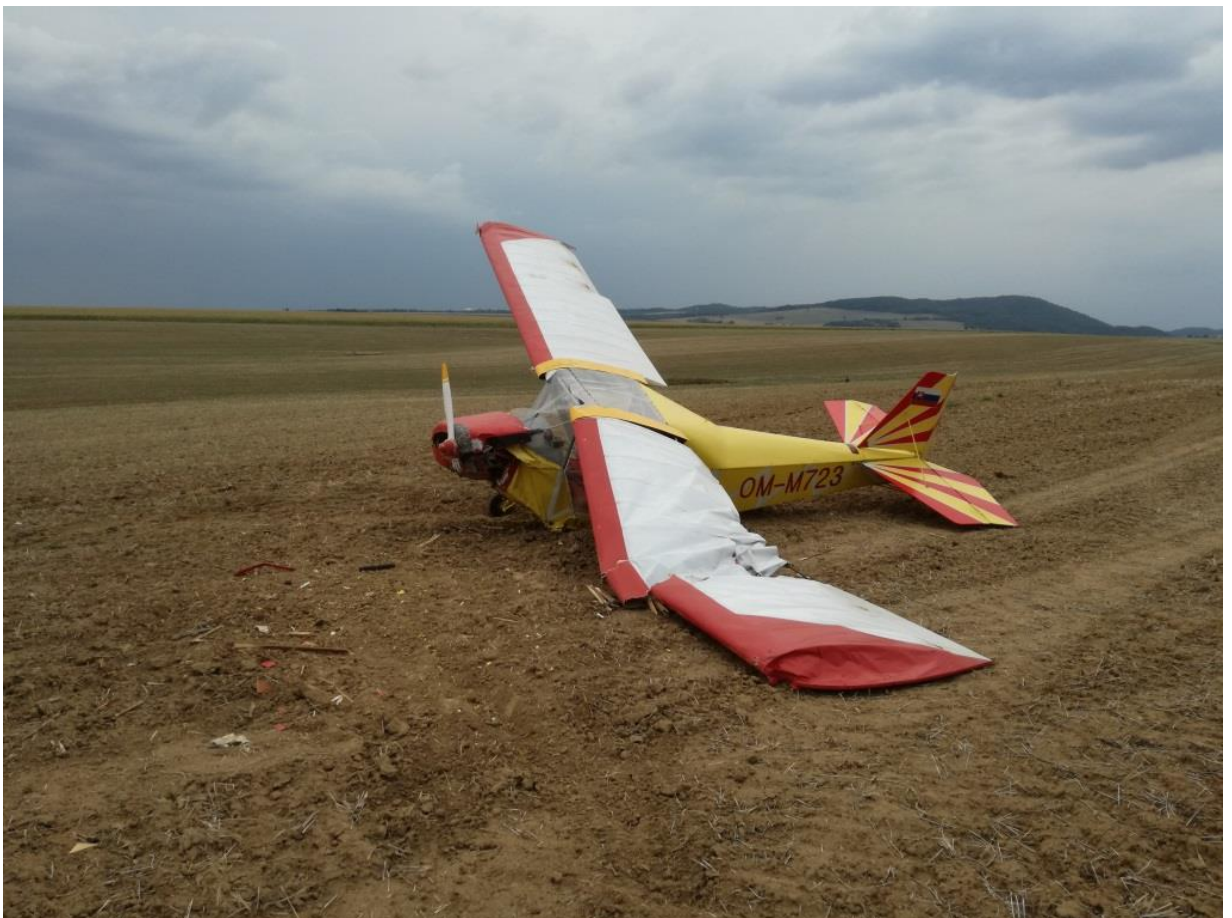
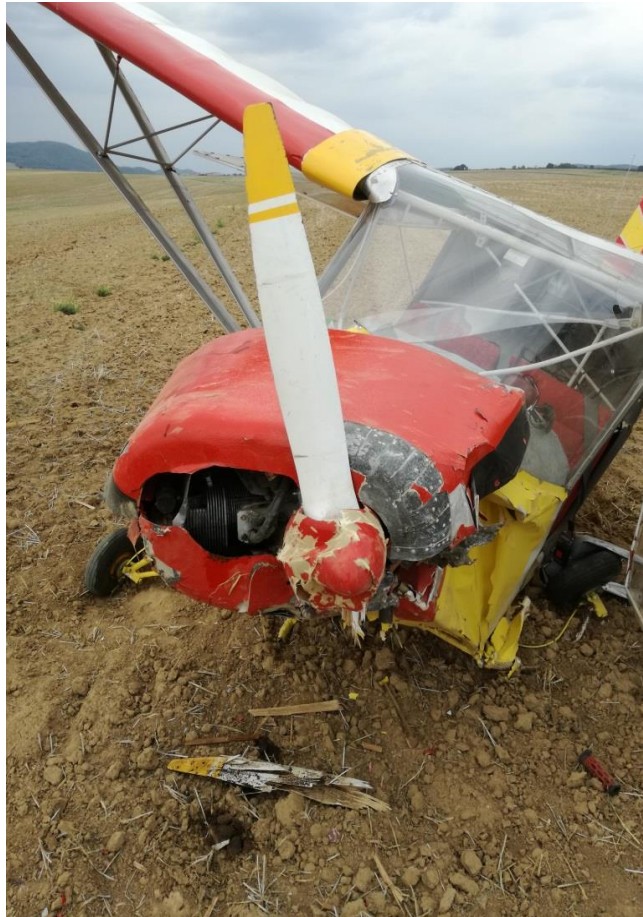
The FSE was destroyed during the air accident - the airframe was twisted, the left wing and the bar were broken, the right wingtip was damaged, the undercarriage was destroyed, the propeller and the engine were destroyed, the cockpit supports were twisted and broken and the instrument panel was destroyed.

The FSE fell on a field 200 m to the right of the VPP-KK 30 threshold.

No petrol leaked of the FSE; one oil slick sized approximately 10x10 cm was found under the engine on the ground. There was no smell of petrol.

The fuel system and the fuel tank showed no signs of damage.
