# FINAL REPORT

on an safety investigation into an air accident  
of the flying sports vehicle of a **paraglider**, type: Axis Paraglider Vega 4 ML

with the registration mark OM - L254

Registered by the "Aviation and Maritime Investigation Authority" under reg. No. SKI2017005

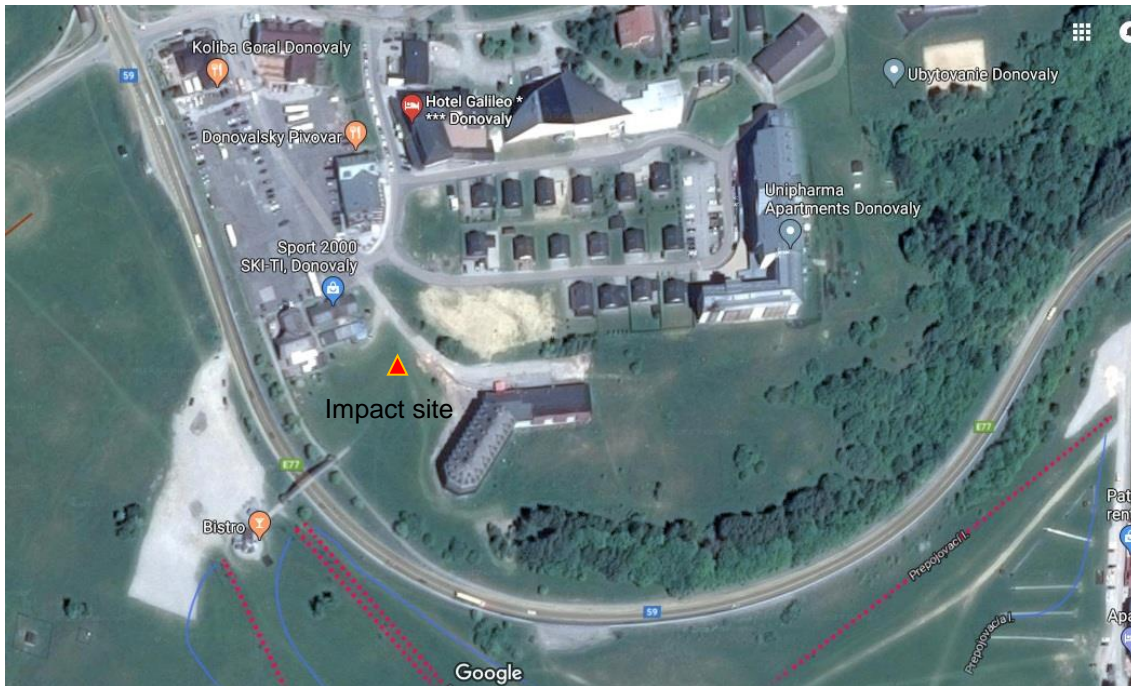
Detail of the place of landing - impact

The pilot fell on a free area close to the Dami Sport hotel and parking place.

At the last moment of his approach, the pilot decided to change his landing area due to a strong wind which prevented him from flying to the official landing area. As a result of the wind, there was significant orthographic turbulence in the landing area, caused by obstacles in the landing area, the expressions of which were intensified by thermal bubbles tearing off, which was caused by uneven overheating of the terrain surface in the landing area.
