AVIATION AND MARITIME INVESTIGATION AUTHORITY
Námestie slobody 6, P.O.BOX 100
810 05 Bratislava

FINAL REPORT

on safety investigation of an air accident
of a flying sport equipment type **EDEL / RESPONSE - M**
without a registration mark

Reg. No: **SKA2017007**

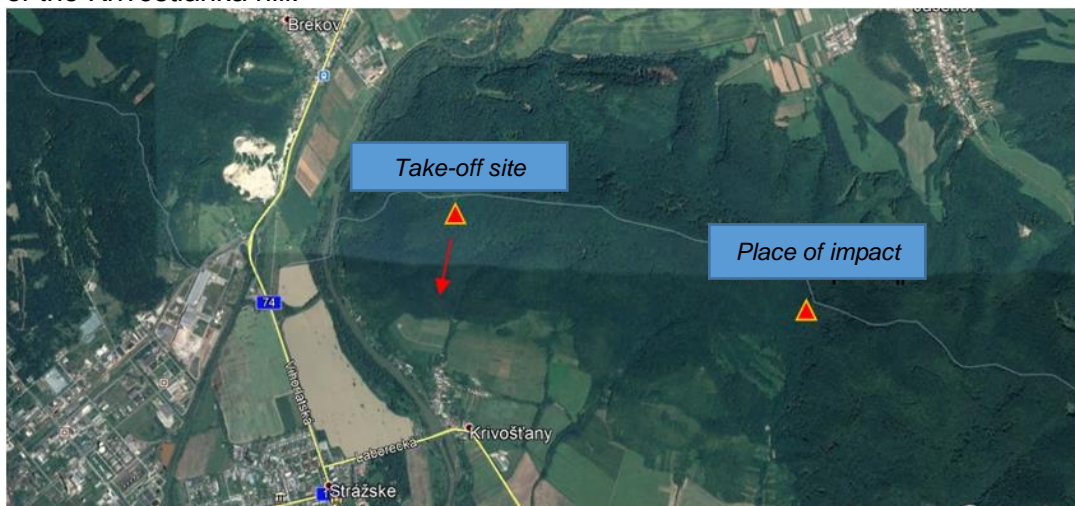
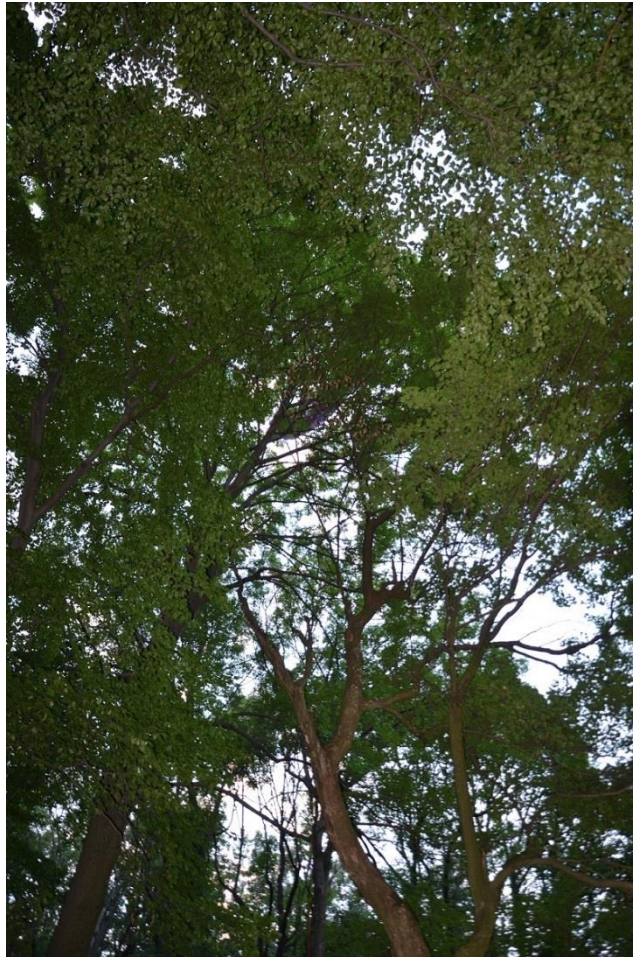
The PG hit trees near the "Vojtov kríž" spot on a tourist track leading along the ridge of the Krivoštianka hill.

PG impact site

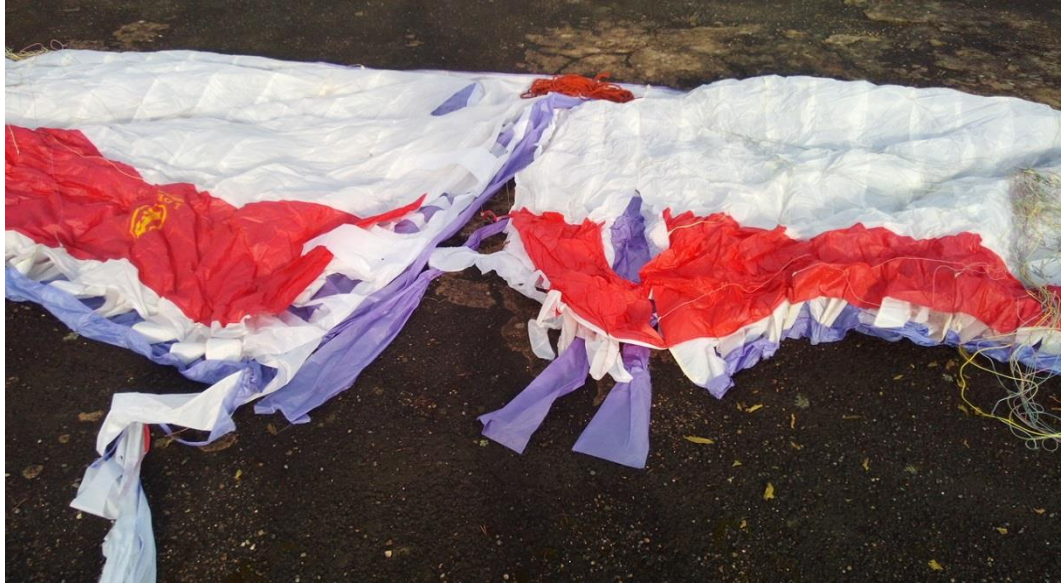
was obsolete, manufactured in 1999. Before the accident it was in a poor technical condition and after the accident it was torn into two pieces. The leading edge and its openings were torn at about one third of the wing. The gallery, main lines and control lines were damaged; more of them were cut or torn. Free endings were not substantially damaged. The upper and the lower cover of the canopy was in a condition corresponding to the year of manufacture. The quality of the fabric and the permeability of the cover did not meet the standards and correspond to the age and the wear and tear of the PG. The upper and the lower cover of the PG was quite dirty as a result of its use.

The PG's wing geometry had not been set for a long time and the porousness of the wing cover fabric was not appropriate. As a result of significant damage to the wing caused when it was

being released from the trees, it was not possible to check the paraglider's geometry but with regard to its age and to the material of the lines it may be assumed that line lengths deviated from the lengths determined by the manufacturer by as much as 5 cm. This has a major impact on flight characteristics of the PG (any change in the wing geometry results in a change in the angle of attack, in the profile shape, more frequent wing collapses, changes in the gliding speed, etc.). According to the gathered data, the take-off weight was not exceeded and corresponded to the authorized take-off weight range specified by the manufacturer.

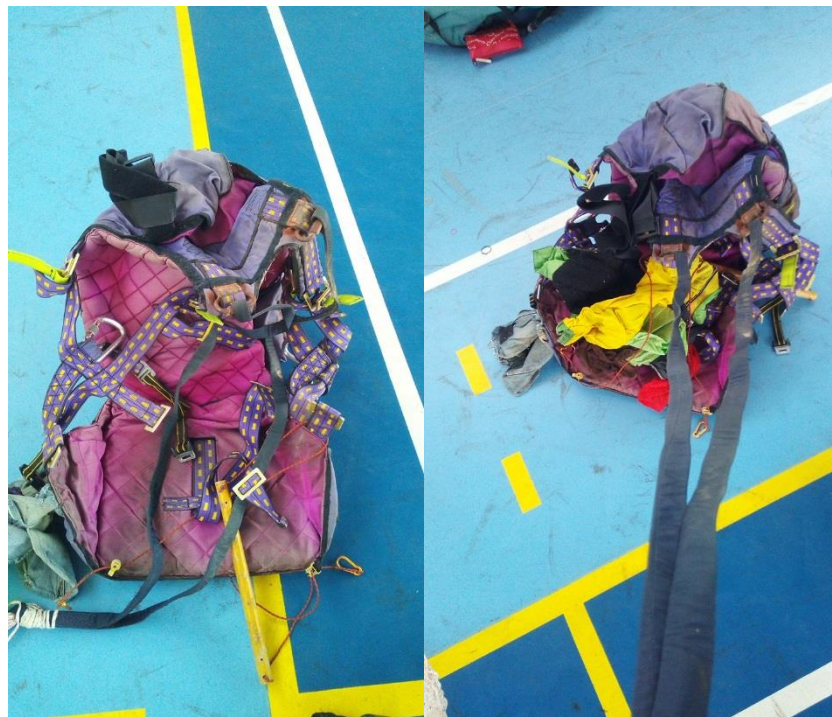
Pilot's harness:

the pilot's harness manufacturer or an approximate age of the harness could not be identified. It is a very obsolete harness which does not correspond to current standards.

The harness was in a poor technical condition. The fabric it was made of was stiff, very dirty and torn at some places. The rings connecting the reserve parachute were corroded; the straps were extremely hard though functional. The spine guard was replaced by a piece of hardened polystyrene. A home-made denim bag for a reserve parachute was sewed to the right side of the seat.

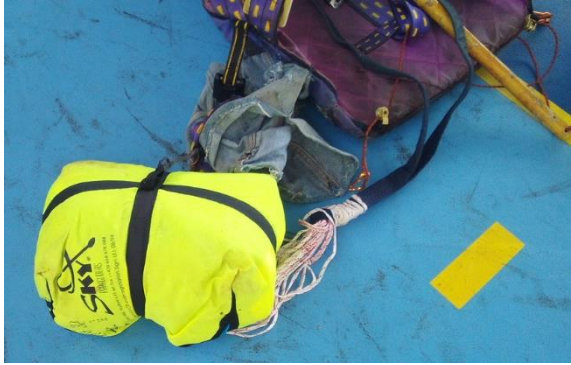
it was obviously older than 10 years, without any documentation. According to the manufacturer, the lifetime of such parachutes is 10 years. The fabric of the cover of the reserve parachute was stiff and without any elasticity. The pilot made a home-made bag for the reserve parachute because the seat did not have any space for a reserve parachute as is the case with modern seats. The bag was sewed from a piece of denim and it was attached to the seat. This solution was inappropriate because the reserve parachute was largely exposed to air humidity and its traces were visible also on the reserve parachute fabric.

Reserve parachute

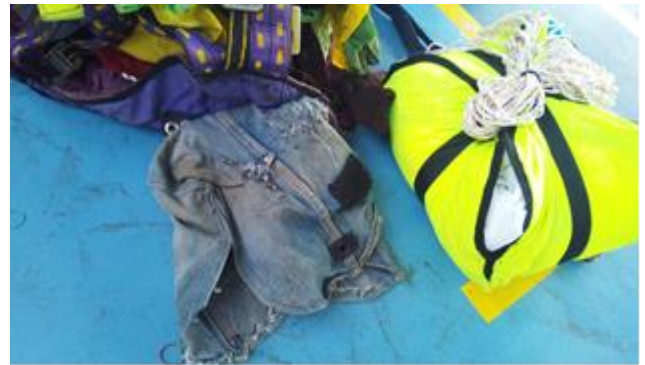
Denim bag for the reserve parachute
