FINAL REPORT

on the safety investigation of the air accident
of aircraft type **Z-37A-C3**
with registration mark **OM-DCC**

Reg. No: **SKA2017008**

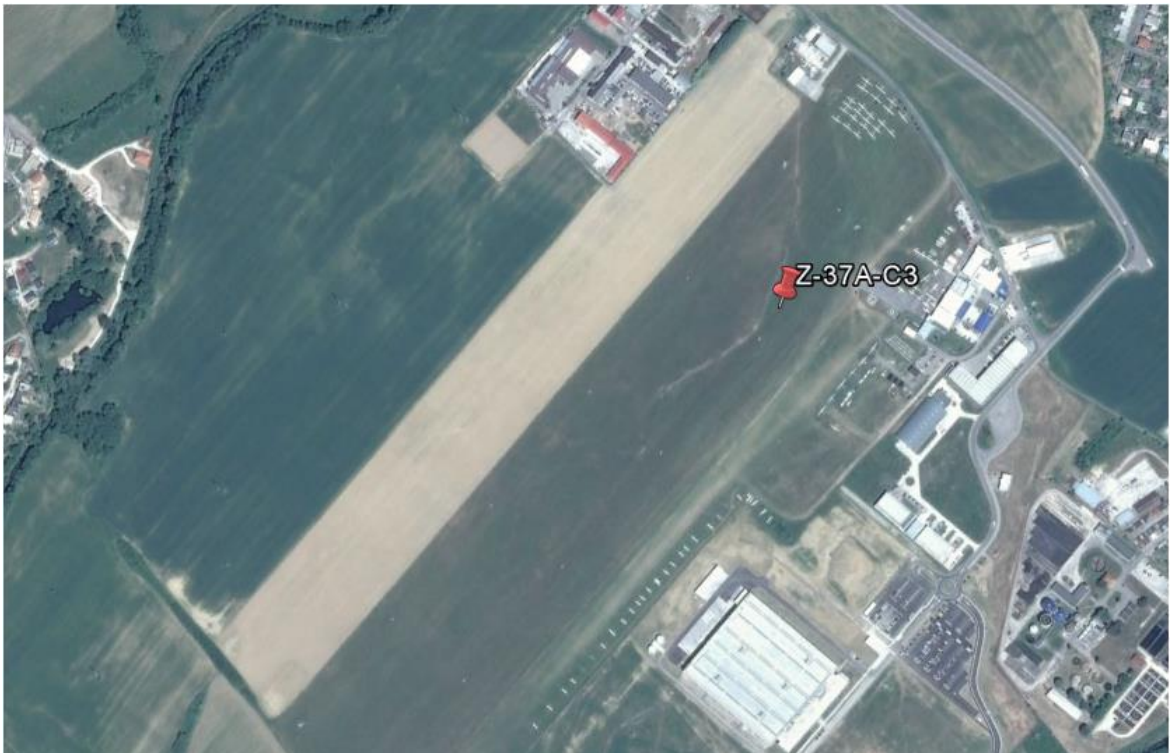
Accident site

The aircraft fell on the grass RWY 22L, 132 m away from its THR. The coordinates of the final position of the aircraft were N48°46'05.0'' and E018°35'24.4''.

The aircraft was found in the middle of RWY 22L with its longitudinal axis in the 092° direction, without the top part of the cockpit which had been removed by FaRS members who provided first aid to the pilot.

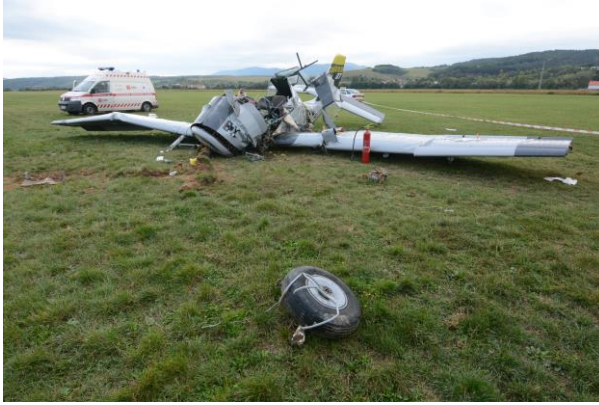
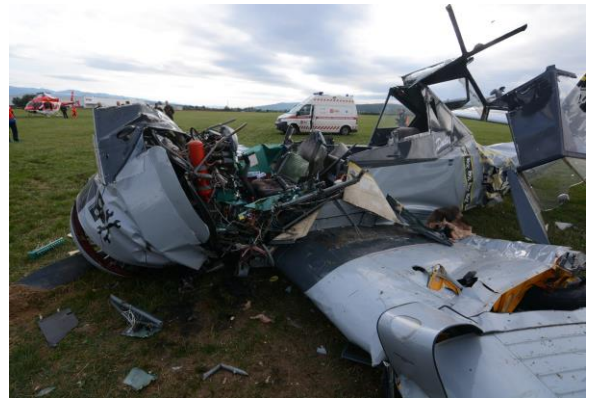
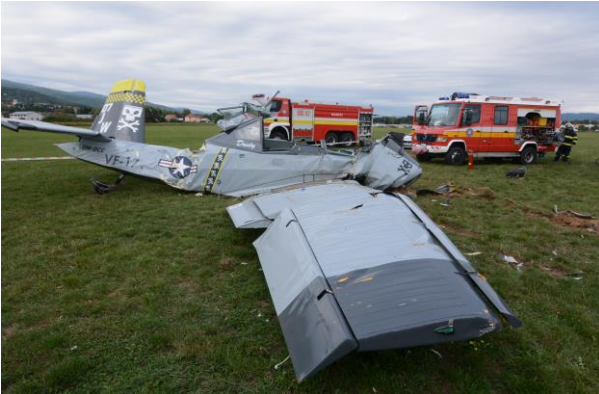
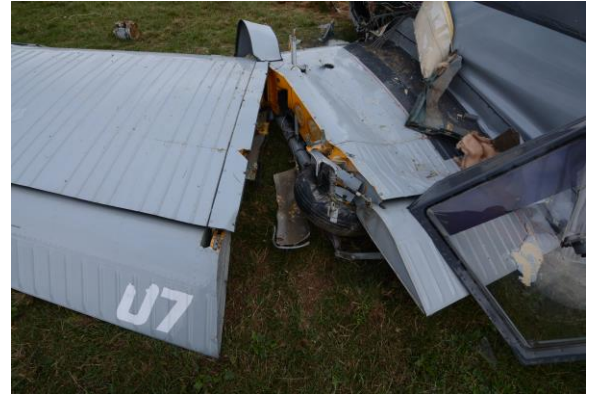
The torn-off wheel of the right main gear was found 5.56 m from the left central wing; the torn-off oil cooler was found 1.3 m from the left wing slot. The left panel with light control switches (landing, taxiing headlight) and control switches of the smoke-emitting equipment was found 0.8 m from the left central wing. The light control switches were "OFF" and the smoke-emitting equipment control switch was "ON". The broken right panel with switches was found 1.5 m from the propeller head. Individual switches were in the following positions: battery – ON, generator – ON, fuel pump – OFF, signalling system – ON, engine equipment – ON, fan – ON, gyros – OFF, overhead light – OFF, Pitot – OFF, landing and position lights – OFF, VHF1 – OFF, VHF2 – ON, ADF – OFF. The broken right splashboard was found 3.5 m from the propeller head; the broken aerial of the aircraft radio station was found 3.8 m from the propeller head.

The right main gear was torn off towards the front; the leading edge of the right wing was distorted; the right wing was broken at the point of the right slot; the right wingtip was broken; the right winglet was damaged at the root; the top and the bottom part of the instrument panel was distorted; the firewall was distorted towards the cockpit; the fuselage was broken behind the cabin; the right stabilizer was broken 0.2 m from the keel area; the right part of the elevator was broken; the left main gear was broken off and pressed into the central wing; the left flap drive cable was torn off; the left wing was broken off at the rear wing hinge; the left flap on the central wing was distorted; the left winglet was damaged at the root; the Pitot tube was pressed into the left wing and ran through the lower and upper covering of the wing; the left wing was broken at the point of the left slot; the engine bed was ripped off; engine cowlings were distorted and the propeller blades were bent.
