FINAL REPORT

safety investigation
of the balloon of BB70Z type
with registration mark **OK-8882**

Reg. No.: SKP2017002

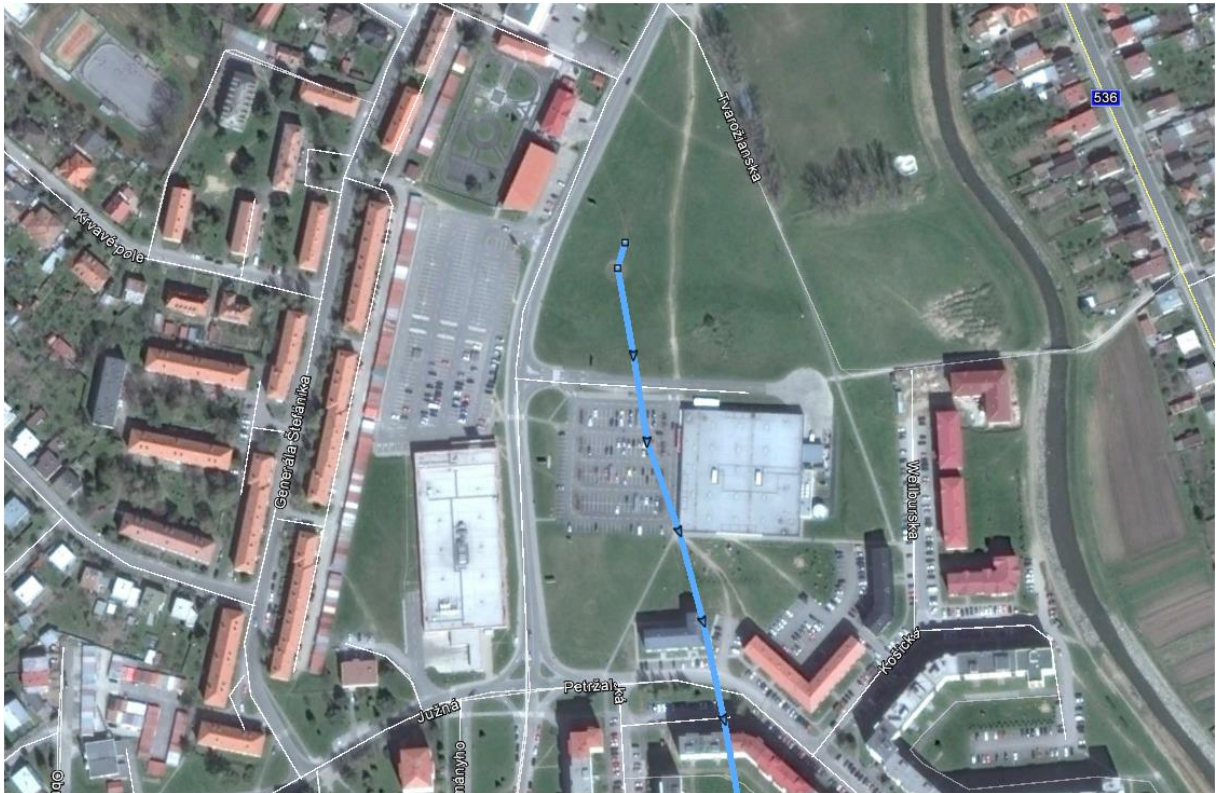
At 17:40, the pilot took off with a balloon from the Tesco Kežmarok department store area with a height of 300 m AGL and continued in flight in the expected south direction at a speed of about 30 km/h.

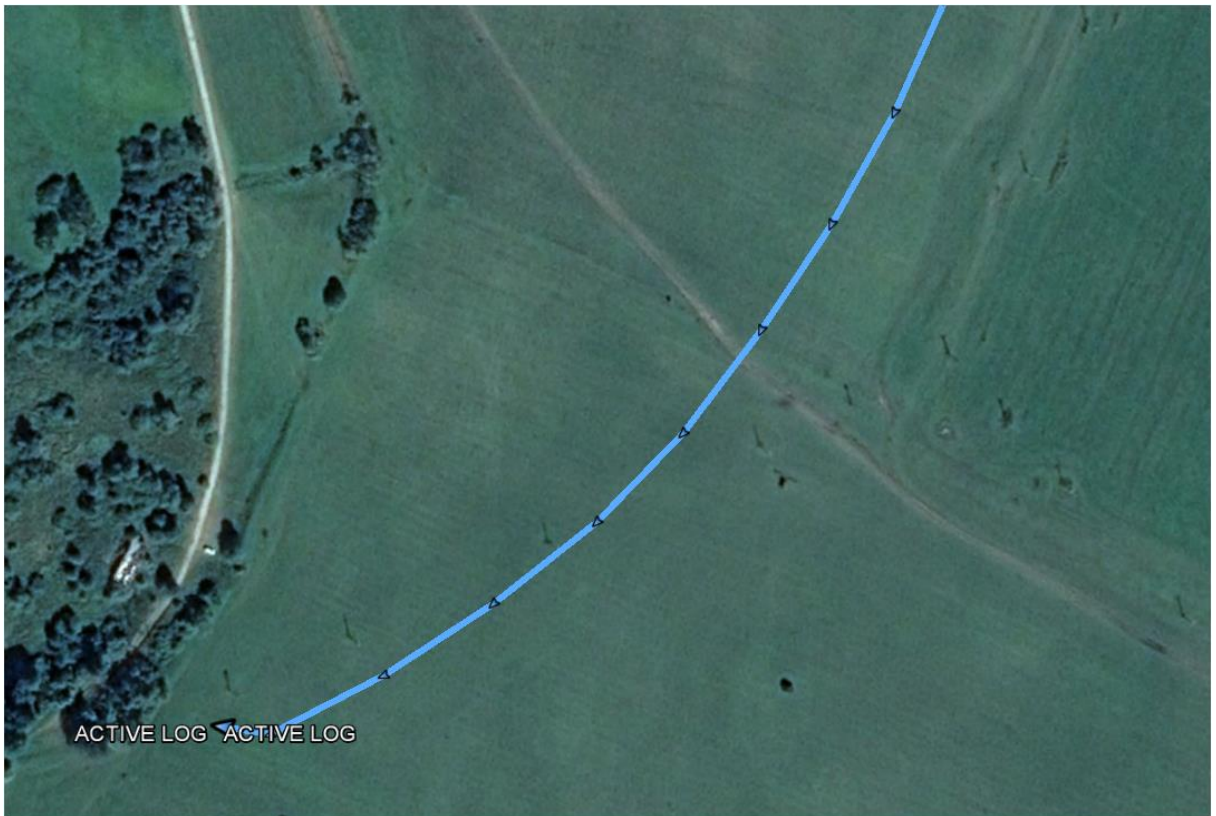
The pilot began to drop the balloon and perform a landing maneuver onto the terrain. During the landing maneuver, with a gradual drop of up to 20 m AGL, the wind direction began

to change northwest. The balloon flew right over the wires of the power line from the right to the left, but the side wind began to waft it back to the power line, coming in from the right.

Subsequently, during the discharge of the air, the weight of the fabric brought the envelope closer to the 22 kV wires at such a distance that there was a short circuit and discharge, causing the balloon envelope to burn and the polyester fabric began to melt.

- perform analysis and training within the company - an analysis of the situation with all pilots,
- perform an analysis and training during the nationwide winter training of pilots.
