AVIATION AND MARITIME INVESTIGATION AUTHORITY  
Námestie slobody 6, P.O.BOX 100  
810 05 Bratislava 15

# FINAL REPORT

on the safety investigation of a parachutist event  
paraglider type MAGELLAN 140

**Reg. No.: SKP2017003**

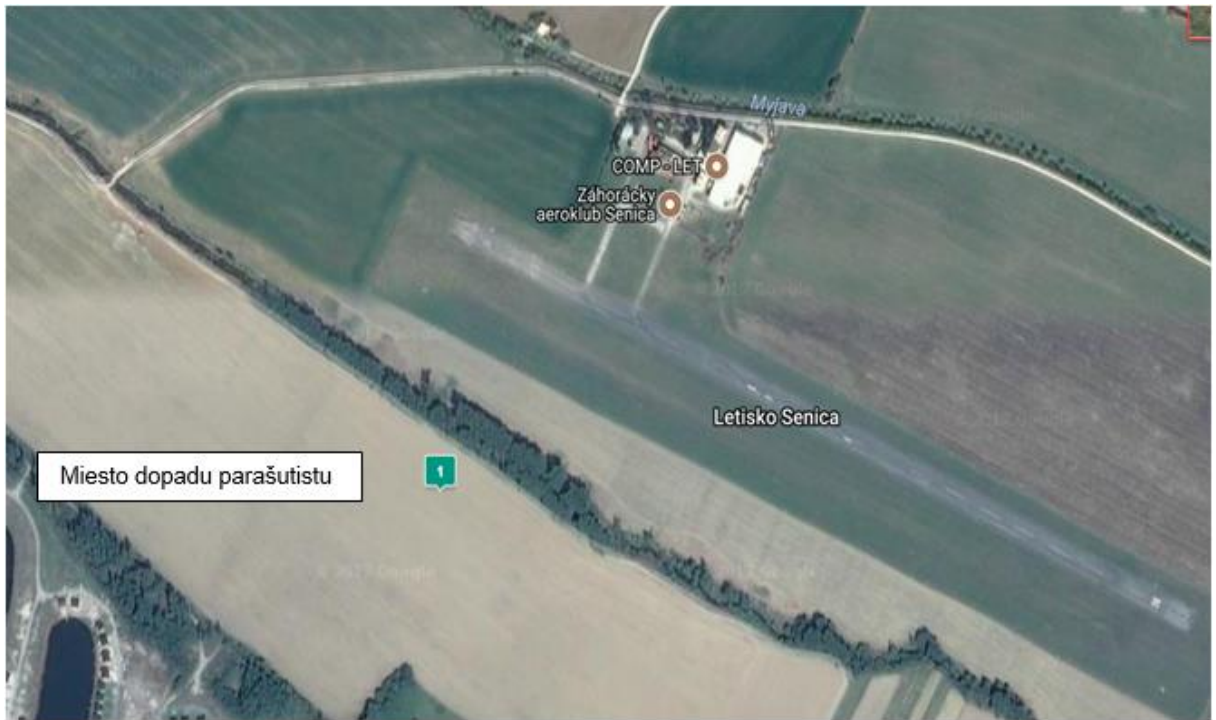
The accident site is located about 310 m south of the RWY12 runway. At the time of the accident, the field, the impact site, was covered with green grass at a height of about 40 cm and is determined by the geographical coordinates: 48° 39' 26.00" N, 17° 19' 22.12" E.

The body of the parachutist was about 10 m south of the first contact with the ground. It was partly tangled in the cords and canopy of the main parachute.

*Site of parachutist impact*

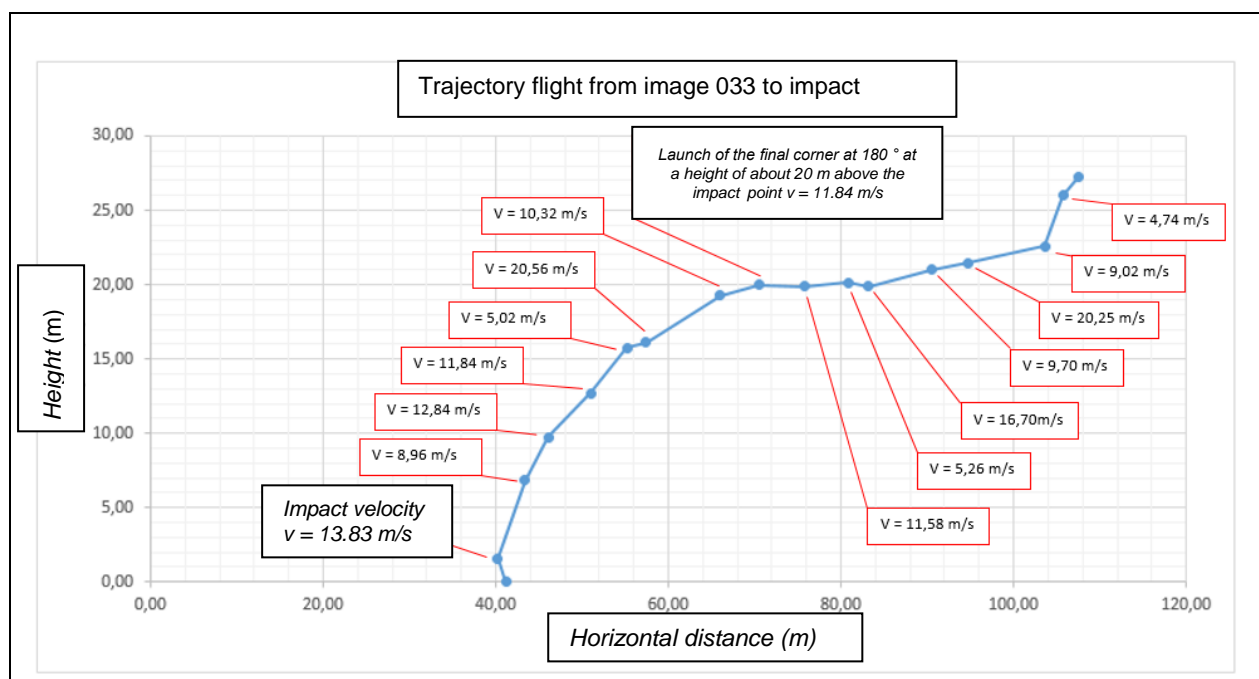
The parachutist, after completing the free fall, opened the main parachute at an altitude of 900 m AGL. Furthermore, on a fully functional main parachute, he continued in position with a westerly wind above the area of LZSE Airport. Flying over the RWY and at the boundary of the airport, in the part of the former tree avenue south of the RWY, he made a third circular turn and continued on the wind at about a height of 60 to 50 m AGL. For the parachutist category and type of parachute, this height is decisive for making the fourth turn: against the wind and preparing for landing.

The parachutist, **probably** due to fear of falling at the boundary of airport where a stream and brook are located, wanted to make a corrective maneuver but the parachute turned sharply to the right after the wind, resulting in a rapid loss of height with an increasing fall in speed. That height was no longer sufficient to open the parachute, and the parachutist hit the ground hard.

Based on the observation of a randomly made remote video from the ground, it can be stated that the parachutist had a parachute that was fully functional until the last minute and the final right-handed turn after the wind was performed by the parachutist using the control elements.

*Graphical representation of the flight trajectory with total average flight speeds in individual segments: the speed indicated at the individual trajectory points corresponds to the always completed section defined by the two points*
