AVIATION AND MARITIME INVESTIGATION AUTHORITY
Námestie slobody 6, P.O.BOX 100
810 05 Bratislava 15

FINAL REPORT

on the safety investigation into a parachutist occurrence
of a parachute, type SKYMASTER 280

Reg. No.: SKP2017005

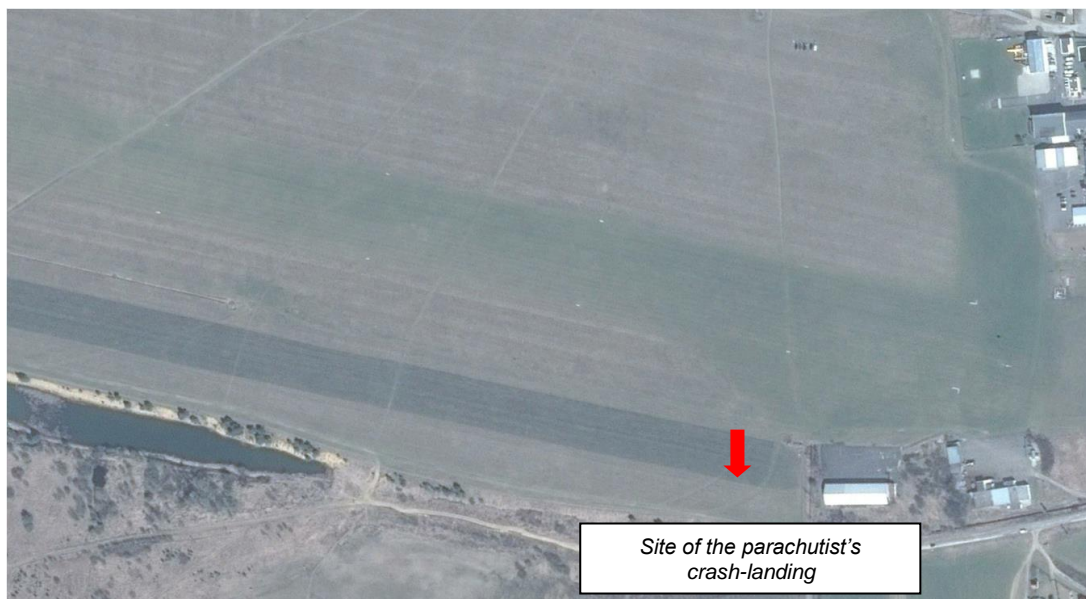
Place of event – the parachutist crash-landed on the border of the LZSV airport grounds, 210 m from the left edge of the RWY30 runway threshold and is determined by geographical coordinates:

48° 56' 15.18" N 20° 32' 20.87" E.
