FINAL REPORT

on the safety investigation of a serious incident
of aircraft type **PS-28 Cruiser**
with registration mark **OM-ARX**

Reg. No: **SKS2017002**

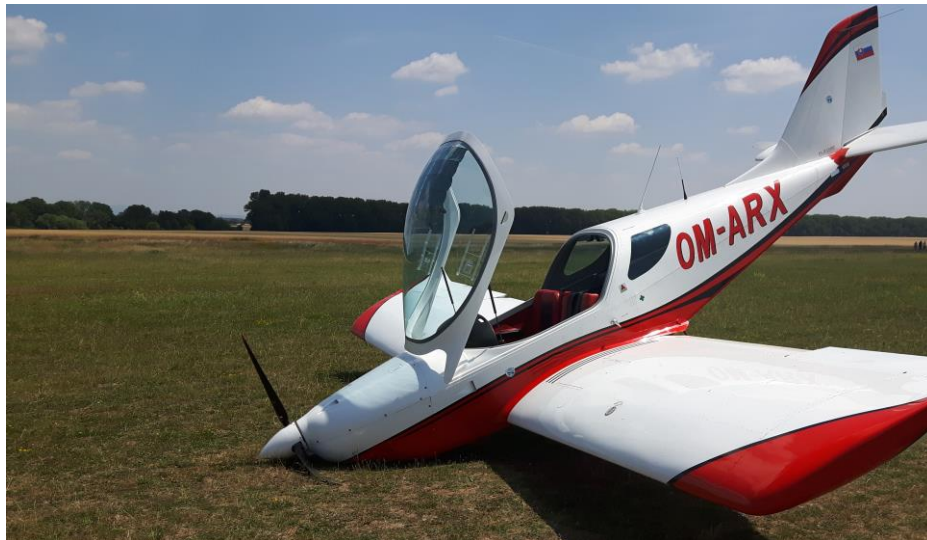
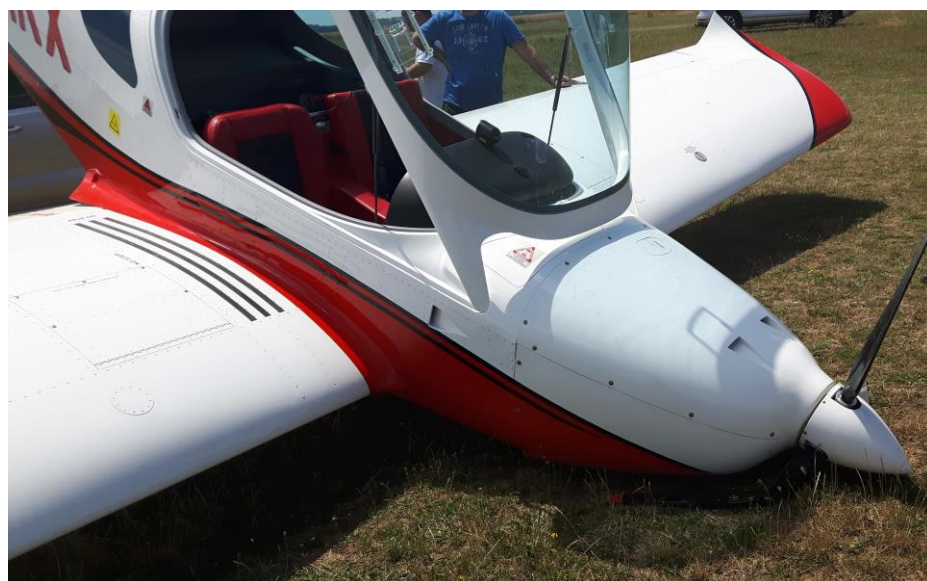
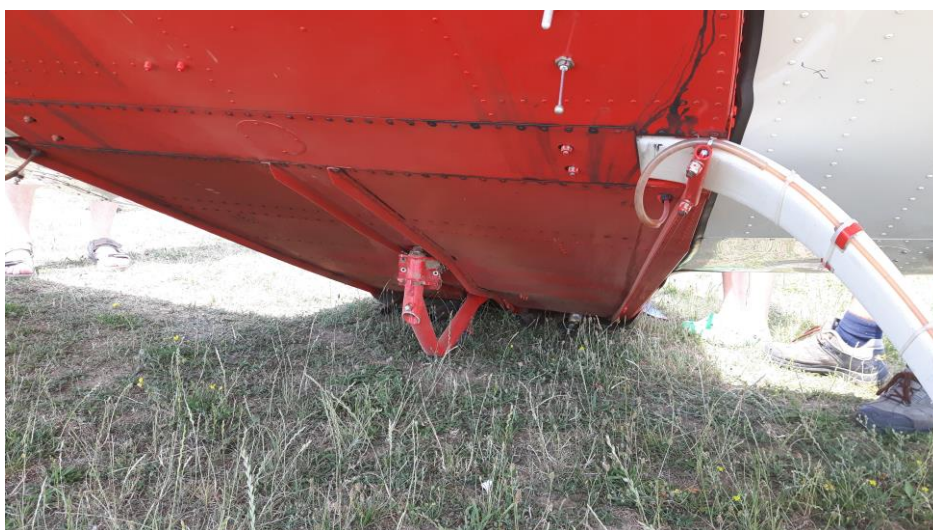
The front gear and the propeller were damaged during the occurrence, the exhaust pipe and the heating pipe were distorted, the engine mount was cracked, and the cabin floor and the fabric of the lower part of the fuselage were twisted.

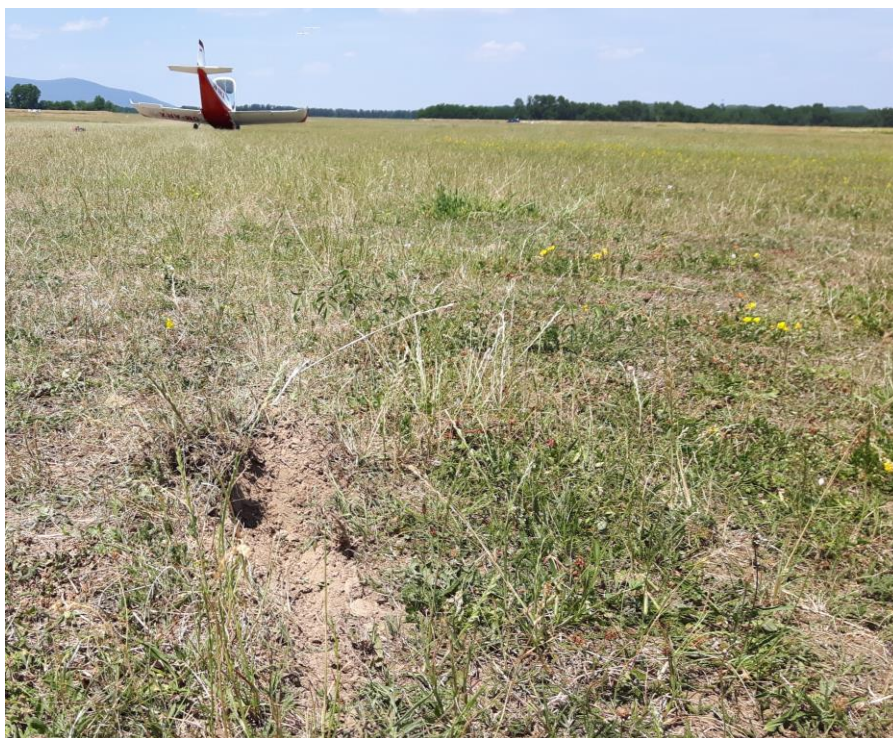
After bouncing, the aircraft remained stationary on VPD 14.
