Reg.No. SKA2012001

## FINAL REPORT

on investigation of air accident  
of gliders **DG-100G Elan** and **Discus b**  
registration No. **OE - 5298** and **D - 8977**

Date: 04.04.2012

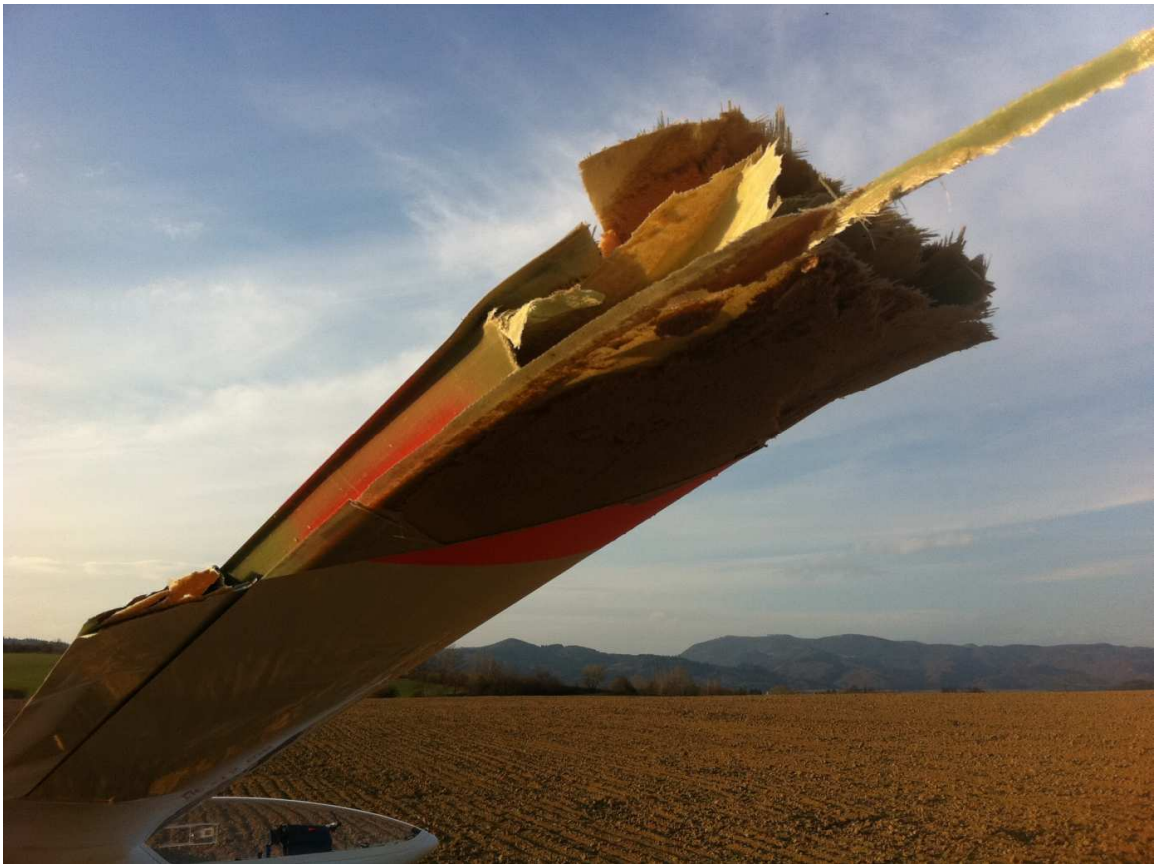
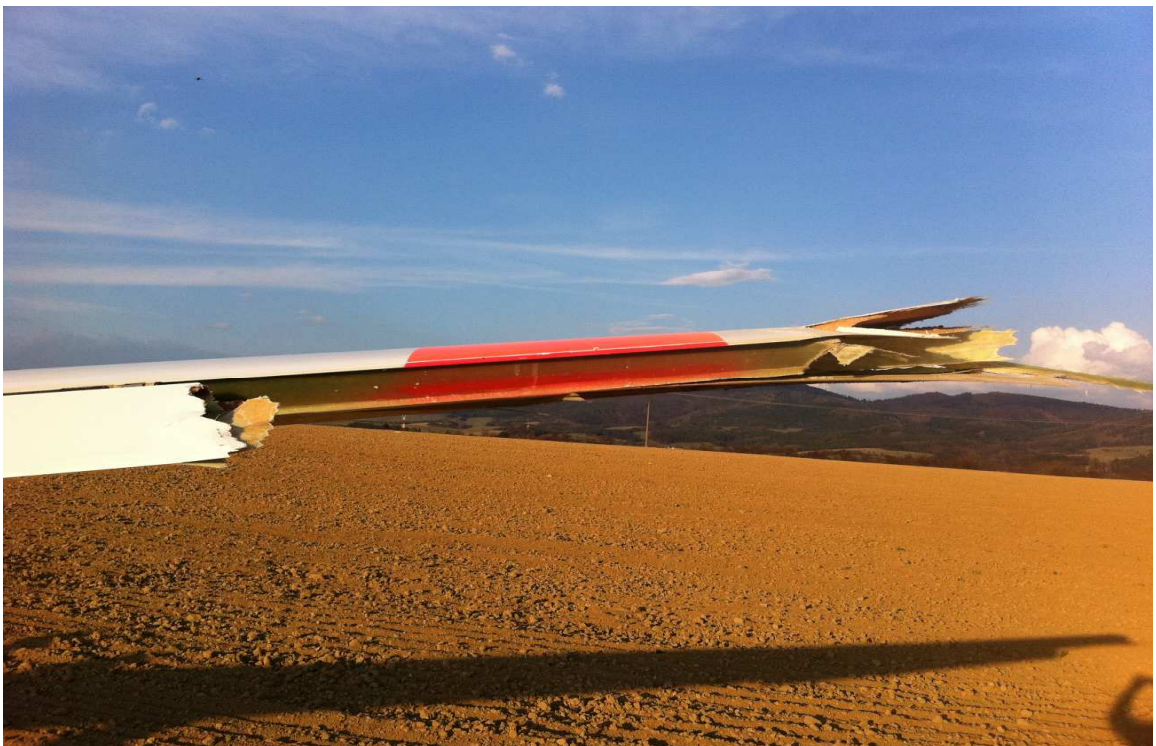
**Glider DG-100G Elan** – after the collision its right wing was broken 0.5 m from its tip, the right aileron was broken 1 m from its external edge, the right wing skin was broken from the spar to the trailing edge on the top part, 0.6 m from the spar in the area of rudder cut-out symmetrically on the upper and lower skin, the wing skin was broken from the spar to the

trailing edge near the butt rib (symmetrically on the upper and lower skin). The glider also had a 7 cm long crack in the skin near the air brake and unstuck wing skin from the butt rib. On the airframe of glider the front edge of left-hand undercarriage door was damaged, the right-hand undercarriage door was torn off and the door hinges were destroyed. The left wing and tail surfaces were not damaged.

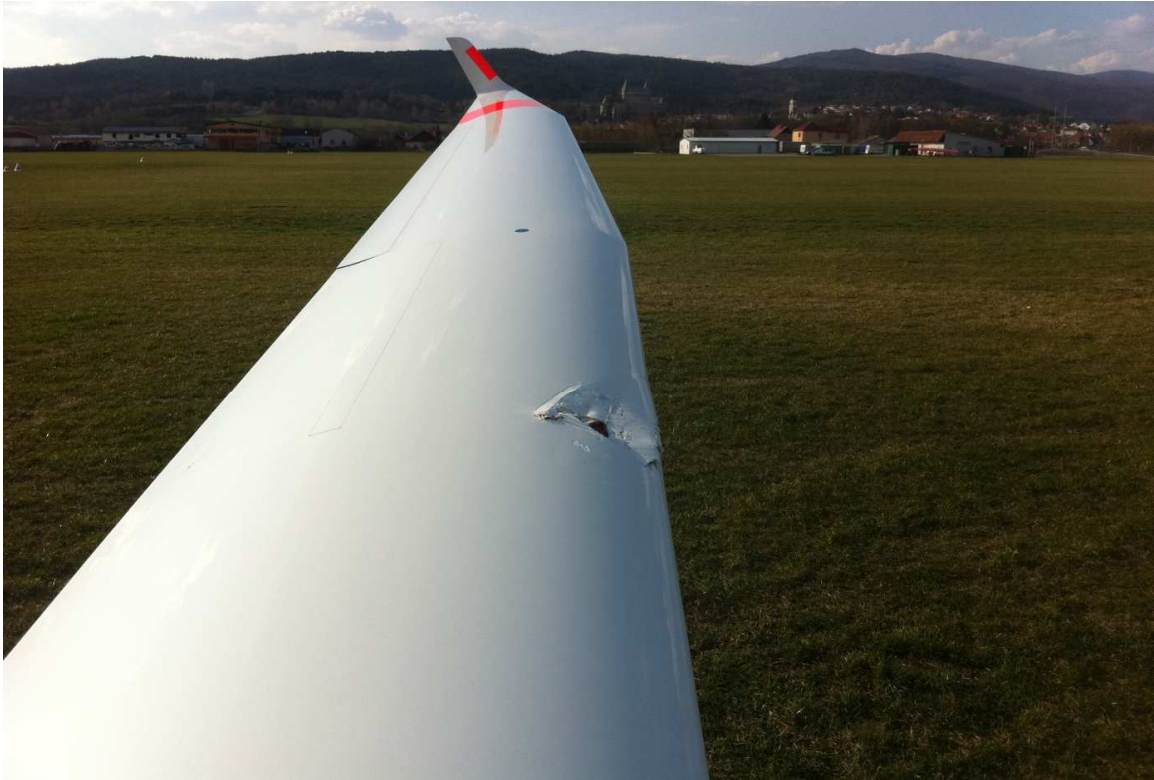
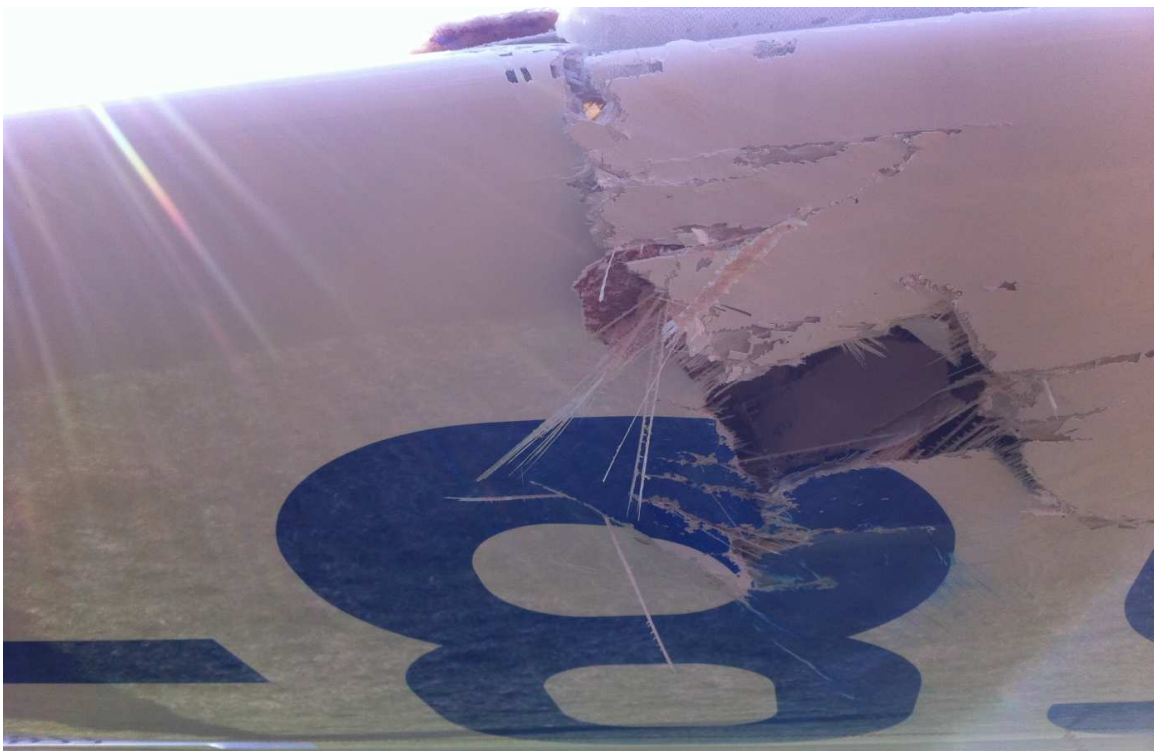
**Glider Discus b** - after the collision its left wind leading edge was broken, the upper and lower sandwich wing skin was damaged 1.5 m away from the butt rib in a length of 30 cm up to the spar boom, the trailing edge of wing was unstuck in a length of 15 cm, about 1.5 m away from the butt rib. The glider also had cracks on the upper side of the laminated wing skin approximately 1.5 m away from the butt rib on the surface from the beam to the trailing edge, cracks on the lower side of laminated wing skin 1.5 m away from the butt rib on the surface from the beam to the trailing edge and upper skin of the upper side of wing detached from the spar boom in a length of 5 cm in the area above the open wing skin. The right wing and tail surfaces were not damaged.
