FINAL REPORT

on investigation of air accident
of aircraft **Schleicher ASW 28-18**,
Registration No. **D - 2766**

Date: 27.04.2012

Place: Čereňany

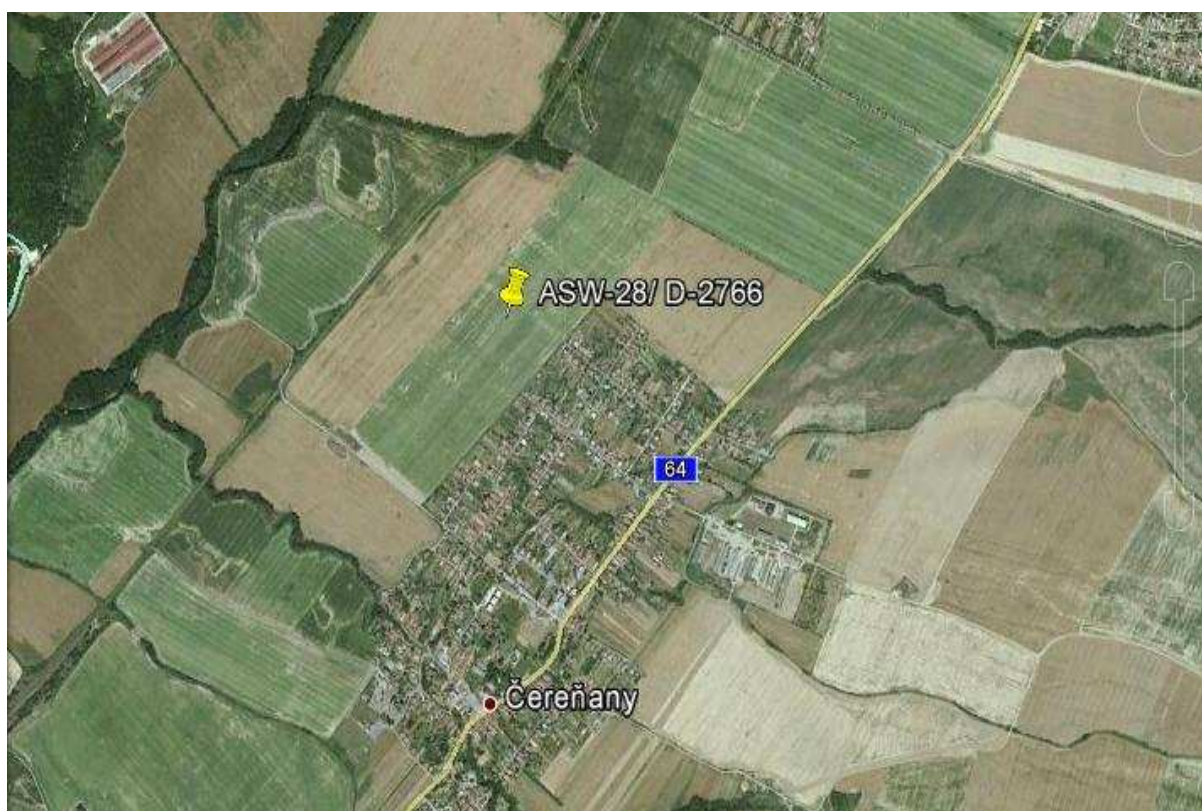
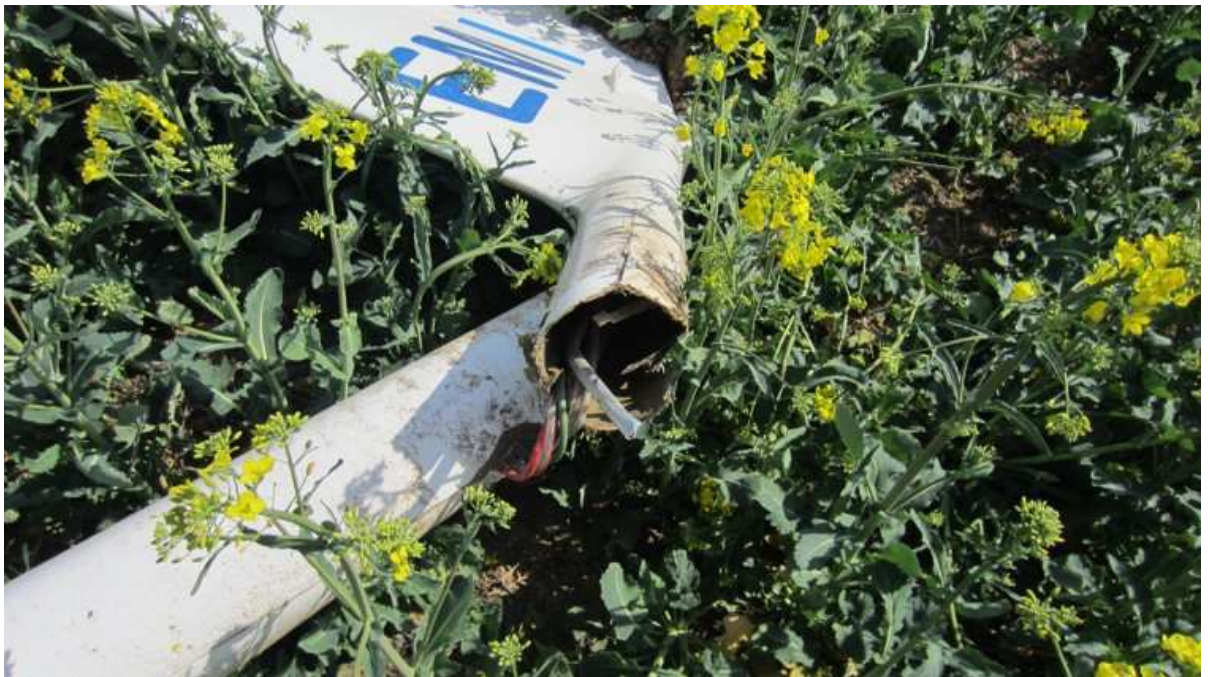
The tail section and the horizontal rudder of the aircraft broke off.

1.12 Wreckage and impact information

The aircraft landed on a field seeded with rape. The place of accident is determined by geographical coordinates: N 48°39' 07'', E 018° 29' 09''

The field landing of gliders requires a thorough previous inspection of chosen landing area and the proper preparation for landing on chosen surface by the pilots. The pilot initially chose a surface suitable for landing, but at the last moment for unknown reasons decided to make another turn (by 360°) before landing, probably due to his incorrect estimate of altitude. However, due to low altitude, the pilot was unable to turn the aircraft in the initially chosen direction of landing and in the middle of the turn he decided to land on a field seeded with rape situated in front of him. The glider wing touched the undergrowth, which caused the glider turning by 180°. The following overswing of the aircraft body caused that the tail section with horizontal rudder broke off.
