## FINAL REPORT

on investigation of air accident  
of glider **VSO-10 Gradient**  
Registration No. **OM - 6519**

Date: 02.05.2012

Place: Lopej

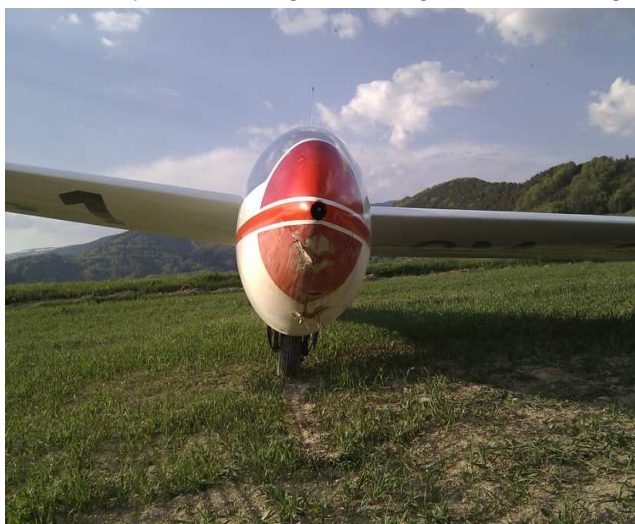
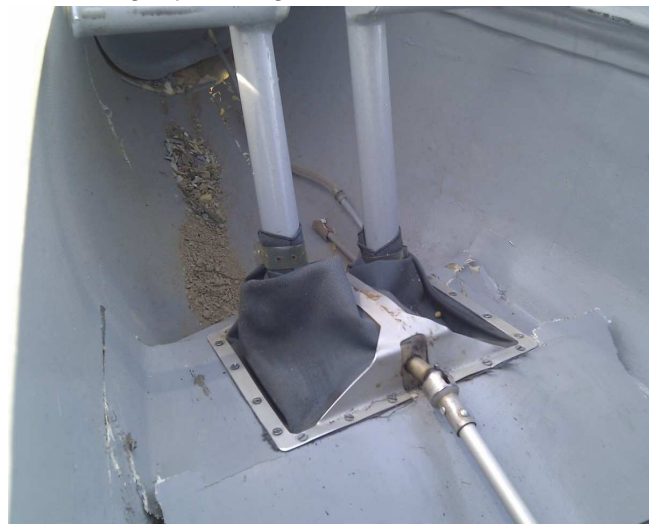
The glider VSO-10 Gradient remained in one piece after the air accident, with damaged forebody and damaged main-gear well. The glider was slightly damage.

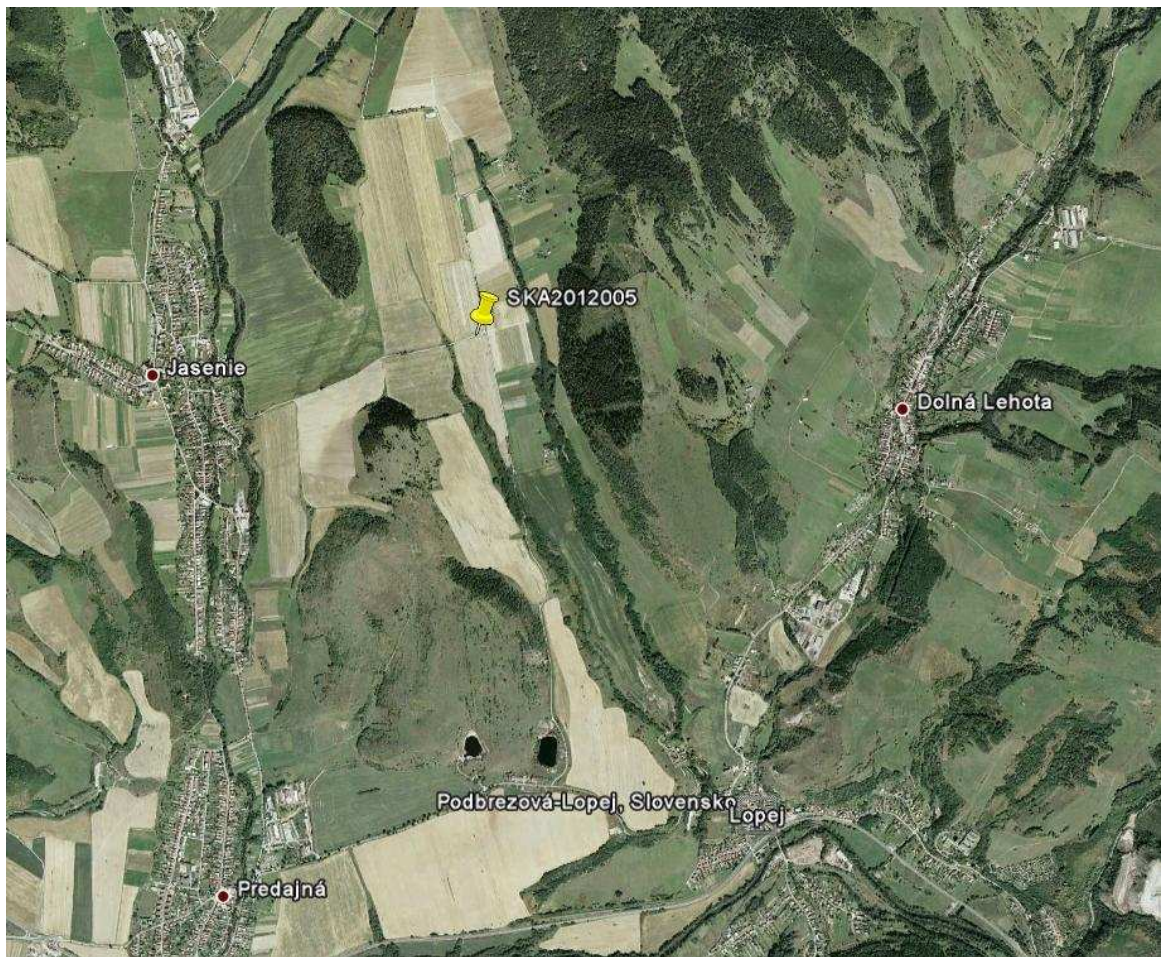
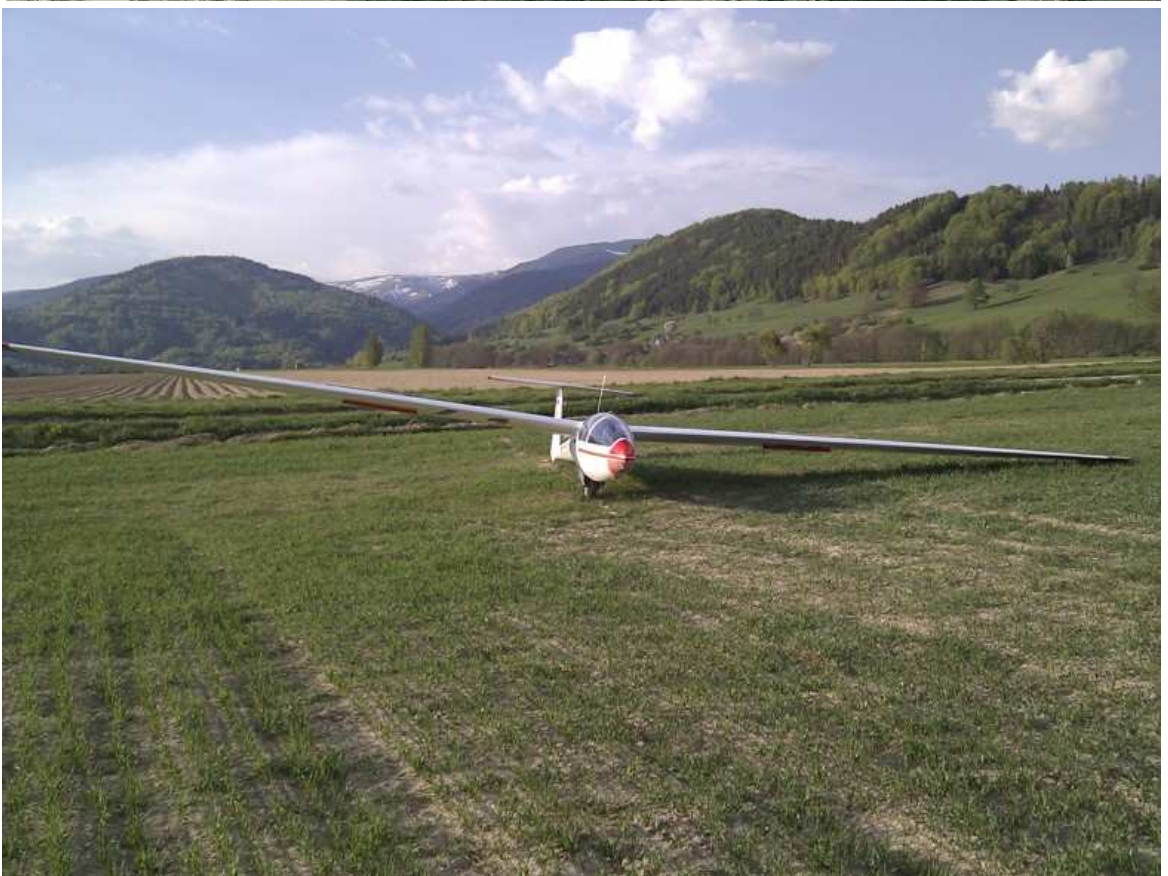
The glider fell to a flat ground without significant obstacles. The place of accident is delimited by geographical coordinates:

After selection of suitable area for forced landing the pilot probably misjudged the altitude and speed of field landing approach and overshoot. At that moment the pilot had not sufficient length of landing run on the selected surface. The glider skipped to a road crossing the end of the selected surface, hit a chuck hole, nosed over and stopped on the field behind the road.
