## FINAL REPORT

on investigation of air accident  
of helicopter **Robinson R22**  
Registration No. **OM - BRH**

Date: 08.10.2012

Place: Airport Spišská Nová Ves / LZSV

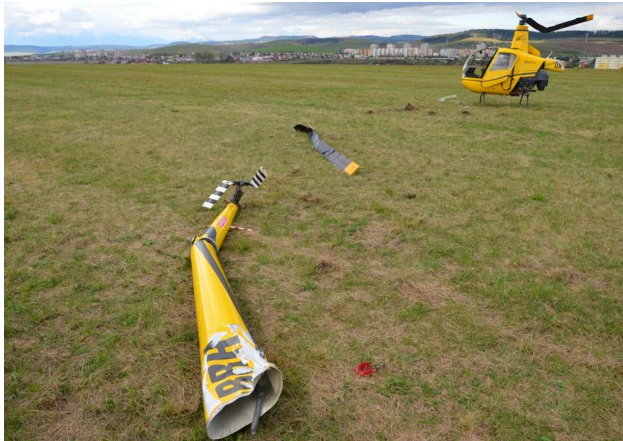
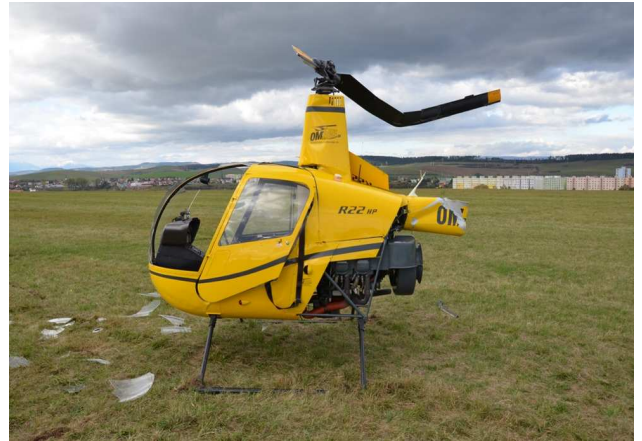
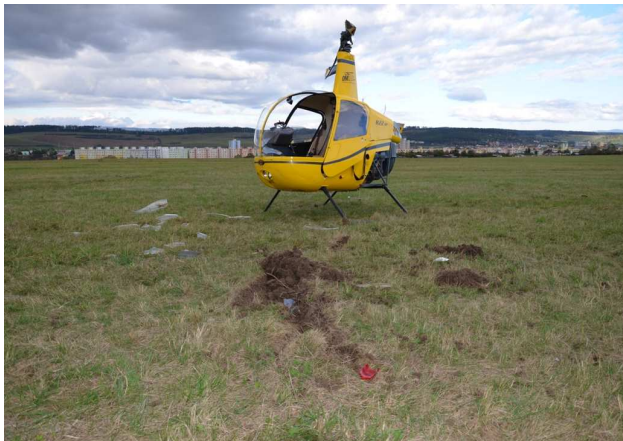
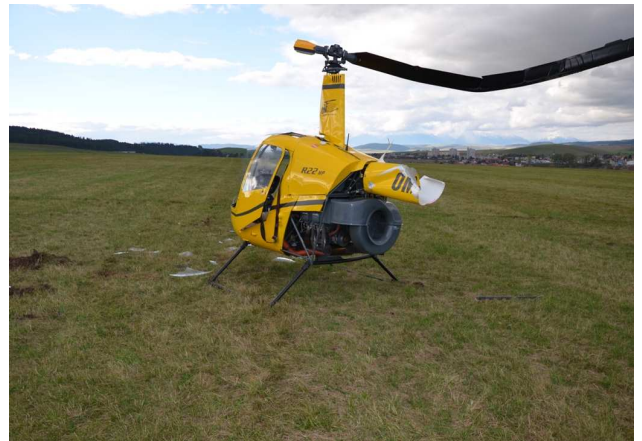
On 8 October 2012 the pilot with helicopter Robinson R22 was doing air operations in the district of Airport LZSV. After their termination, during air-taxiing, the helicopter grazed the grass airport surface with its right and then left skid and rotor blades. The tail rotor mast came off and the main rotor was destroyed.

The helicopter came to a standstill on damaged skids in the area of the Airport LZSV.
