AVIATION AND MARITIME INVESTIGATION AUTHORITY
Námestie slobody 6, P.O.BOX 100
810 05 Bratislava 15

FINAL REPORT

on the safety investigation of an air accident
of flying sports device
type Axis Paraglider Compact 3 M
registration mark **OM-P835**

Reg. No: SKA2018007

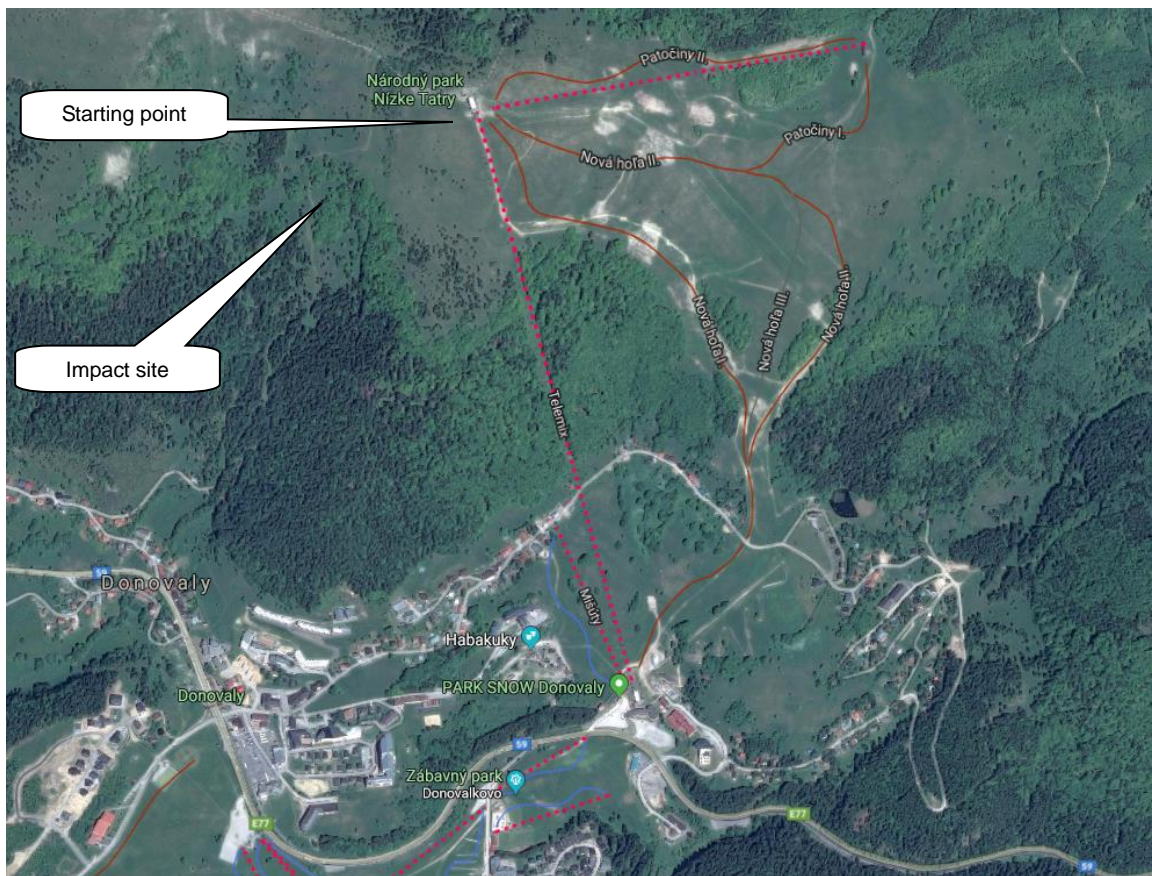
The PG fell close to its take-off site. Coordinates of the accident site:
48° 53' 19.71" N, 019° 13' 32.28" E
