FINAL REPORT

on investigation of air incident
of aircraft **Beechcraft B90 Cargo liner**
Registration No. **G-JOTA**

Date: 03.04.2012

Location: FL120 during the climb out from LZIB airport on a TOVKA2K departure routing

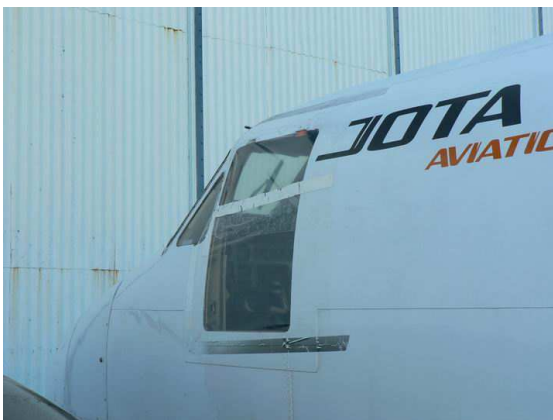
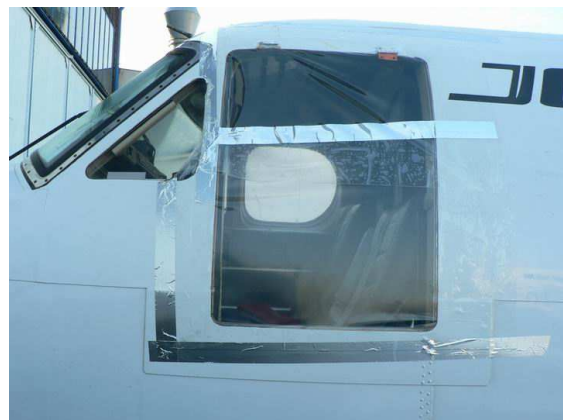
Crew access door detached / the door has still not been recovered.

No damage to door frame.

Inspection of the door structure showed no apparent damage to indicate aircraft structural failure. The upper frame, forward frame, aircraft frame and lower frame were inspected internally and externally for missing or loose fasteners, gouging, scoring, cracking. Door shoot bolt striker plates were inspected for security and serviceability. No defect was noted to indicate aircraft structural failure.

Both the forward and aircraft door hinges were attached to the aircraft structure. The hinges are structured from stainless steel material. The forward hinge lower half had torn away from upper half aircraft structure and the aircraft hinge was intact but the lower hinge half was deformed and twisted around the fastener attachment holes. Both hinge pins were still intact.

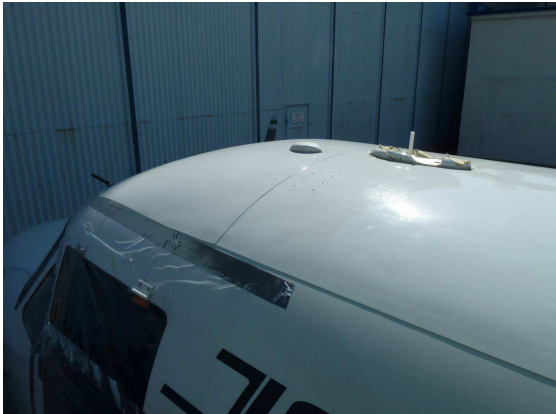
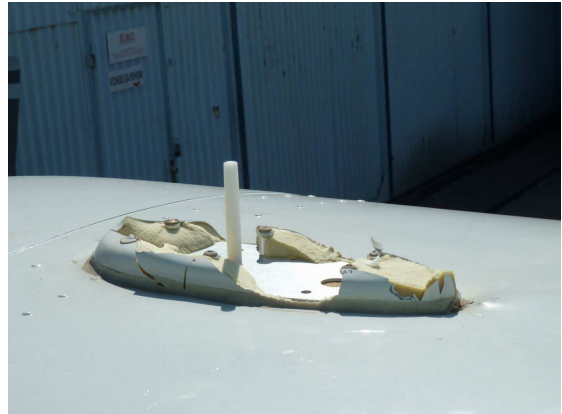
Comm 2 antenna detached / missing - heavily damaged.

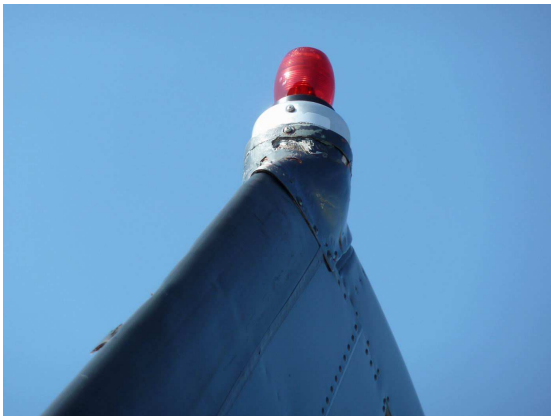
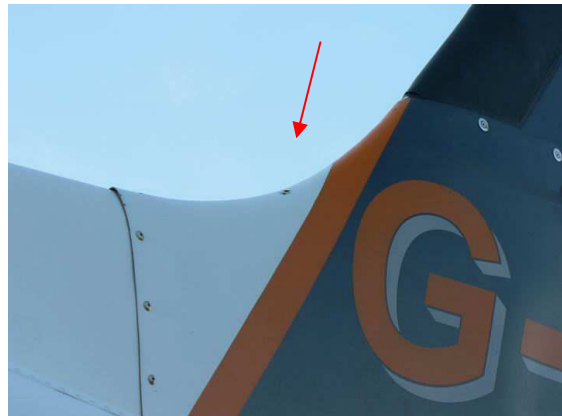
Damage Tail De-Ice boot vertical fin

Damage to dorsal fin fairing
