AVIATION AND MARITIME INVESTIGATION AUTHORITY
Námestie slobody 6, P.O.BOX 100
810 05 Bratislava 15

FINAL REPORT

on the safety investigation into a parachutist occurrence
of a parachute type SOLO 290

Reg. No: SKP2018001

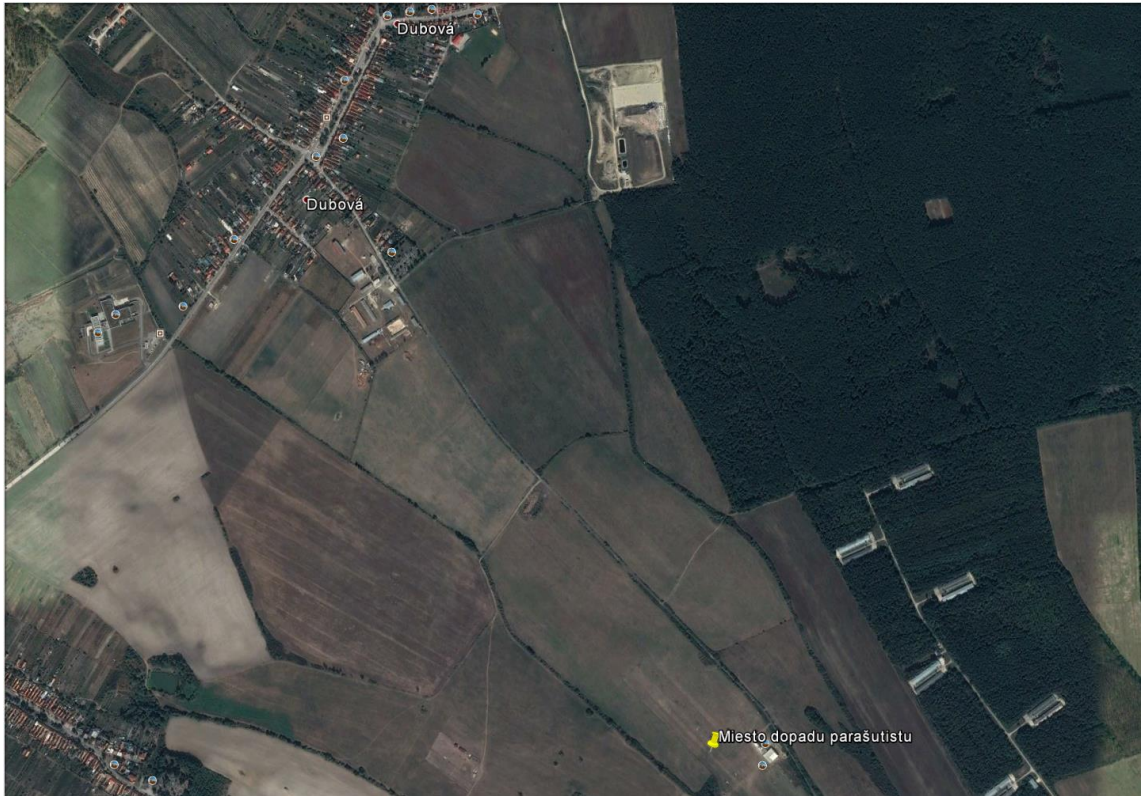
Incident site - the parachutist landed 70 m in the axis and after the threshold of RWY31 and it is delimited by the following coordinates:

48° 20' 57.08" N

17° 21' 11.83" E
