FINAL REPORT

on investigation of serious incident
of aircraft **CESSNA 310Q**
registration No. **OM-GEO**

Date: 05.03.2012

Place: Košice Airport / LZKZ

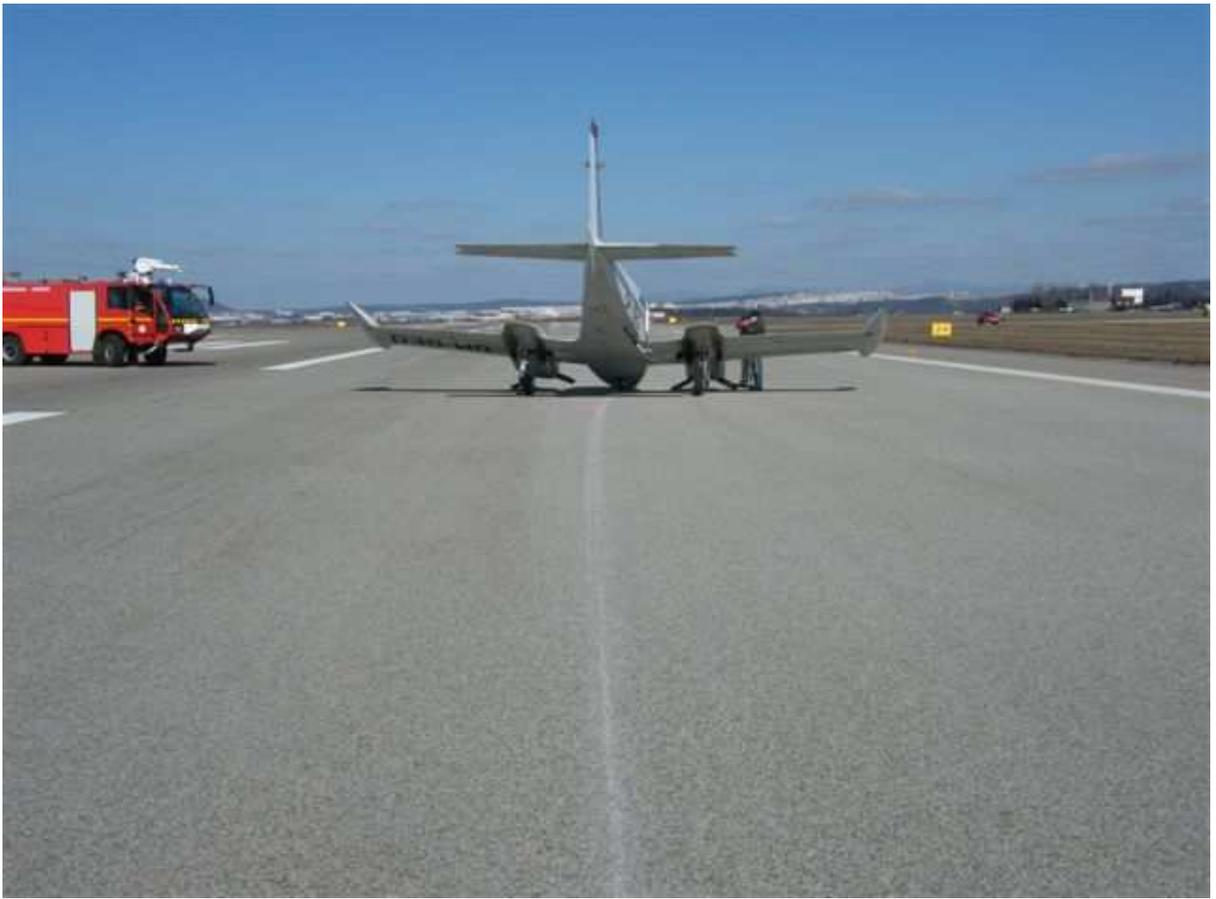
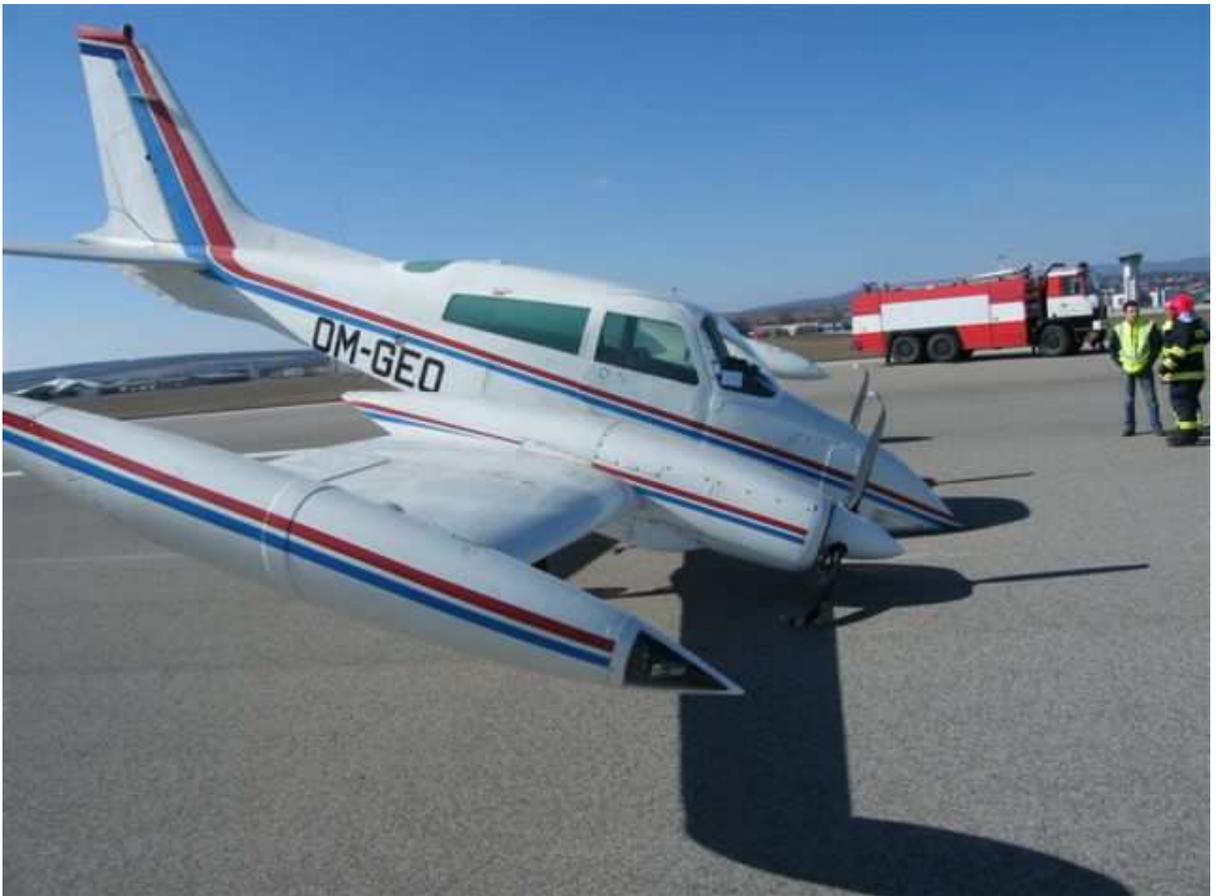
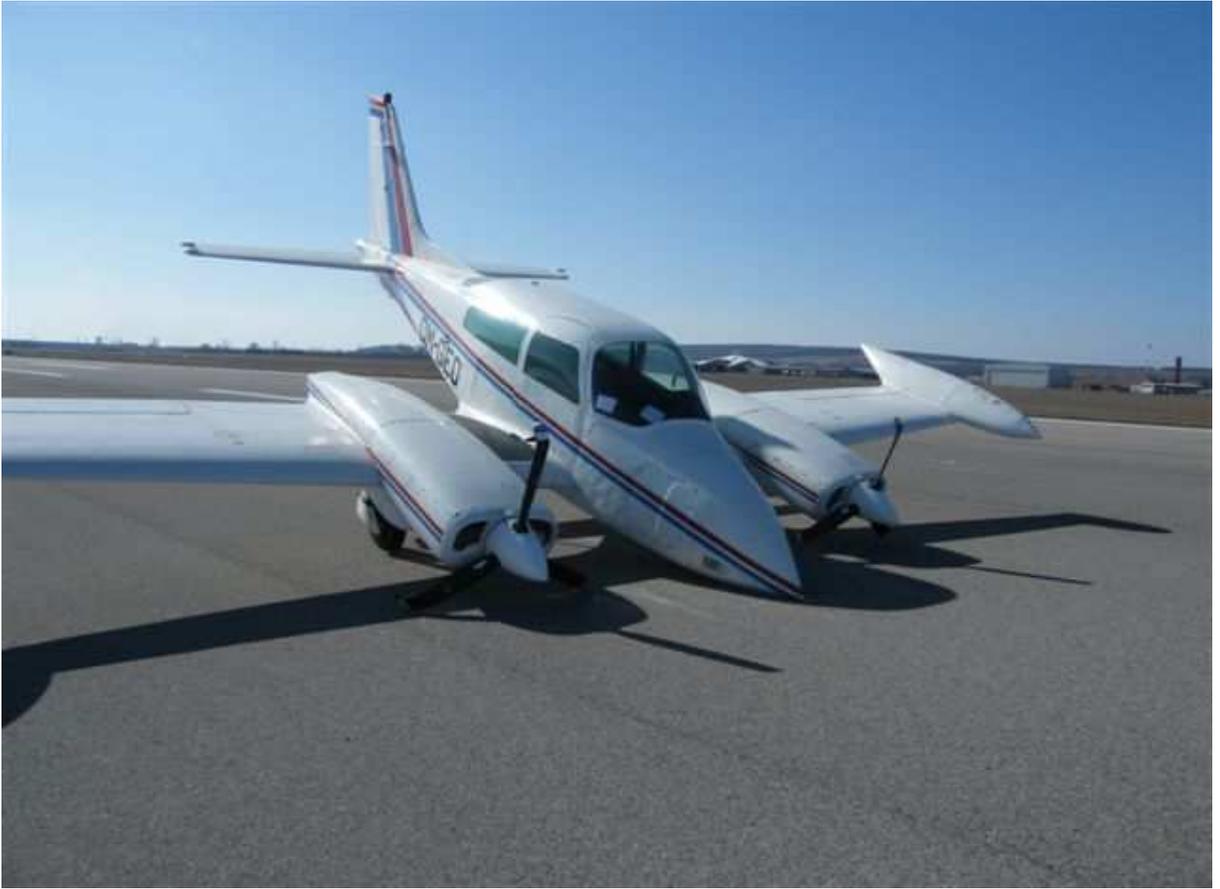
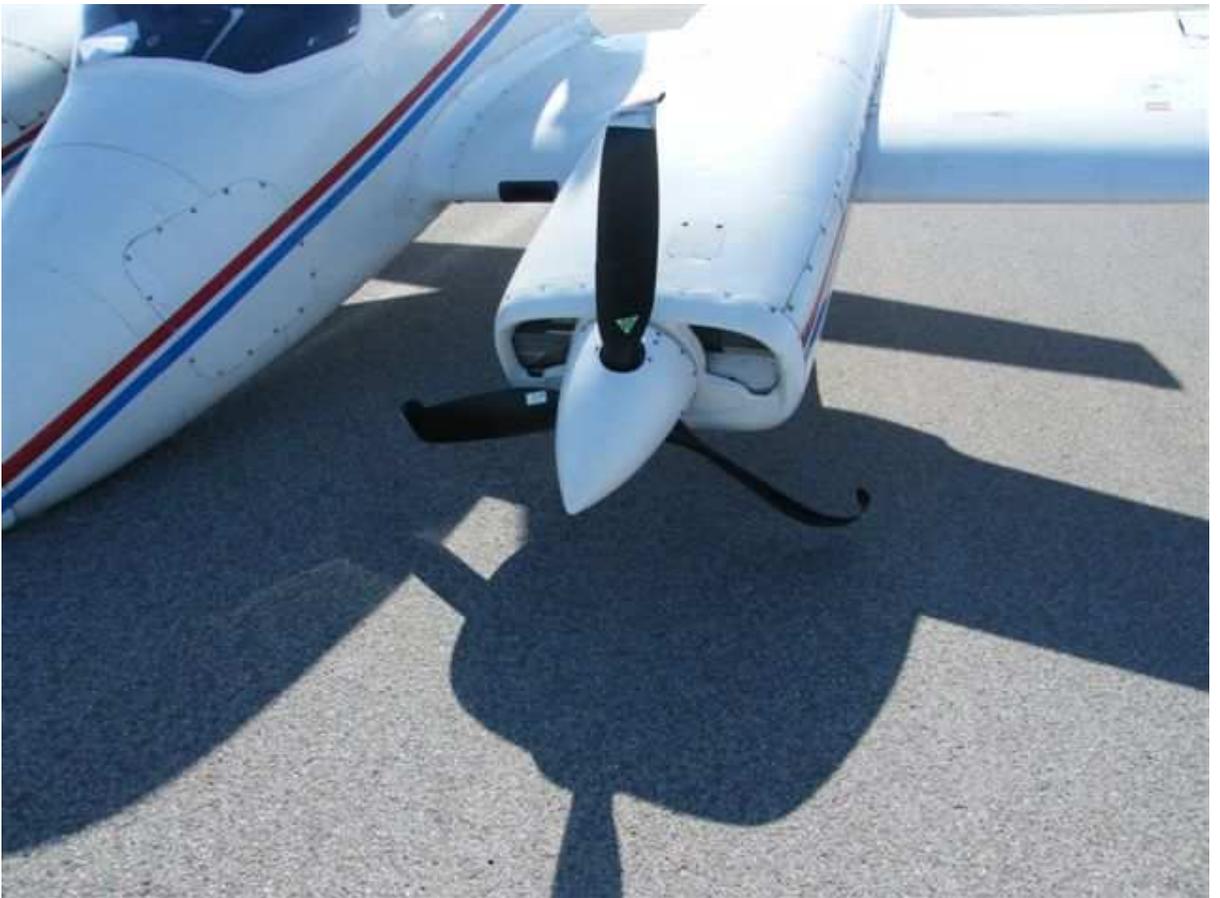
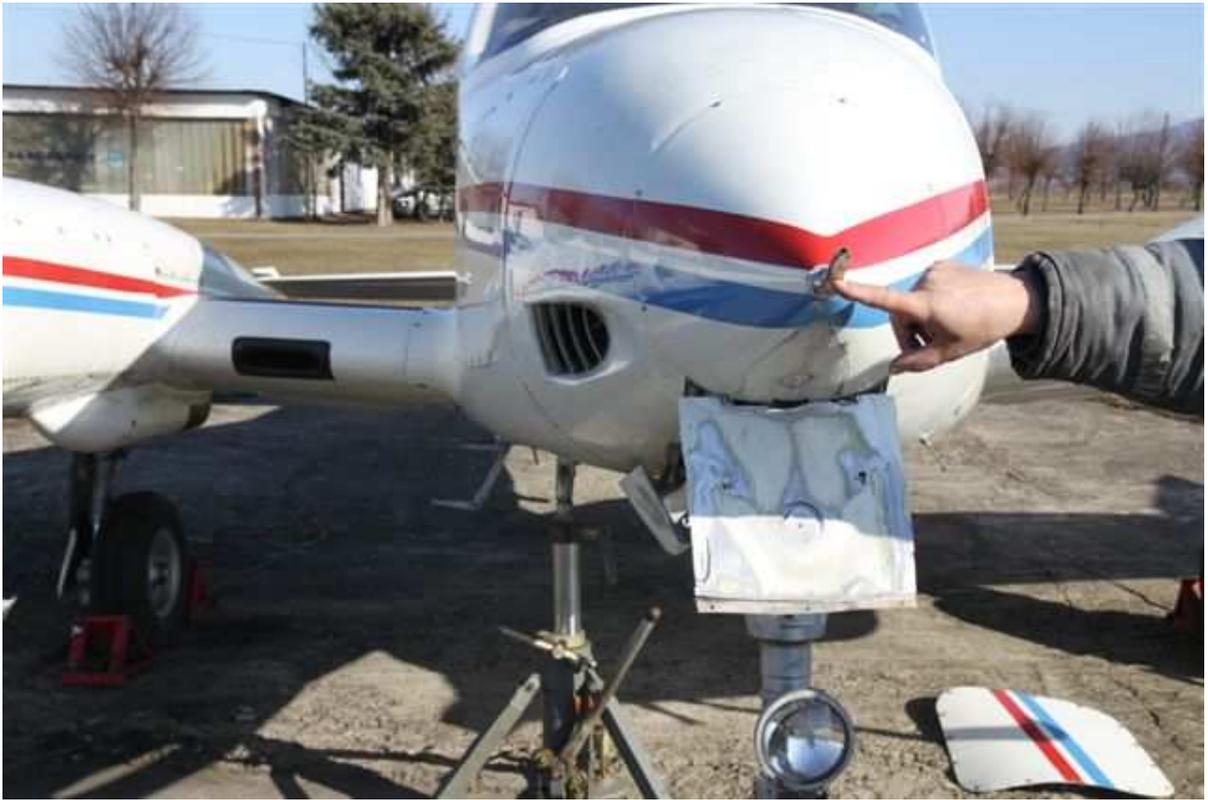
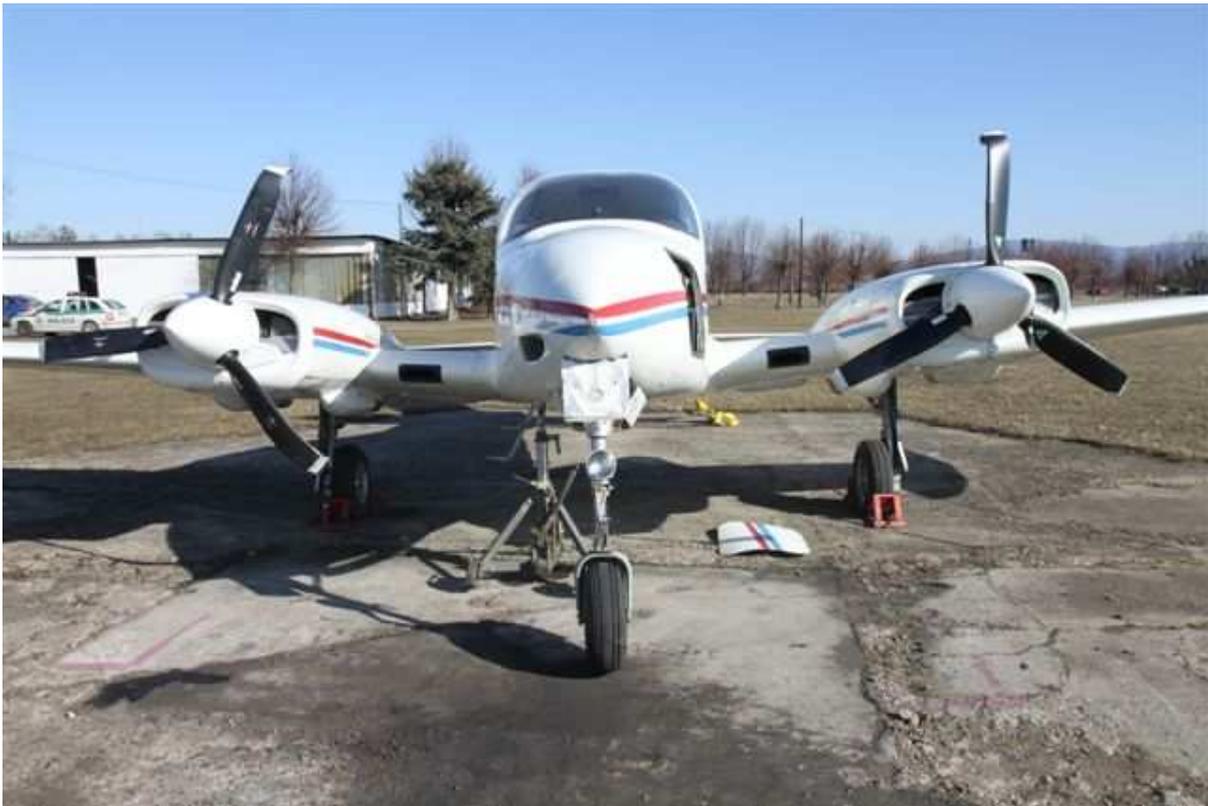
The aircraft suffered substantial damage in the serious incident. The following parts of the aircraft were damaged as a result of retraction of the unblocked front landing-gear leg and subsequent contact of the forebody with RWY:

front landing-gear leg,

pitot tube,

right and left-hand front landing-gear doors,

right and left-hand propellers and

deformation of the right-side engine hood skin and the front landing-gear retraction and extension rod.

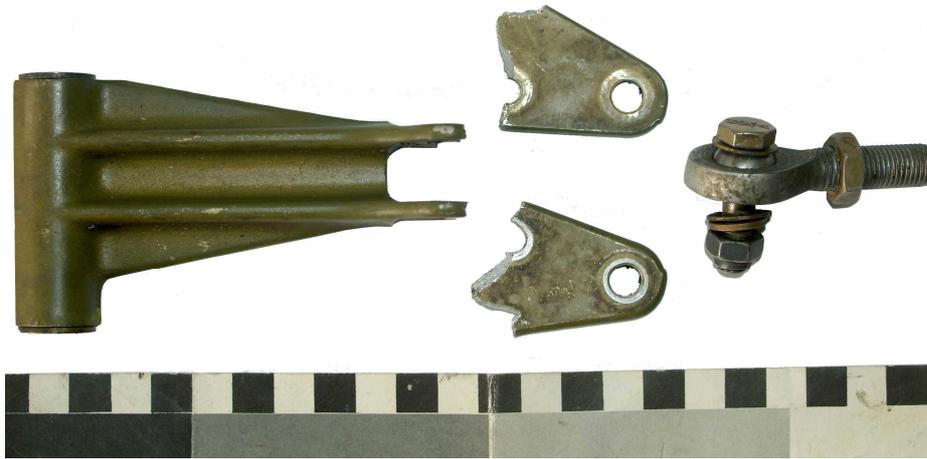
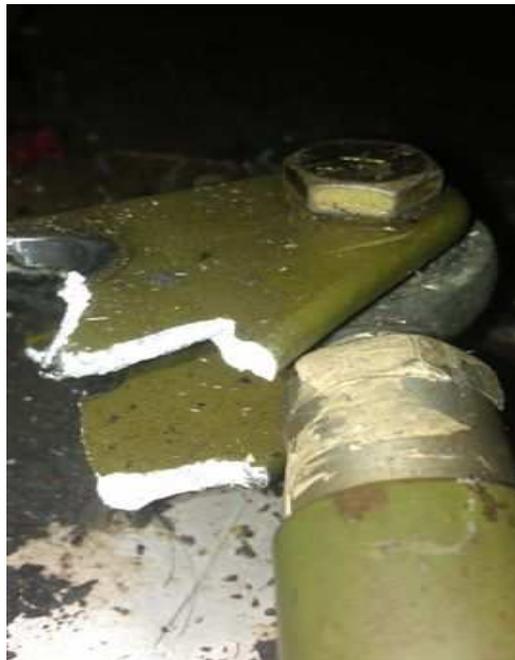
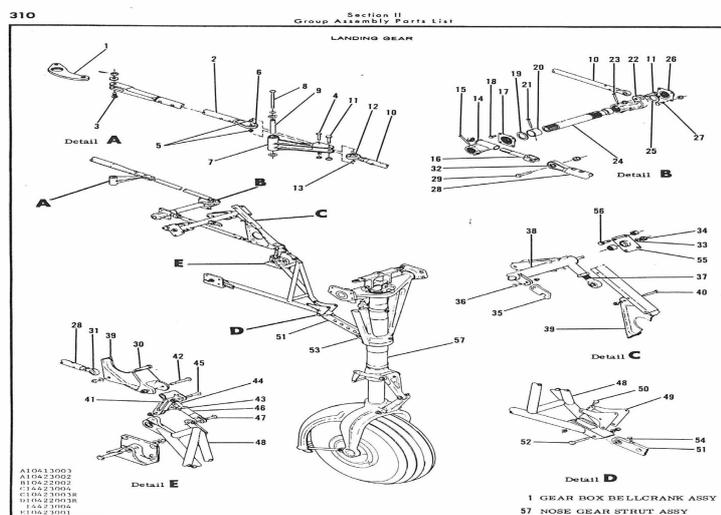
Figure 100. Nose Gear Retraction Linkage Installation

The rupture of the front landing-gear tie rod was subjected to expertise.

Two flat supports of the tie rod were broken at a point, where the pin boss of piston rod of hydraulic operating cylinder was connected to the rod.

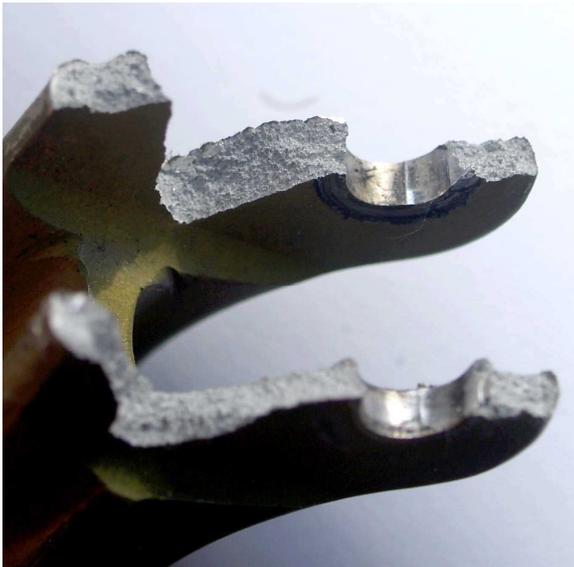
fig. 1

From the macroscopic aspect all ruptures of the rod had a fragile or fission character without transverse contraction of material on their periphery. The presence of progressive and relaxation belts of potential fatigue mechanism of material damage were not detected on the ruptures. The ruptures had unusual saw-tooth form (fig. 1), which means that they could not have been caused by simple tensile load, where ruptures spread vertically on the direction of load in case of damaged section with certain homogeneity

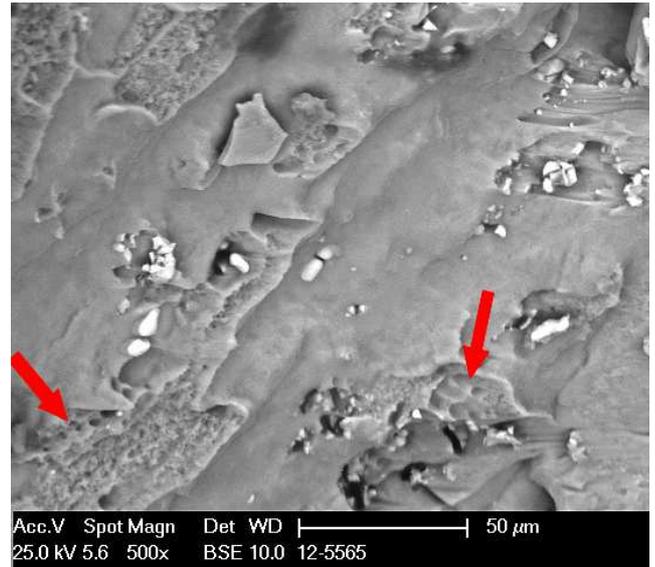
fig. 2

Subsequently the ruptures were examined using electron scanning microscope with an energy-dispersive X-ray spectrometer. The examination detected that they were quasi-cleavage ruptures with observable areas of plastic mechanism of material damage with a distinct cup and cone morphology (fig. 2).

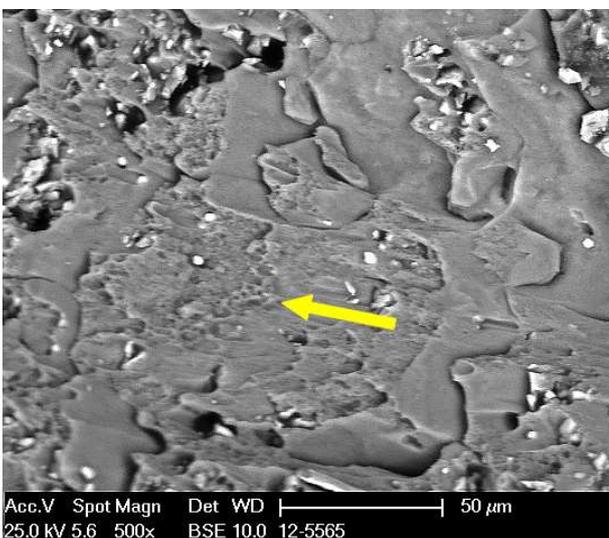
fig. 3

Potential striae of the rupture spreading fatigue mechanism were not detected in any of the examined rupture surfaces. Areas with visible traces of shearing mechanism of material damage, with material grain margins bent in the direction of load, were detected on slant sections of ruptures forming their saw-tooth shape (fig. 3). As far as the material composition concerns, the rod was made of aluminium, copper and manganese alloy with trace of iron (see the spectrogram, fig. 4).

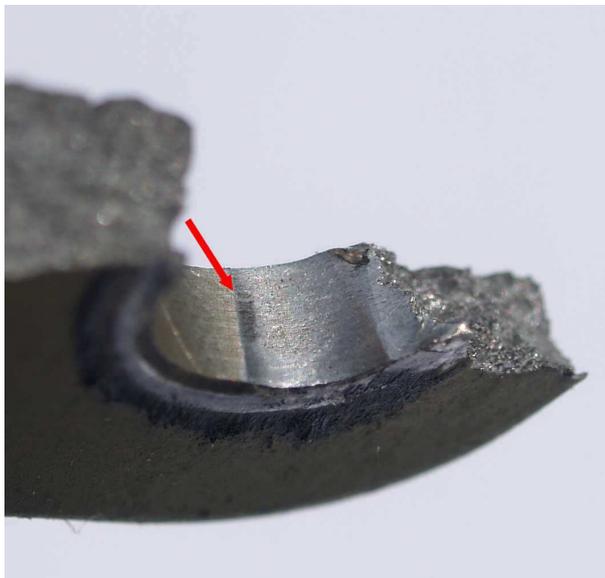
The absence of traces of potential fatigue mechanism of material damage proved that the rod had been damaged by power overload of the material. This assumption was confirmed by the presence of new deep imprints on internal walls of openings, through which the piston rod eye bolt passed via the broken attachments of the rod (see margins of these imprints marked with arrows, fig. 5 and fig. 6).

- the rod was damaged by quasi-cleavage ruptures with areas of plastic mechanism of material damage with distinct cup and cone morphology. Areas with visible traces of shearing mechanism of material damage were detected on slant sections of ruptures that are responsible for their saw-tooth form. Neither macroscopic nor microscopic traces of fatigue material damage were found.
- the rod was damaged by force overloading in the incorrect working regime of the rod at the time of damage.
