# MINISTRY OF TRANSPORT, CONSTRUCTION AND REGIONAL DEVELOPMENT OF THE SLOVAK REPUBLIC

Reg. No. SKS2012004

## FINAL REPORT

on investigation of serious incident of  
non-observance of separation minima  
between flight TTJ 603 and military flight SK 01

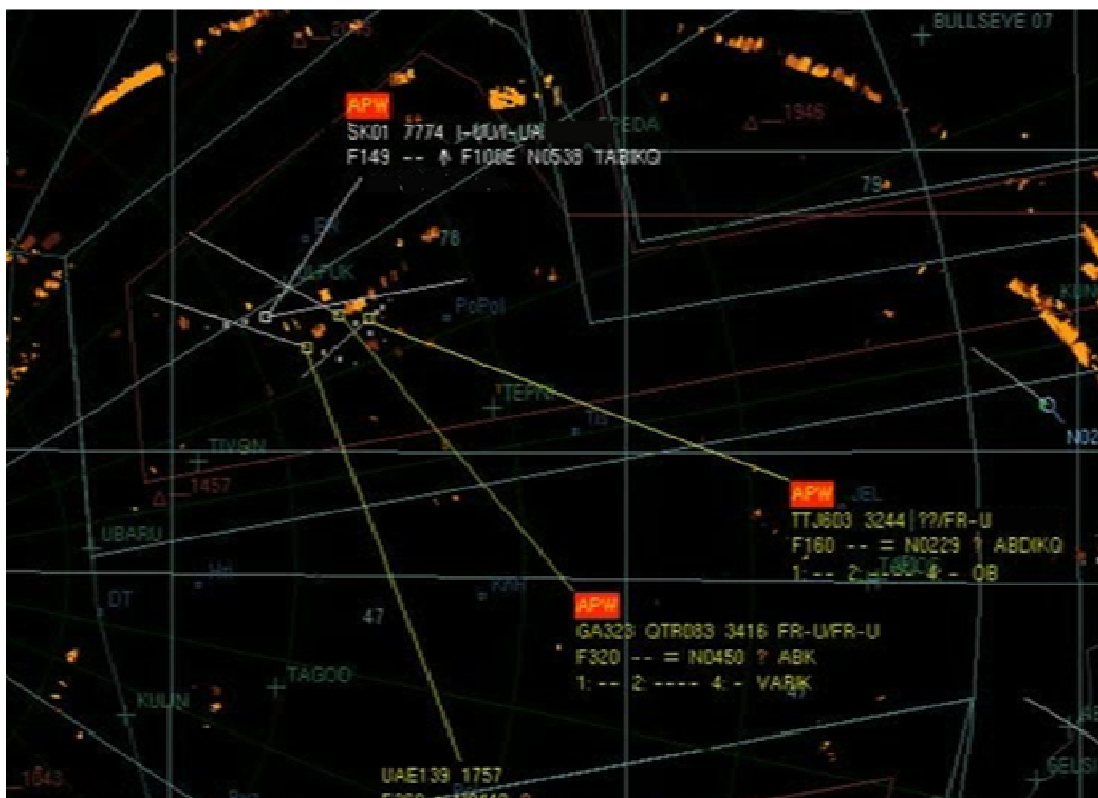
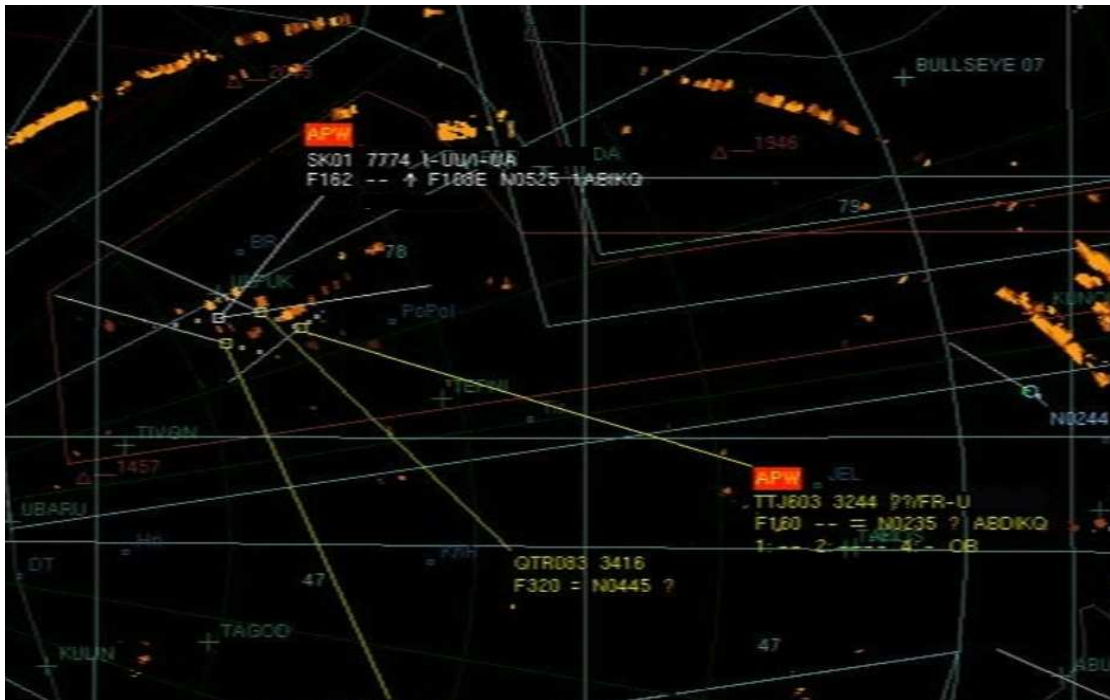
During this practical examination the distance between military aircraft SK 01 climbing to FL240 and civil aircraft TTJ 603 maintaining FL160 (opposite direction course) was reduced on two occasions for 11 sec from initial value of horizontal separation of 4.2 NM and vertical separation of 0 ft up to 2.6 NM, when the vertical separation of 1000 ft was renewed. At that time the ACAS system of TTJ 603 signalled „TA“. After FA's warning of conflict civil traffic RRBP in training ordered the pilot of aircraft SK 01 to climb up to FL140. However, at that time the pilot of SK 01 exceeded FL160, which he subsequently reported together with information that he was descending to FL140.

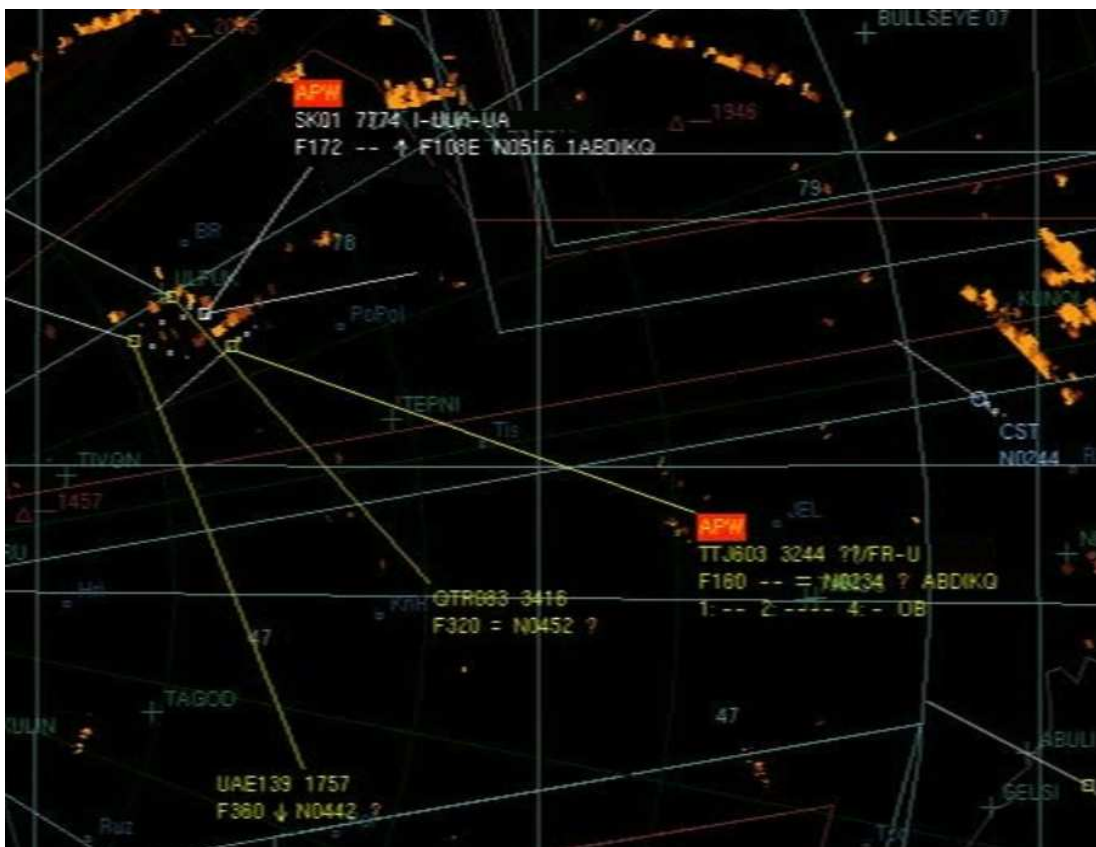
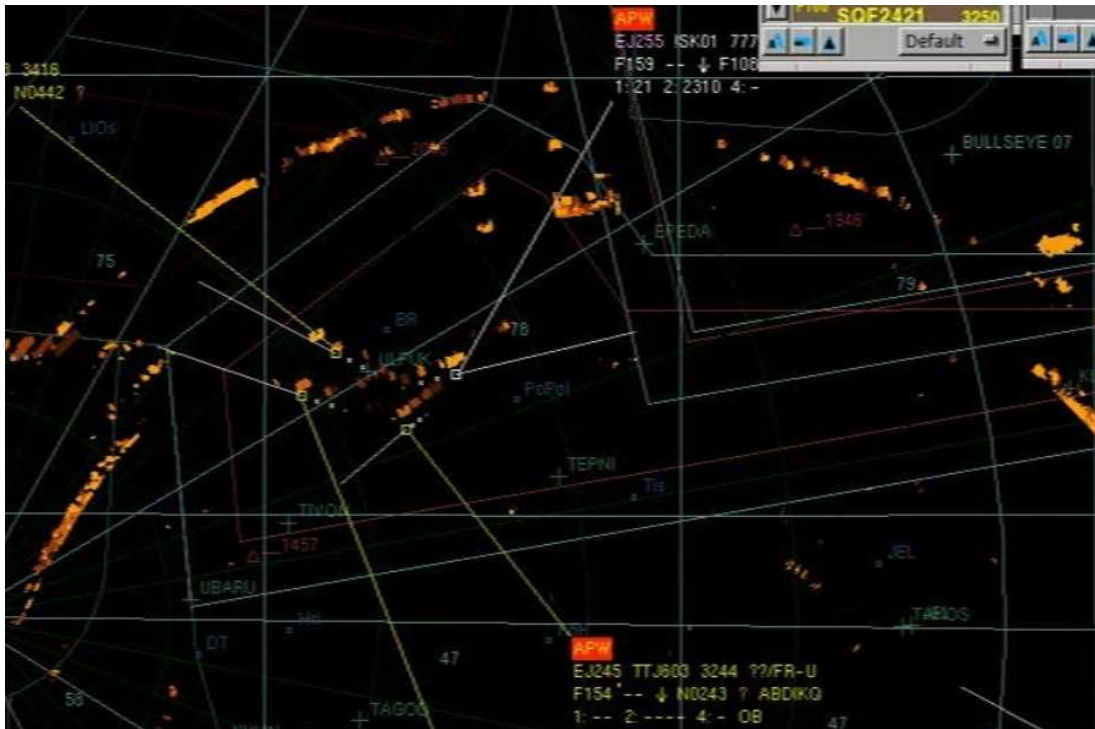
The second air miss occurred in the phase of moving away from TAJ 603, when SK 01 descended from FL170 to FL140 during 12 sec from the value of horizontal separation of 1.6 NM to 3.4 NM, where the vertical separation of 1000 ft was renewed. In this air miss the crew of aircraft TAJ 603 received from ACAS the avoidance advice (RA), which they immediately followed and descended to FL146. At that time SK 01 was on departure in a distance of 1.8 NM with vertical separation of 200 ft.
