FINAL REPORT

on investigation of serious incident
of aircraft type **DA-42NG**
registration No. **OM-IVO**

Date: 30.09.2012

Place: Airport Piešťany / LZPP

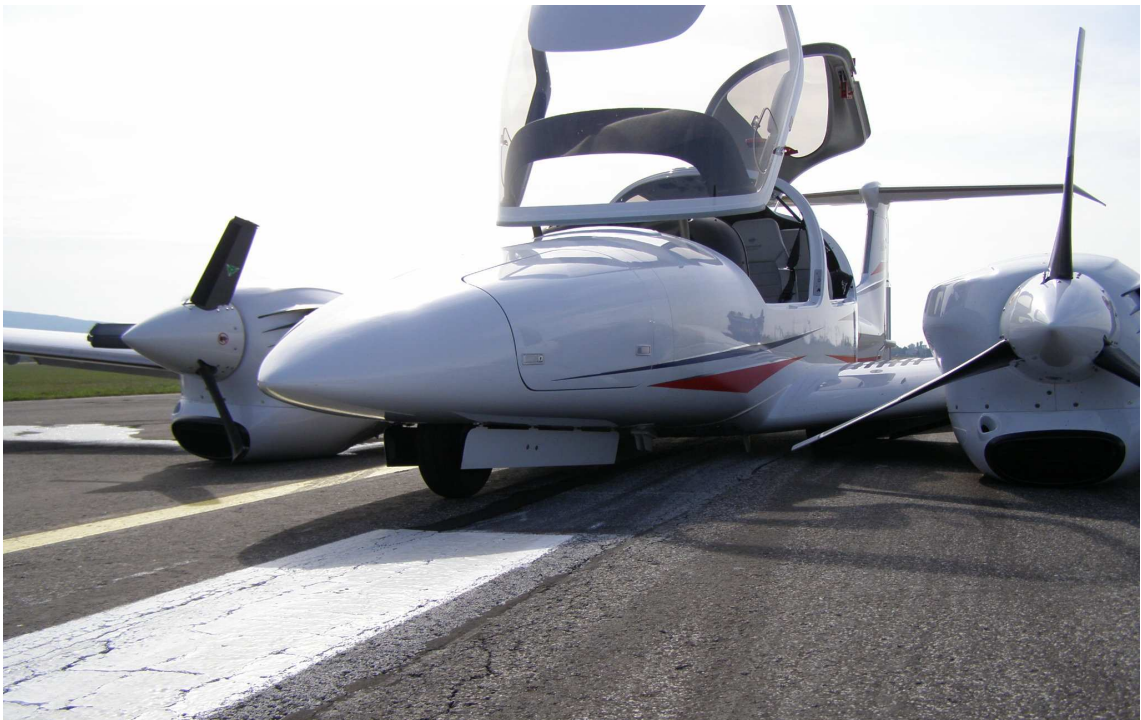
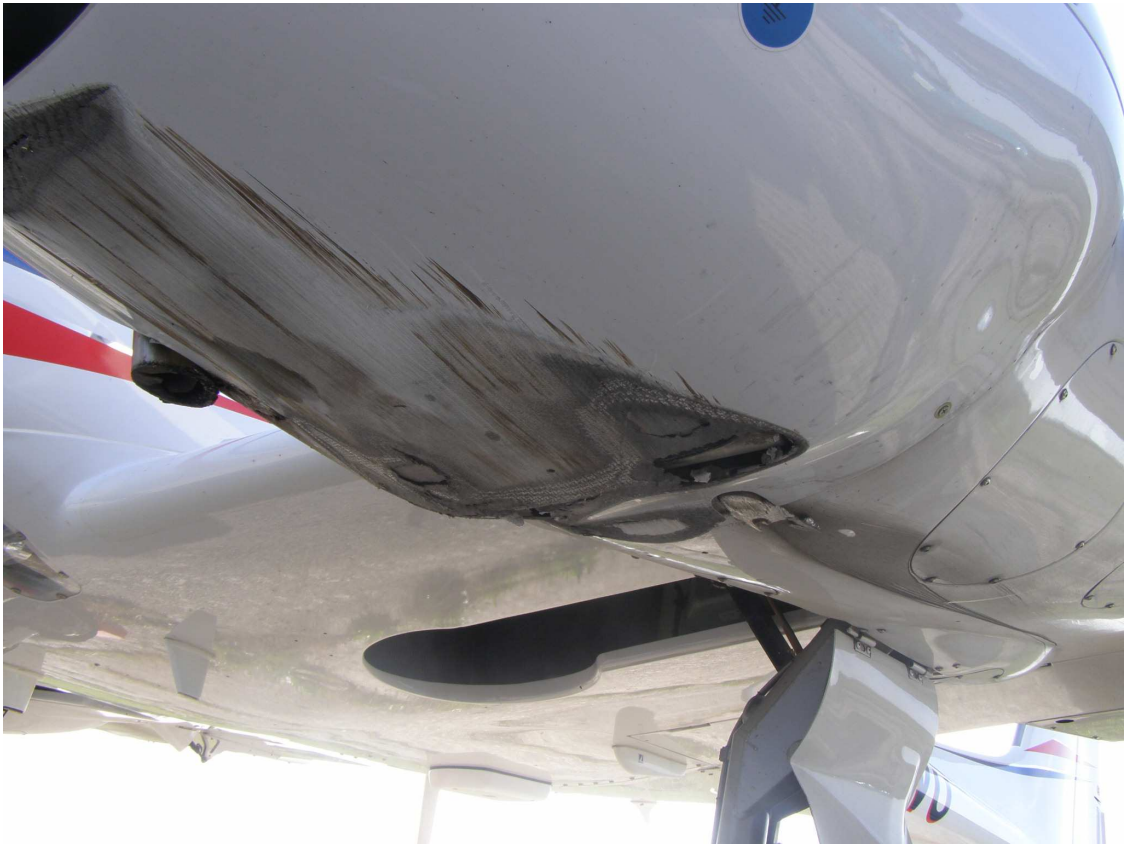
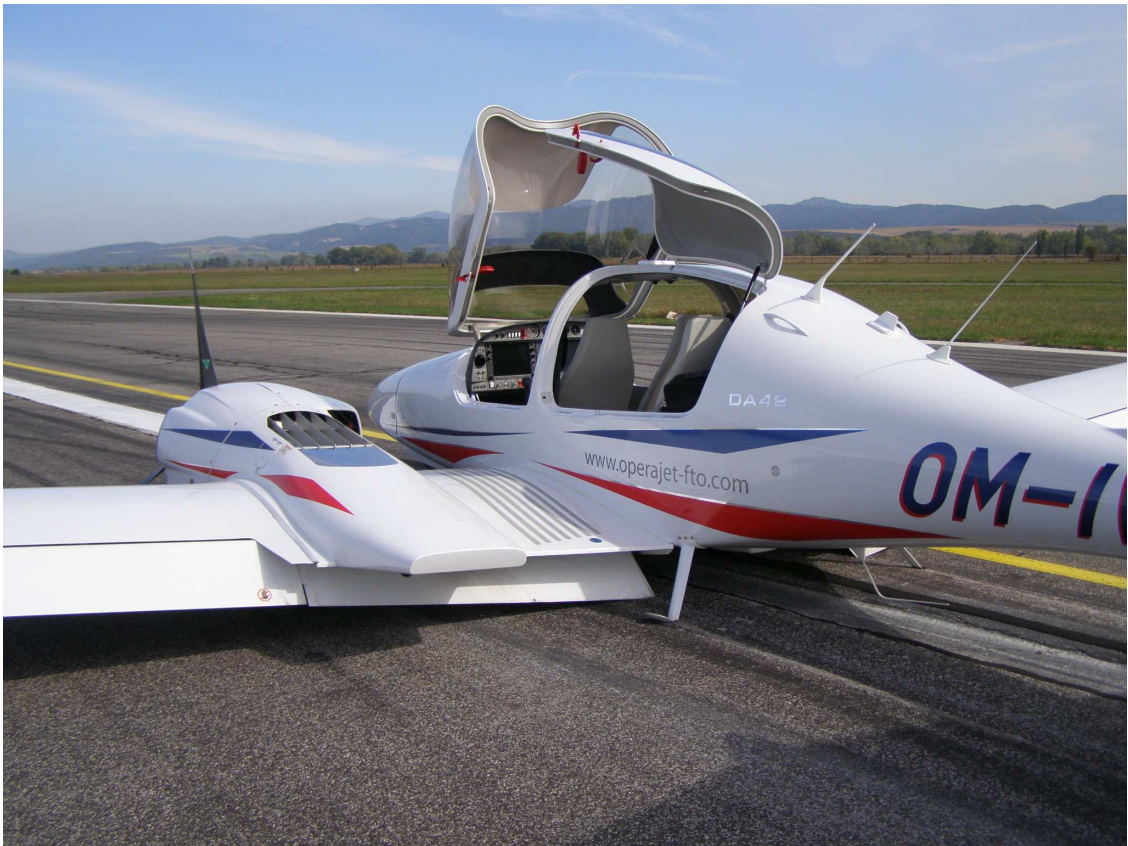
During landing training on the airport LZPP with aircraft with one driving unit switched off, the crew failed to timely extend the landing gear and landed on the asphalt runway ("RWY") with the belly ("belly landing"). The aircraft became damaged in the landing manoeuvre.

Destroyed right-hand engine propeller, scratched bottom engine nacelles, damaged footsteps on both sides of the aircraft.
