AVIATION AND MARITIME INVESTIGATION AUTHORITY  
Námestie slobody 6, P.O.BOX 100  
810 05 Bratislava

# FINAL REPORT

on safety investigation of a serious incident  
of an aircraft type **Z-142**  
registration mark **OM-LNS**

Reg. No: **SKS2019002**

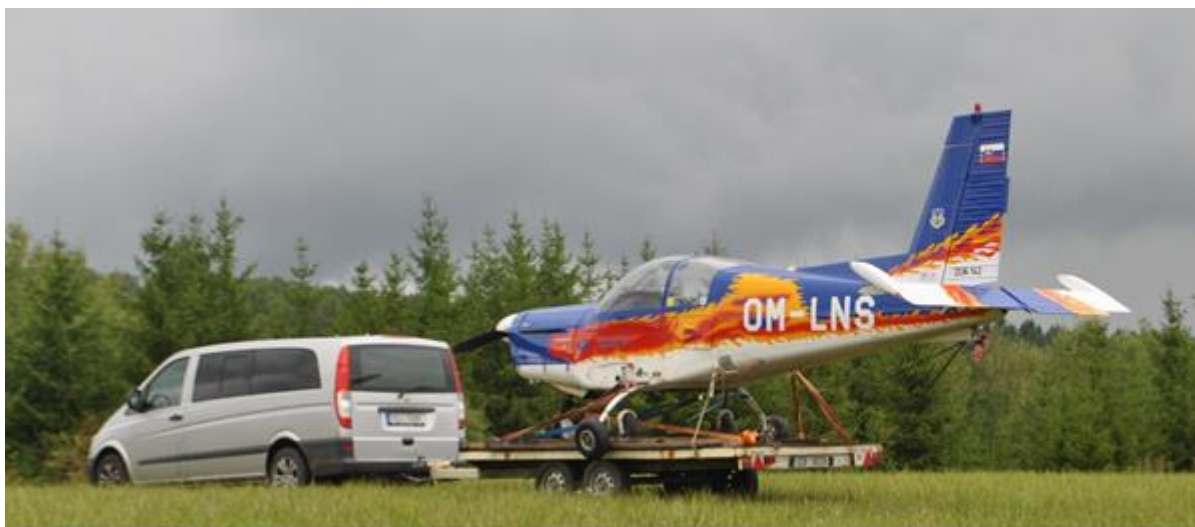
The aircraft sustained major damage during the serious incident (damaged engine - engine block pierced with a torn-off piston rod, damaged propeller, firewall, front gear, left main gear and both parts of the wing).

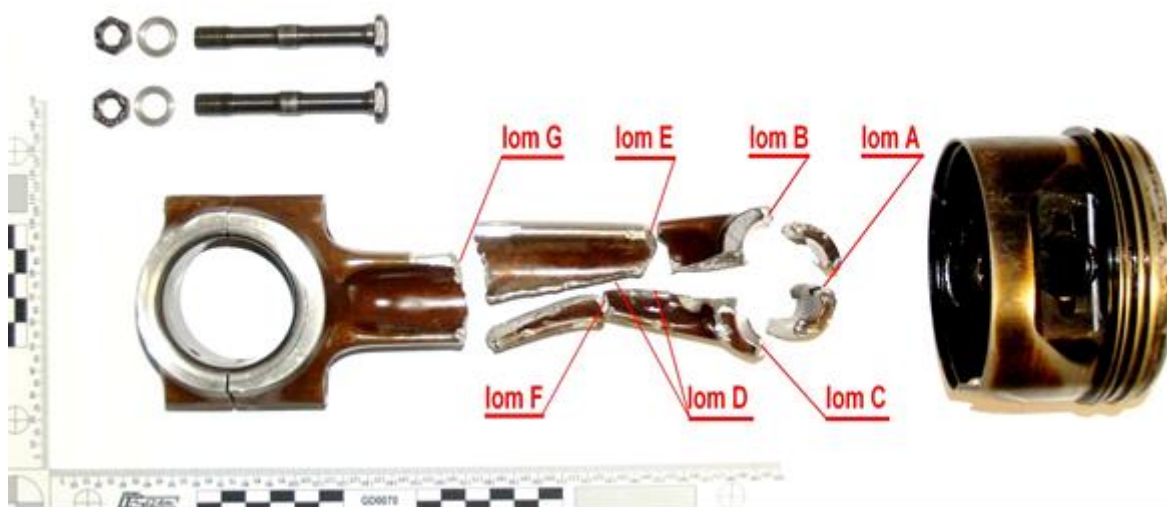
The examined piston rod was broken into seven parts. To make the description of the damaged piston rod clearer, the individual fractures are identified with letters A to G.

It was obvious from the layout and the direction of the fractures that the longitudinal fracture D in the connecting rod shank originated earlier than longitudinal fractures E, F and G – the positions of E and F did not correspond (such fractures were not connected, i.e. the connecting rod shank must have already been longitudinally divided by D at the time when E and F originated).

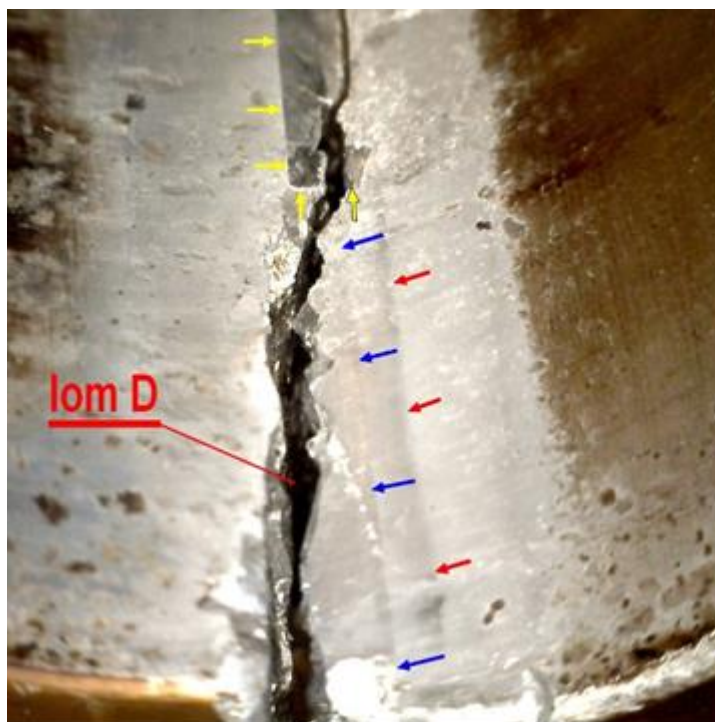
The fracture D originated as a result of intrusion of a solid object into the connecting rod shank in the direction from the inner wall of the connecting-rod eye. Several local material imprints originated at the place when the fracture D initiated (see the lines of such imprints marked with arrows), indicating that G could not have existed at that time, and that at the time when D originated the gudgeon pin was not pushing correctly to the lower part of the connecting-rod eye, i.e. that the upper connecting-rod eye must have been damaged at that time.

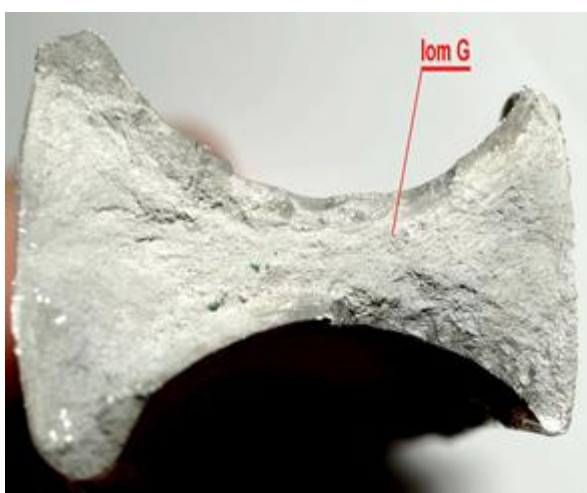
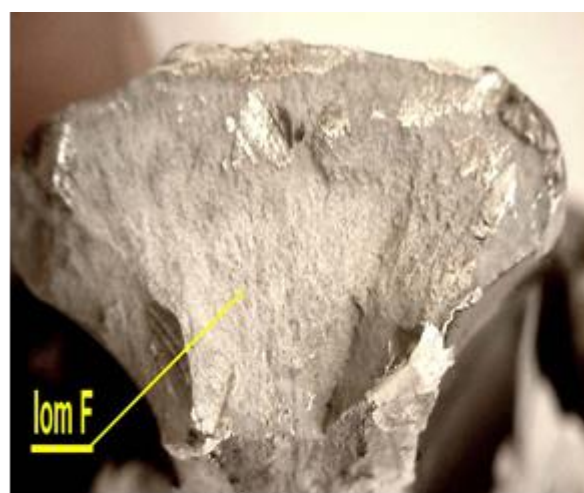
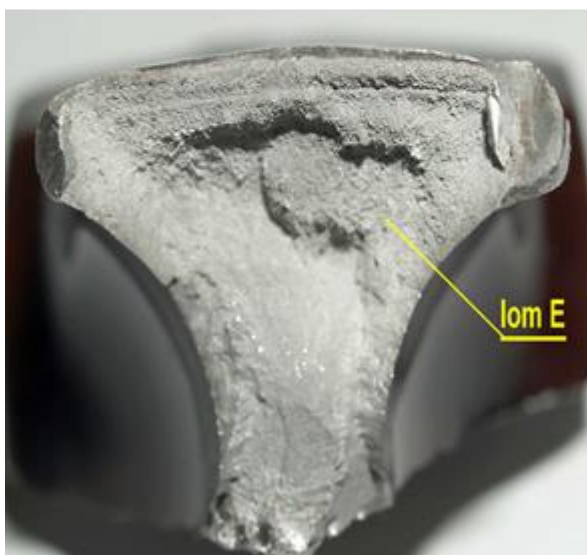
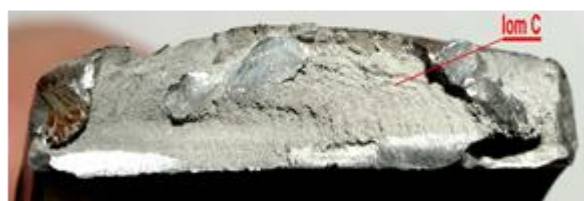
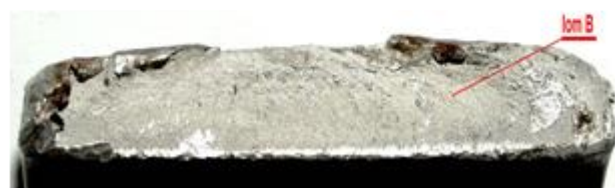
G, F, E, C and B had similar surface morphology (Details of the fracture surfaces on the piston rod)

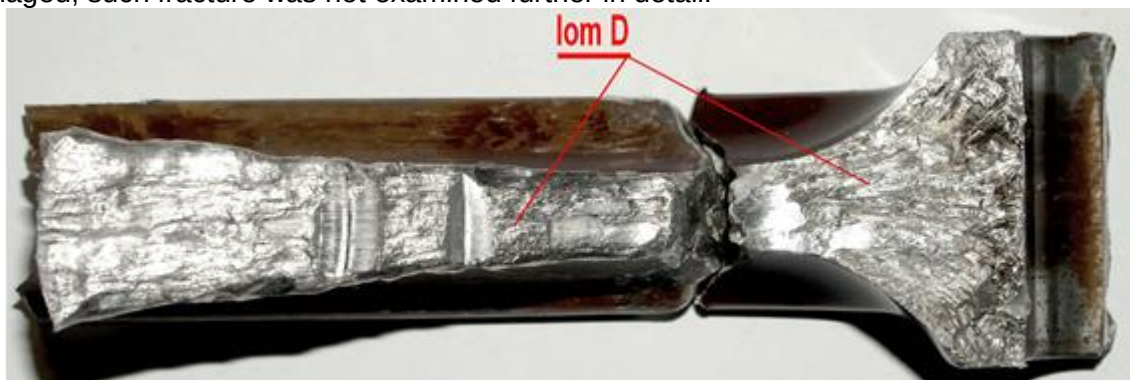
Fracture D had an obviously different morphology and secondarily imprinted surface. Since it has been proved that it originated only when the upper connecting-rod eye was already damaged, such fracture was not examined further in detail.

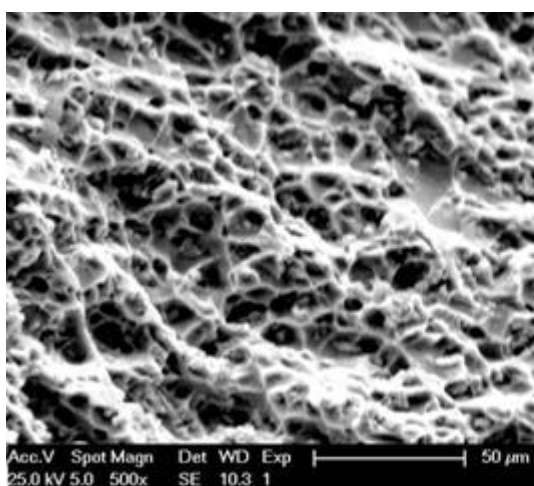
It was discovered from F that the fracture had a nature of a ductile fracture with obvious cup morphology and that the piston rod was made of an aluminium alloy.

*Cup morphology of the fracture F*

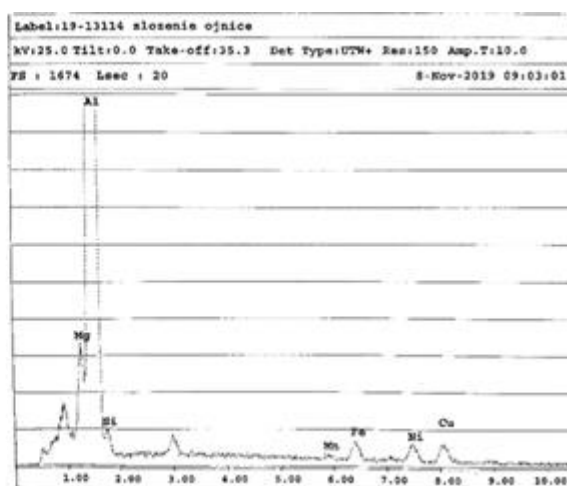
Traces of magnesium, copper, nickel, ferrum, manganese and silicium were discovered on the fracture surface (see the spectrogram).

The piston rod was thus made of an alloy type Al-Cu-Mg. Such alloys are commonly used in aviation. Nickel further increases their firmness at higher temperatures - this corresponds fully to the use of such material for production of piston rods in aircraft engines.

*Spectrogram - material composition of the piston rod discovered on the surface of the fracture F*

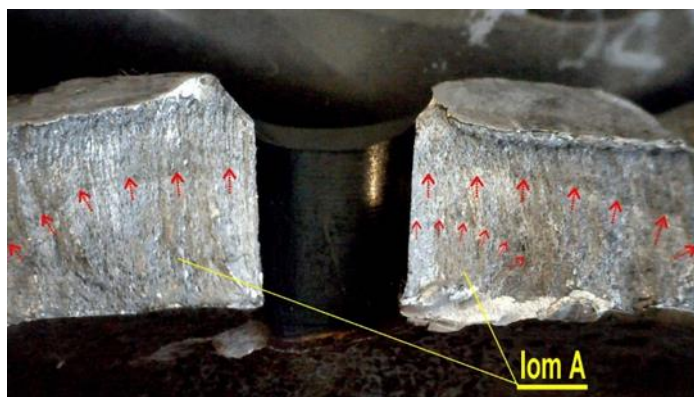
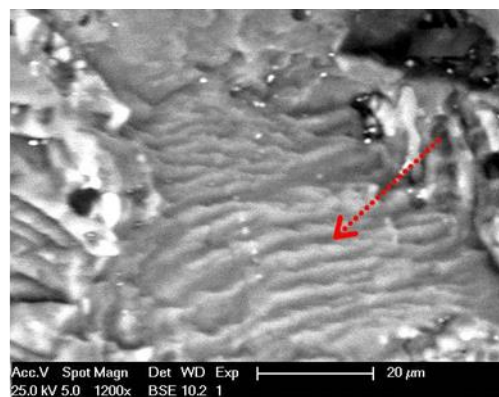
Fracture A located in the upper part of the connecting-rod eye directly at the lubrication aperture demonstrated less obvious signs of a certain staged damage to the material. Presence of the so-called growth striations was discovered during examination, confirming the fatigue mechanism of damage to the material in this part of the piston rod.

Destruction of the piston rod of the piston 5 was caused by development of a **fatigue-caused fracture** in the upper part of the connecting-rod eye. Exceeding the so-called fatigue limit could have been related to rubbing of mechanical impurities between the piston and the cylinder liner in such part of the engine.

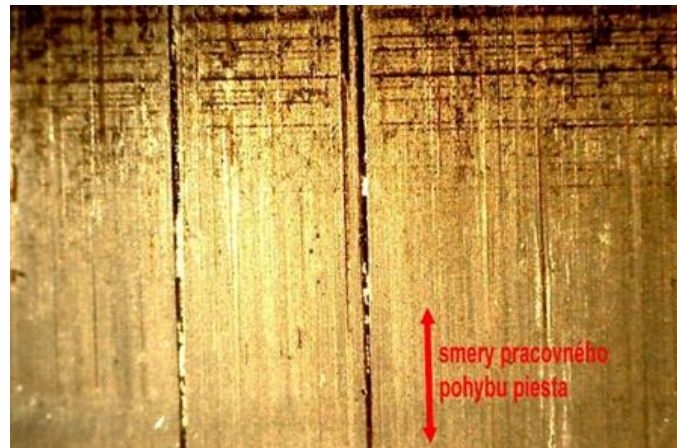
Piston rings of the piston which worked together with the examined damaged piston rod were not damaged. Longitudinal dents resulting from light rubbing of the piston in the cylinder liner were found on the piston side wall; it was due to presence of mechanical impurities located in the working space between the piston and the liner.

*Directions of the working movement of the piston*

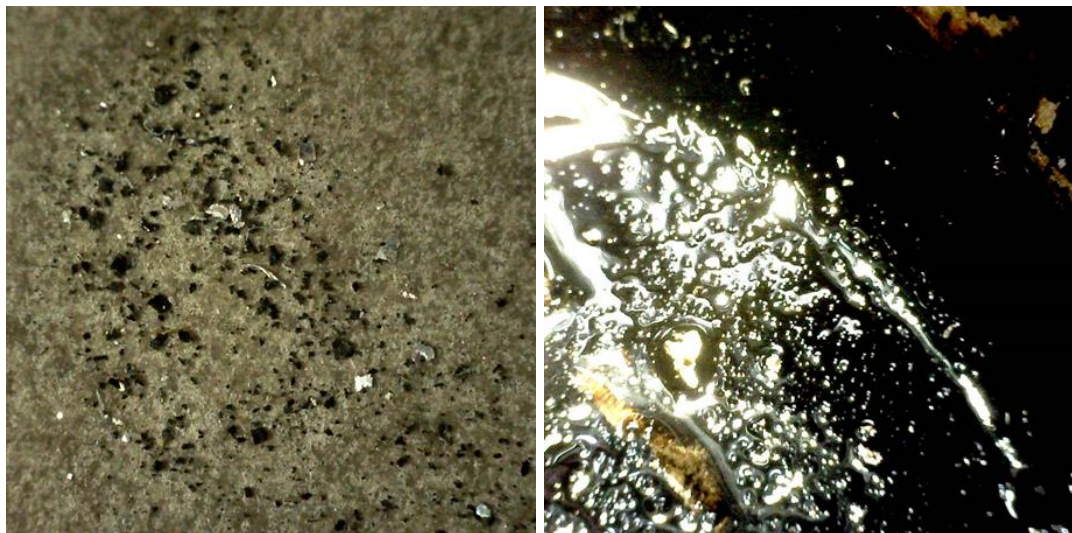
The remaining oil found in the piston cavity contained mechanical impurities. Analysis of such impurities using the scanning electron microscopy method confirmed two types of impurities or particles: particles based on magnesium with aluminium addition and particles based on lead with bromine addition.

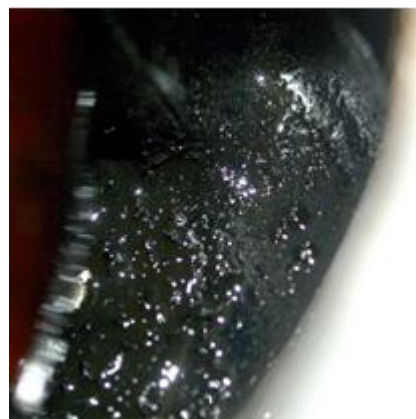
The damaged piston rod and its piston was submitted together with an intact piston rod and its piston for comparison. Mechanical impurities of risky dimensions were discovered in the cavity of such piston as well. No similar longitudinal dents on the surface of such piston were discovered.

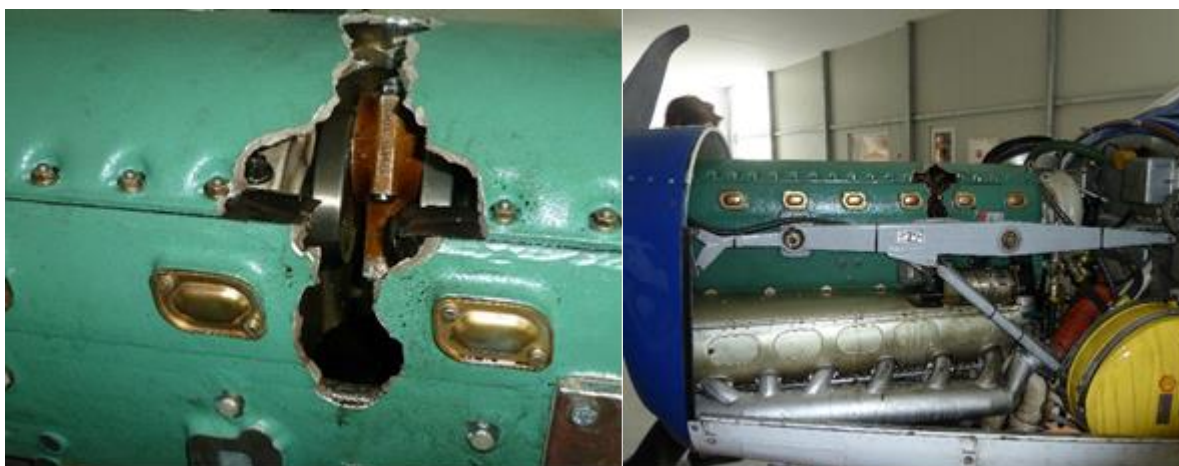
- the piston rod of the piston 5 was destroyed during the occurrence; it pierced the engine block and its remains were found in the engine;

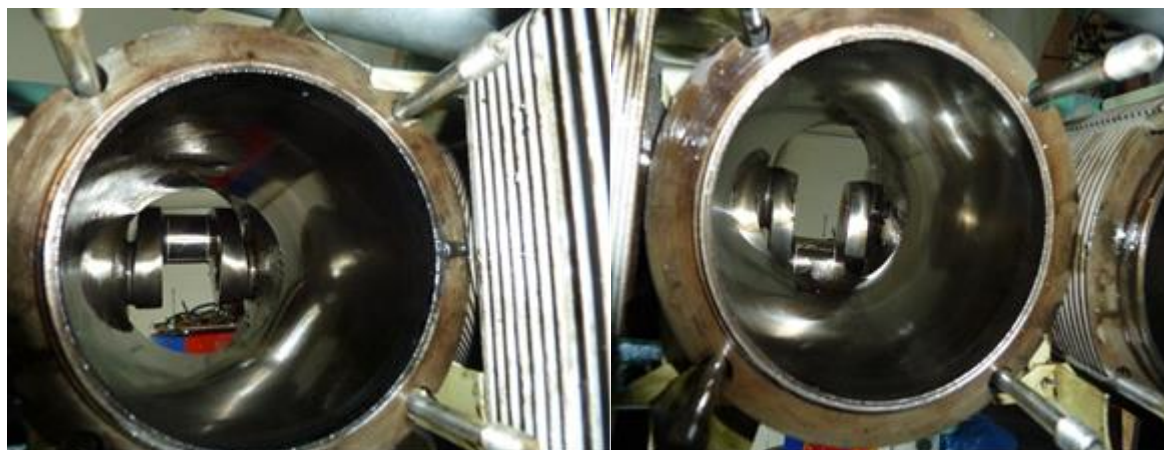
- when the oil filter was disassembled and checked, an undefined amount of water was found in oil;
- no damage was discovered on the walls of the dismantled cylinders 4 and 5 which would indicate engine rubbing; however, their significant carbonization was discovered.
