FINAL REPORT

on the safety investigation
of flying sports device

type **paraglider** FORCE 2M, APCO Aviation LTD
without a registration mark

Reg. No: **SKA2019006**

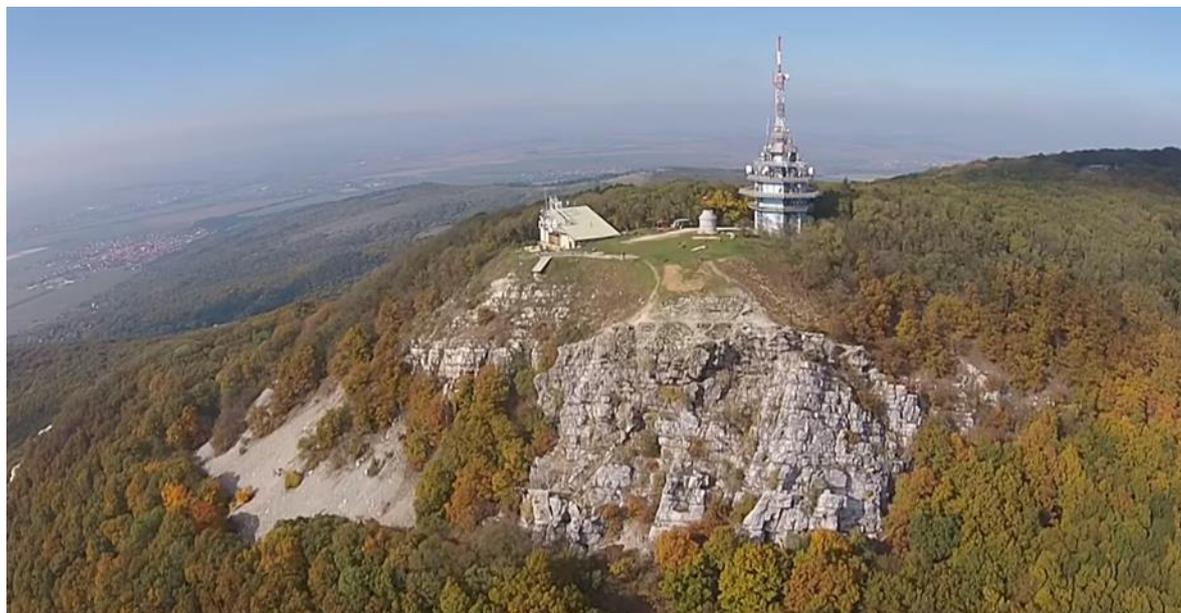
At the end of the launch area the pilot had a feeling he had lifted off the ground to height of 1-2 metres. Then the wing deflated and the PG fell onto a rocky terrain located below the pilot's feet in the direction of the launch. The pilot did not manage to clear the rocky terrain. The bottom part of the seat hit a rock and bounced to the right.

View of the launch area.
