FINAL REPORT

on a safety investigation of the accident
of flying sports vehicle
paraglider type **GRADIENT / BiGolden 3 - 39**
with registration mark **OM - L101**

Reg. No.: SKA2017006

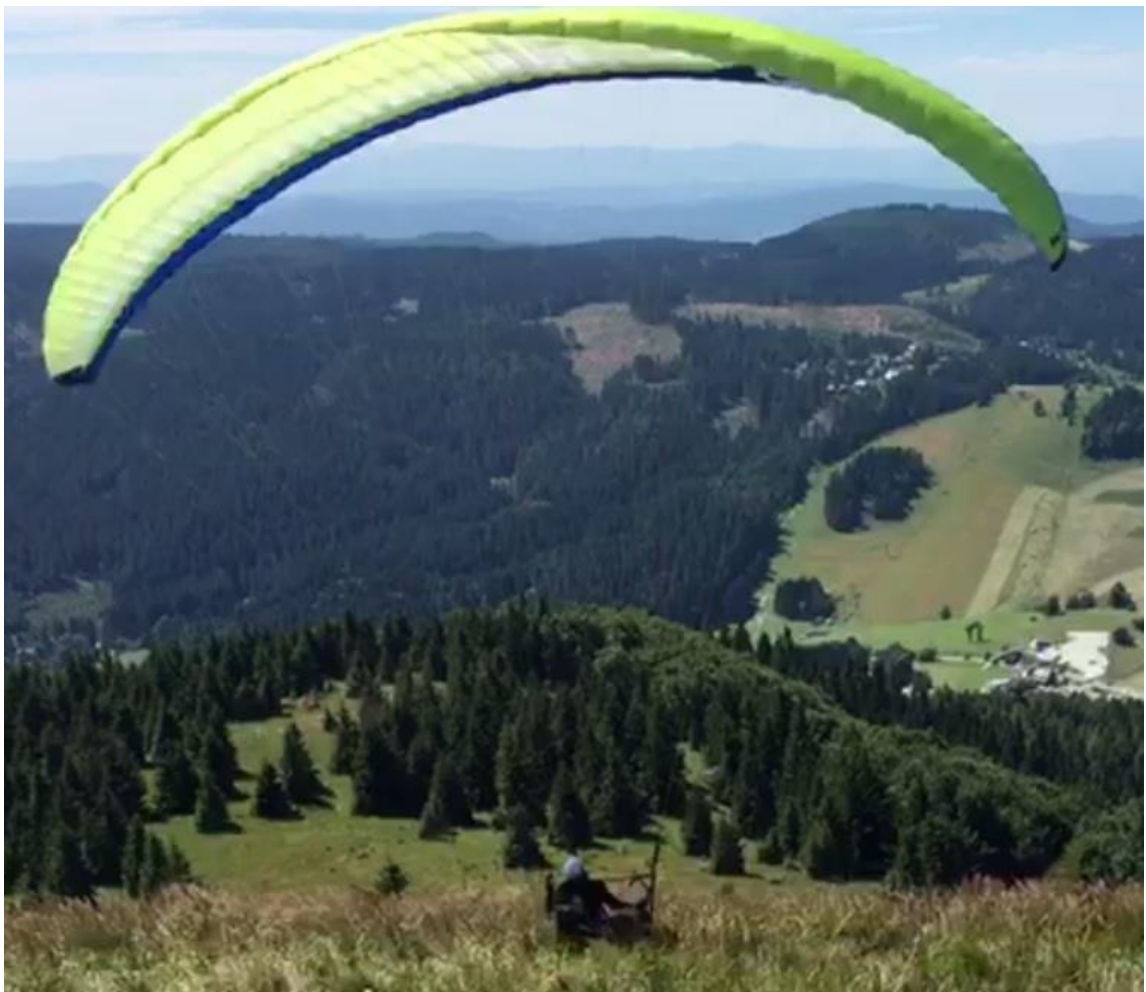
Fig. 1 View of the first attempt to take-off

The pilot made preparations for take-off with a tandem PG and at about 9:00 he made the first attempt at take-off. Due to the course of the take-off, when the passenger, probably as a result of the unexpected jerking in the direction of the inflation of the PG, she was unable to keep her feet and fell to the ground, the pilot disrupting the take-off by symmetrically pulling the brake lines. Based on the video shot by the flight accident witness, it is obvious that the pilot had not been clamped with the right carabiner to the tandem bracket at the time of the first takeoff attempt. The pilot, but neither the people who were by the place of takeoff, did not notice this.

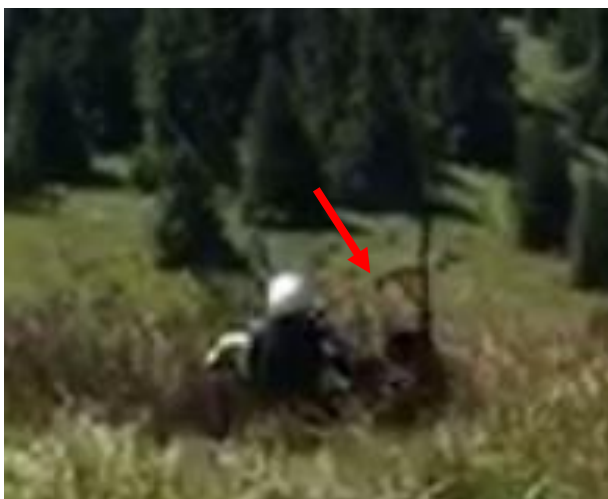
The pilot took off at 09:04. From the moment of take-off, it was clear that the flight was not running in a standard way because the pilot evidently hovered only on the left carabiner. The right carabiner was not attached to the tandem bracket. The passenger was properly fastened. After the take-off, the pilot attempted to maintain the PG in forward flight with the help of the brake lines, but due to the need to grab the right side of the PG, the right half of the wing went into a negative turn. In an effort to halt the negative turn, the pilot launched the right brake line, causing the right side of the PG to regroup and accelerate. This acceleration immediately led the PG into a left descending spiral, which the pilot was unable to compensate. The flight lasted 31 seconds and ended with a crash into the field in the left descending spiral. Both crew members suffered fatal injuries.

Fig. 2 Detailed view of the pilot showing the non-attachment of the carabiner to the tandem bracket

The pilot did not attach the right carabiner into the tandem bracket.
Insufficient performance of five-point pre-flight check by the pilot.

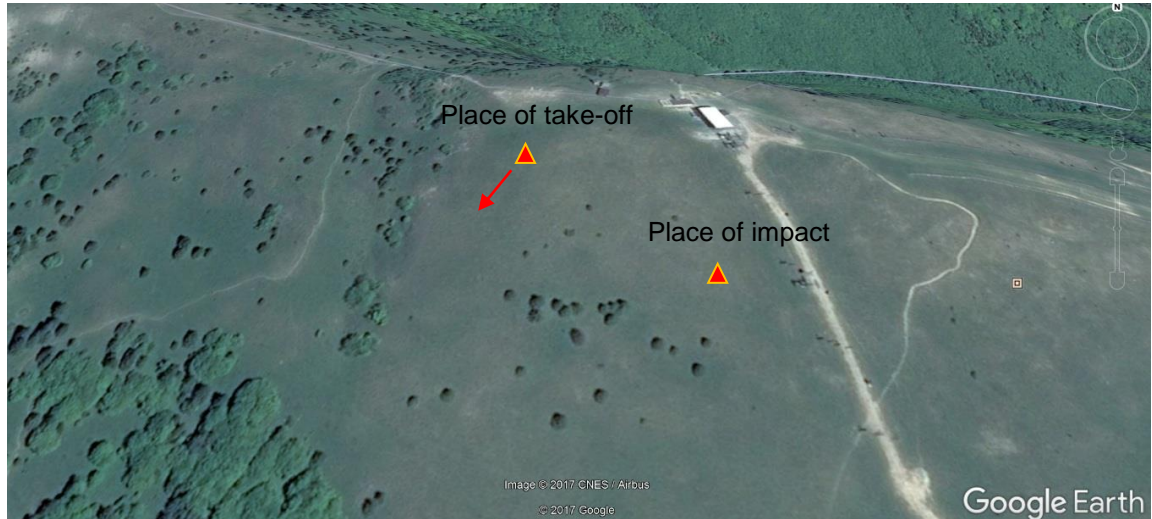
The PG fell to a field near the starting point.

Fig. 3 View of the take-off and impact site in Donovaly - Nová hoľa

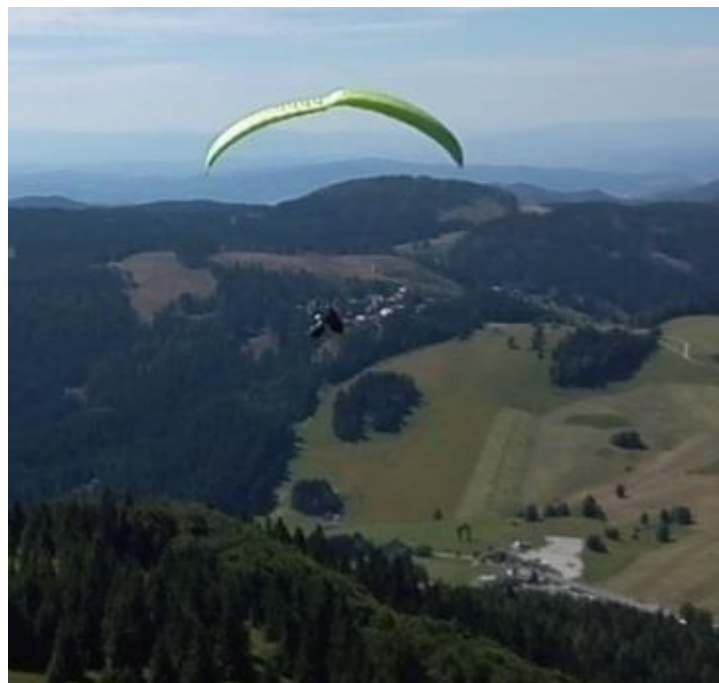
Fig. 4 Deformation of the PG support surface due to uneven load

The deformation was caused by the uneven weight distribution of the crew. The greater part of the weight was on the left half of the PG and therefore the parachute was trying to spontaneously turn to the left side. The pilot compensated that for the braking of right half of the wing by the brake line, which is visible in Fig. 4, where the outtake edge on the right side of the PG is significantly impeded.

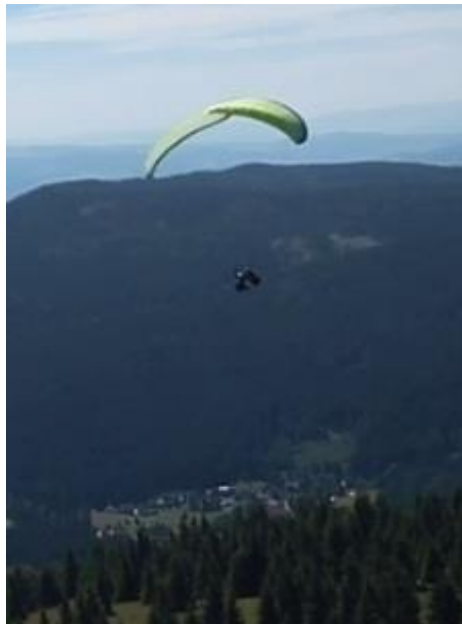
From the moment of takeoff, the pilot attempted to maintain the PG under control, but due to the need to brake the right side slightly, the right half of the wing went into a negative turn.

Fig. 5 The moment of transition of the right half of the PG into a negative turn

Due to the fact that in this mode the pressure inside the wing is very low, there was also a deformation of the support surface, which was clearly split into half and the PG went into a negative turn. After two seconds of dropping in a negative turn, the pilot released the right brake line as a result of which the right side of the PG restored and accelerated. One second after the release of the right brake line, the PK turned 90° to the left and went into a left descending spiral. At this point the pilot was unable to steer the PG because he did not have the brake line in his hand. Because he was hung only on the left carabiner, he could not reach the right brake line. In the next 5 seconds, the rotation of an approximately 180° under continuous fall occurred and subsequently the PG impacted on the ground.

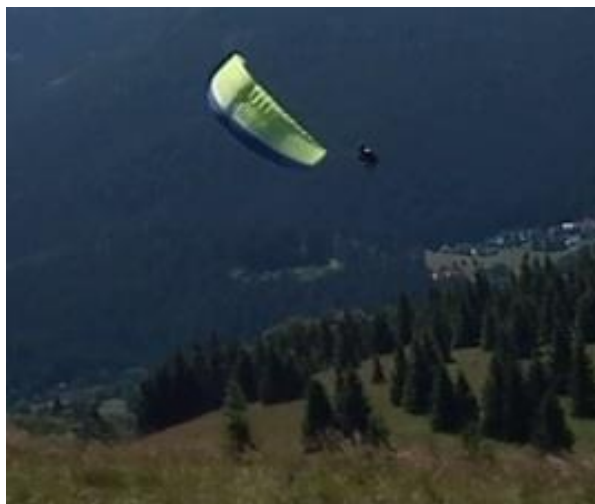
Fig. 6 Falling spiral

Both crew members suffered fatal injuries. The pilot did not use a rescue parachute, but it cannot be ruled out that he did try. Since the pilot had the rescue parachute handgrip on the right side of the seat, it was not possible to use it until the right brake line was released. But at the moment the pilot released the brake line, the PG gathered dynamics so dynamically that feeling the release system of the rescue parachute was almost impossible. Another adverse factor was the proximity of the ground, which greatly reduced the time of possible use of the rescue parachute. Even at the highest point of the flight, the use of a rescue parachute would have been questionable and would have depended on many factors.
