FINAL REPORT

on investigation of accident
of aircraft DA-20-A1 Katana
Registration No OK-CLO

Reg. No.: **SKA2014004**

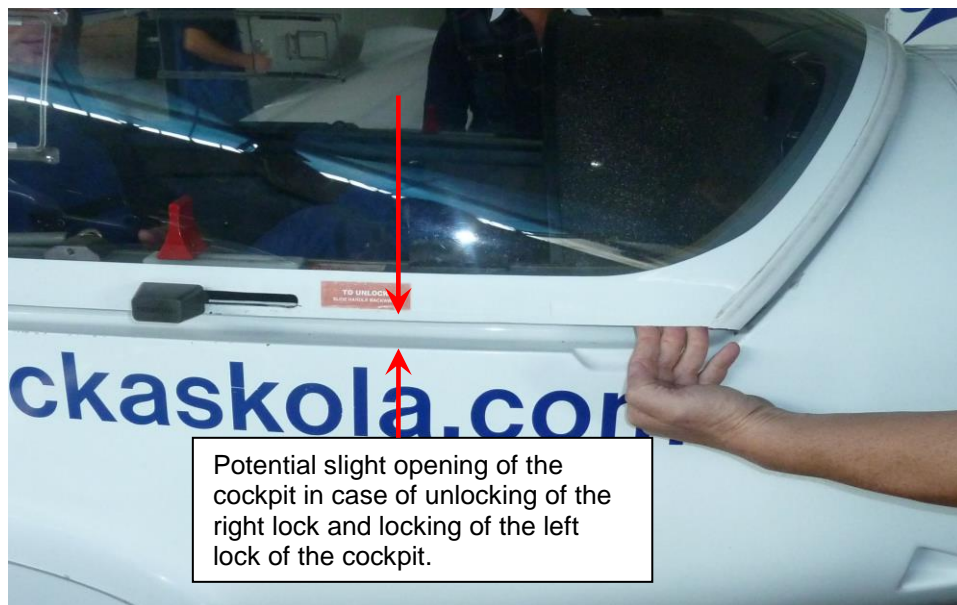
Fig.3 Activation of the LED lamp in the cockpit

The commission was unable to unambiguously prove the cause of separation of the cockpit canopy.

Fig.3 documents a slight motion of the cockpit lock handle (as prerequisite of the opening of the cockpit), which causes the activation of the red LED lamp “CANOPY” situated in the view field of both the pilot and the passenger.
