FINAL REPORT

on investigation of accident
of helicopter type **CH-7B Cicaré**
Registration No. **OM-M669**

Reg. No. **SKA2014006**

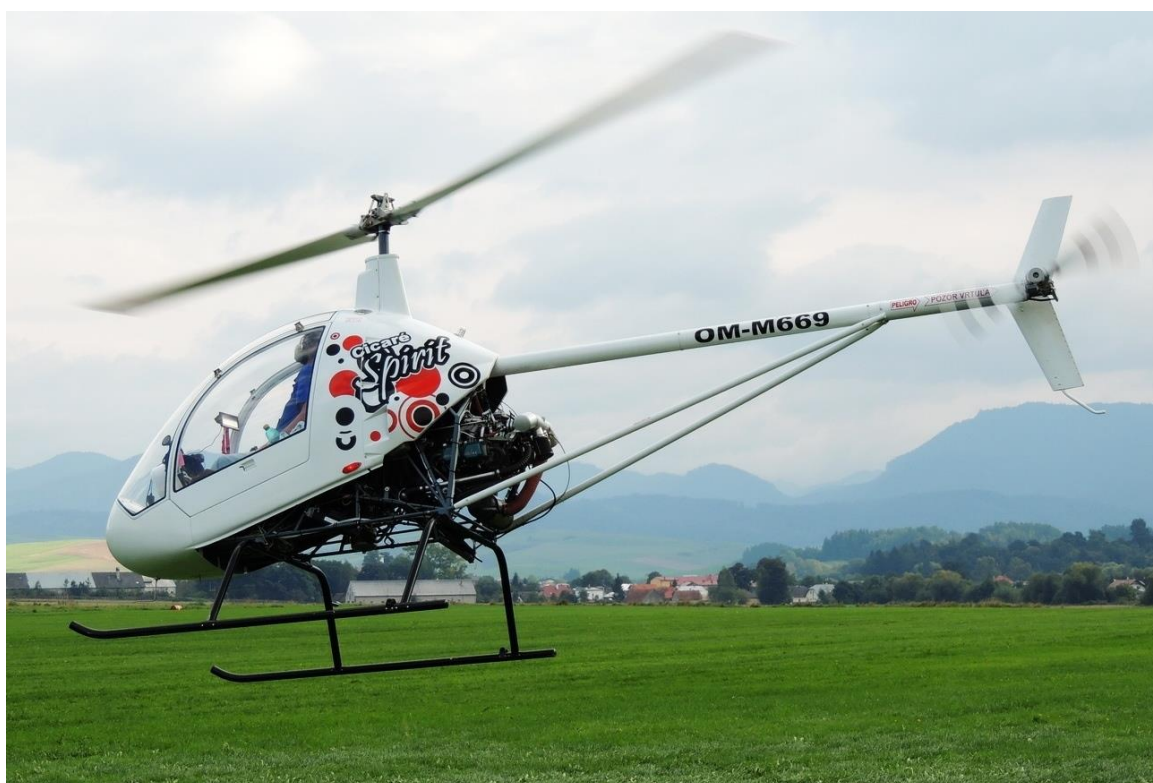
FSV was destroyed in the accident – broken rotor blades, separated tail section, broken cockpit canopy, damaged and bent parts of landing gear.
