FINAL REPORT

on the safety investigation of the air accident

aircraft type **L-29 Delfin**

Registration Mark **OM-JLP**

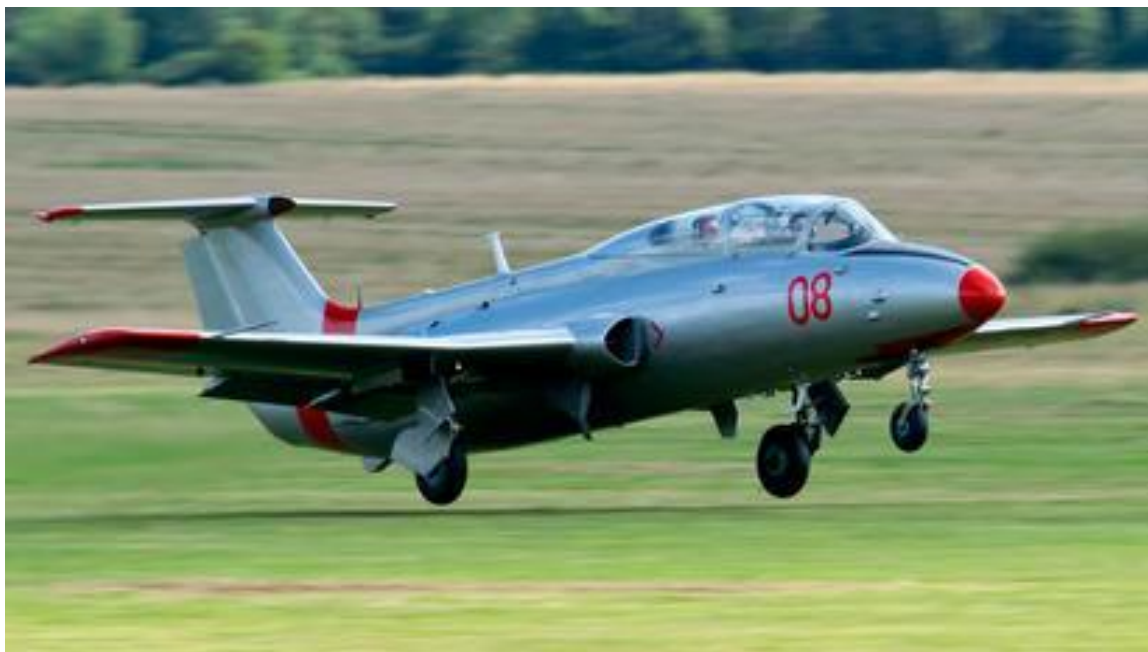
The aircraft was damaged to a large extent in the abutting and movement along the concrete RWY (covering on the rear fuselage, bar nos. 5-26, main landing gear covers, damage by local fire in the engine section, damaged wing beams, damaged AFT) , so its repair would be inefficient.
