# FINAL REPORT

on an safety investigation into an air accident  
of the flying sports vehicle of a **paraglider**, type: Axis Paraglider Vega 4 ML

with the registration mark OM - L254

Registered by the "Aviation and Maritime Investigation Authority" under reg. No. SKI2017005

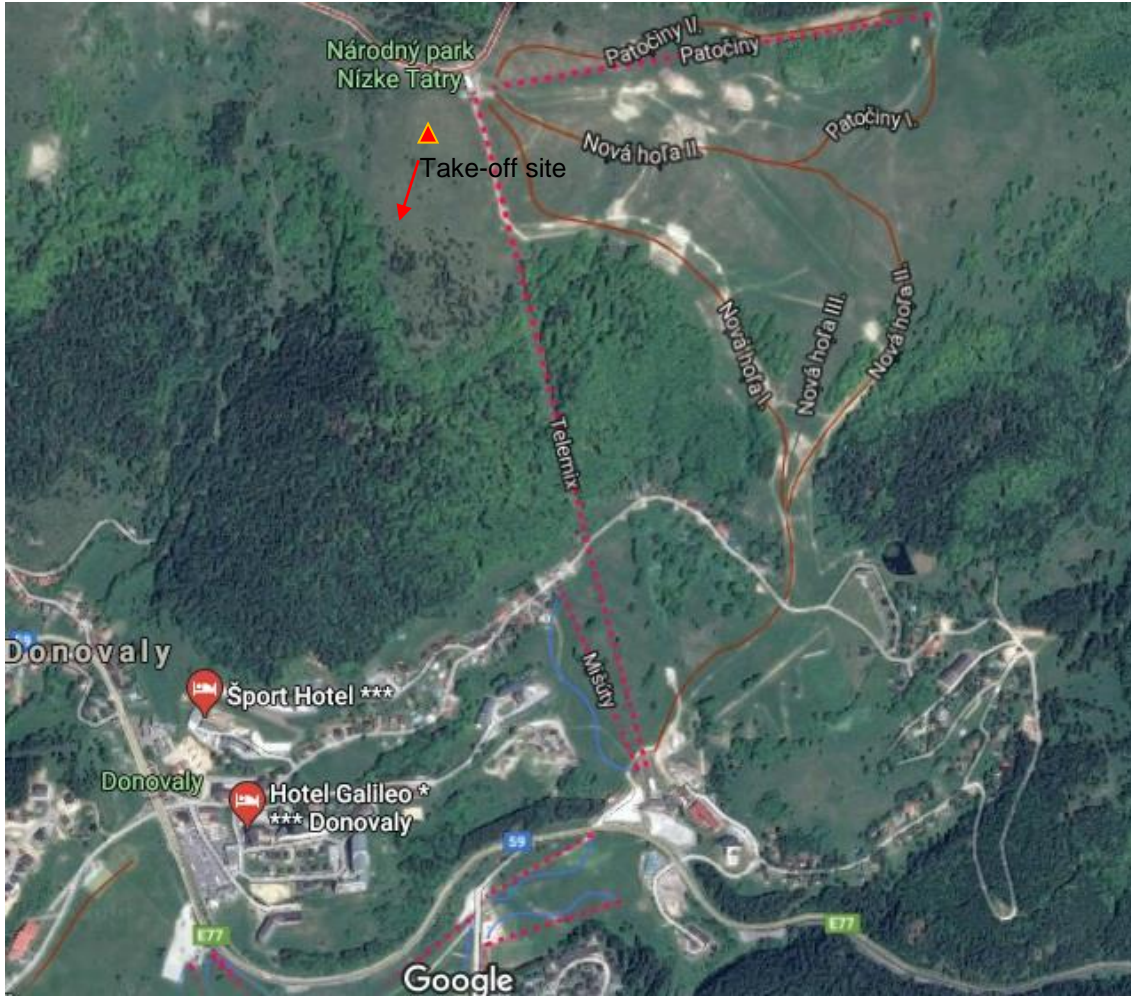
Take-off and landing sites

At the last moment of his approach, the pilot decided to change his landing area due to a strong wind which prevented him from flying to the official landing area. As a result of the wind, there was significant orthographic turbulence in the landing area, caused by obstacles in the landing area, the expressions of which were intensified by thermal bubbles tearing off, which was caused by uneven overheating of the terrain surface in the landing area.
