FINAL REPORT

on investigation of serious incident
unauthorized access of vehicle to an active RWY 31

Place: M.R. Štefánik Airport Bratislava / LZIB

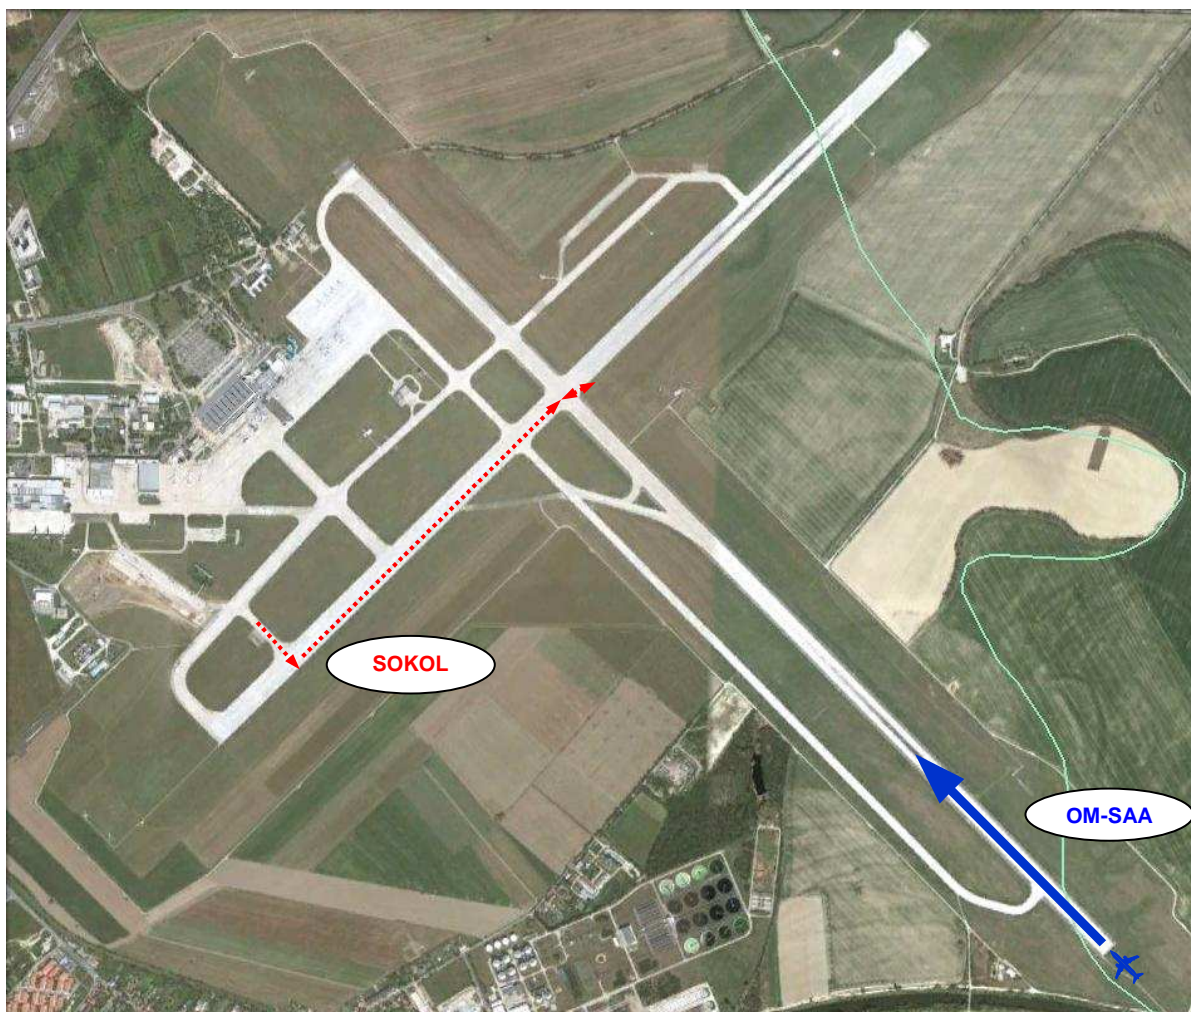
At 10:55:40 TWR informed that the vehicle „SOKOL“ had not been permitted to enter RWY 31, but that it had been supposed to stop in front of RWY 31 and wait for further instructions from TWR, or to continue to TWY F and TWY G and to stop in front of RWY 31. „SOKOL“ informed TWR that he had forgotten to stop in front of RWY 31 when performing his activity.

The commander of aircraft OM-SAA broke off final approach in an altitude of 400 ft AGL (i.e. about 1,930 m in front of THR RWY 31) and following the instructions of TWR made a manoeuvre – procedures for repeated final approach (communication on frequency 120.9 MHz). Only after this manoeuvre and landing he received information that the vehicle „SOKOL“ had been moving on RWY 31 and blocking the air traffic.
